GLACIAL LAKE OUTBURST FLOODS AND RISK ENGINEERING IN THE HIMALAYA

Jack D. Ives

ICIMOD OCCASIONAL PAPER NO. 5

Kathmandu, Nepal
November, 1986

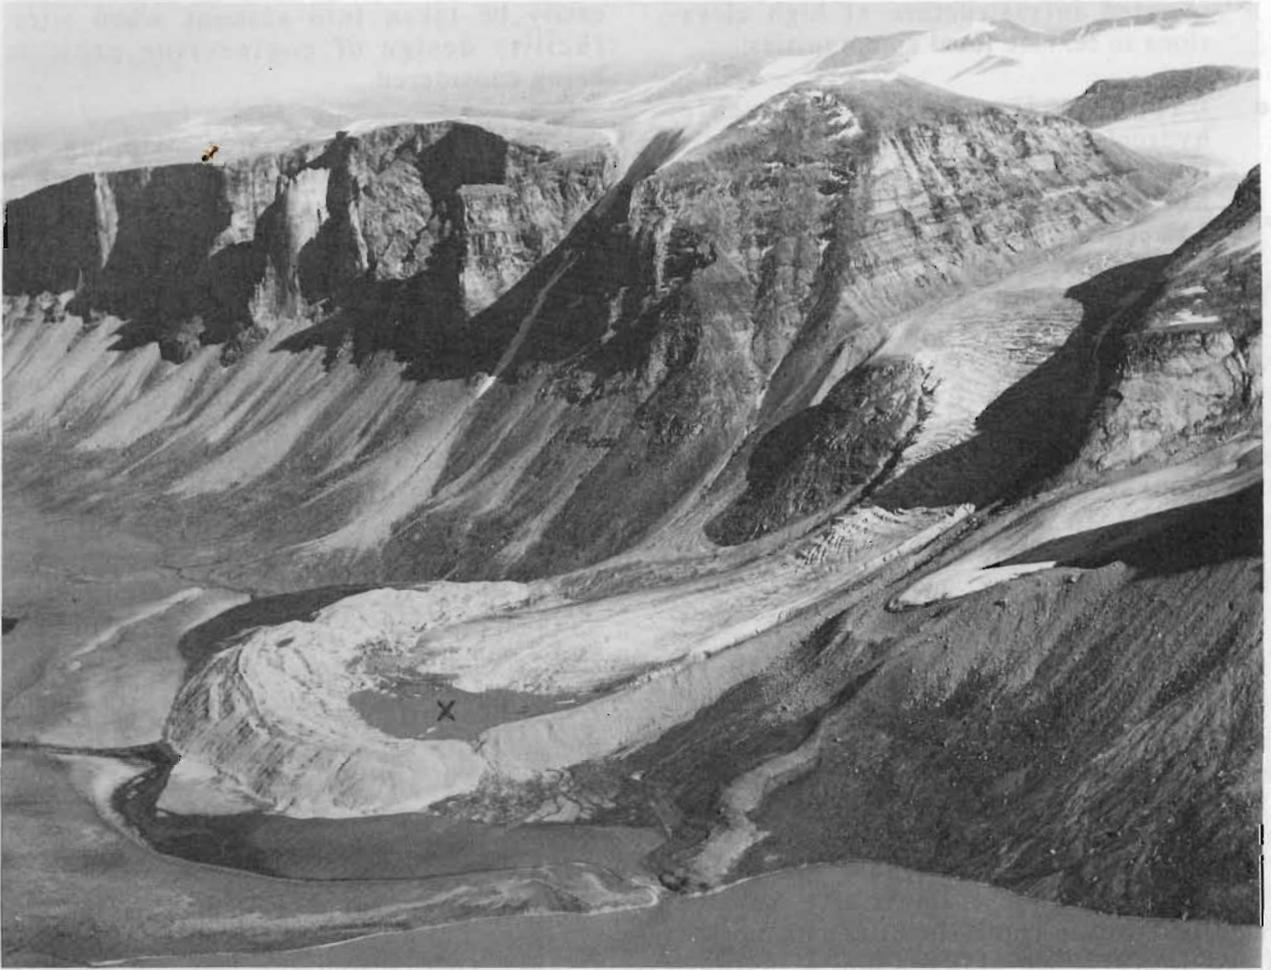
Plate 1. Small outlet glacier with end and lateral moraines, northeast Baffin Island. The lake (X) is a typical moraine-dammed lake, held up by an ice-cored system of end moraines that are 100 metres high.

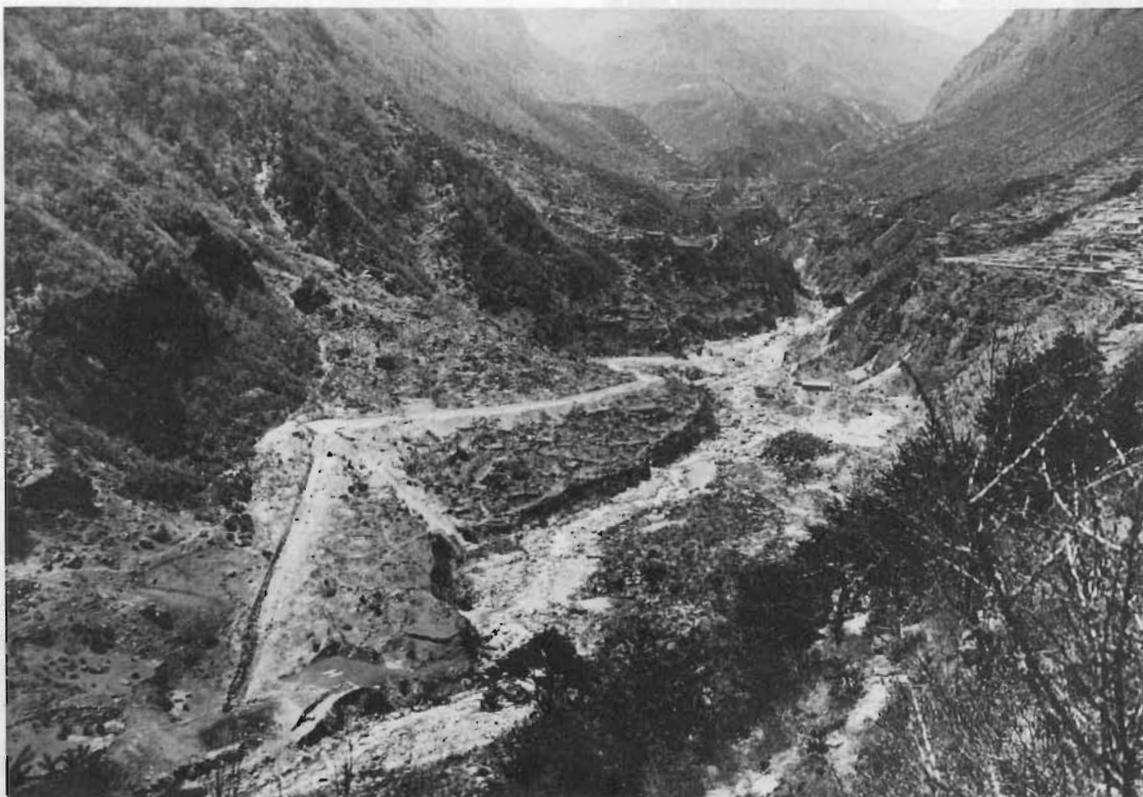
Plate 2. Site of the Namche Small Hydel Project looking upstream from the Namche Bazar trail. Photographed on 4 April 1985, by D. Vuichard.

Comparison of two sets of ground photographs, one set from the north side of the Bhote Koshi looking directly across the river onto the debris fan, and the other set taken from the Namche Bazar trail looking upstream, clearly demonstrate the extent of the damage. The first set was photographed by Dr. Victor Galay in November 1984, and after 4 August 1985; the second set was photographed by Daniel Vuichard on 4 April 1985, and 19 Oc-

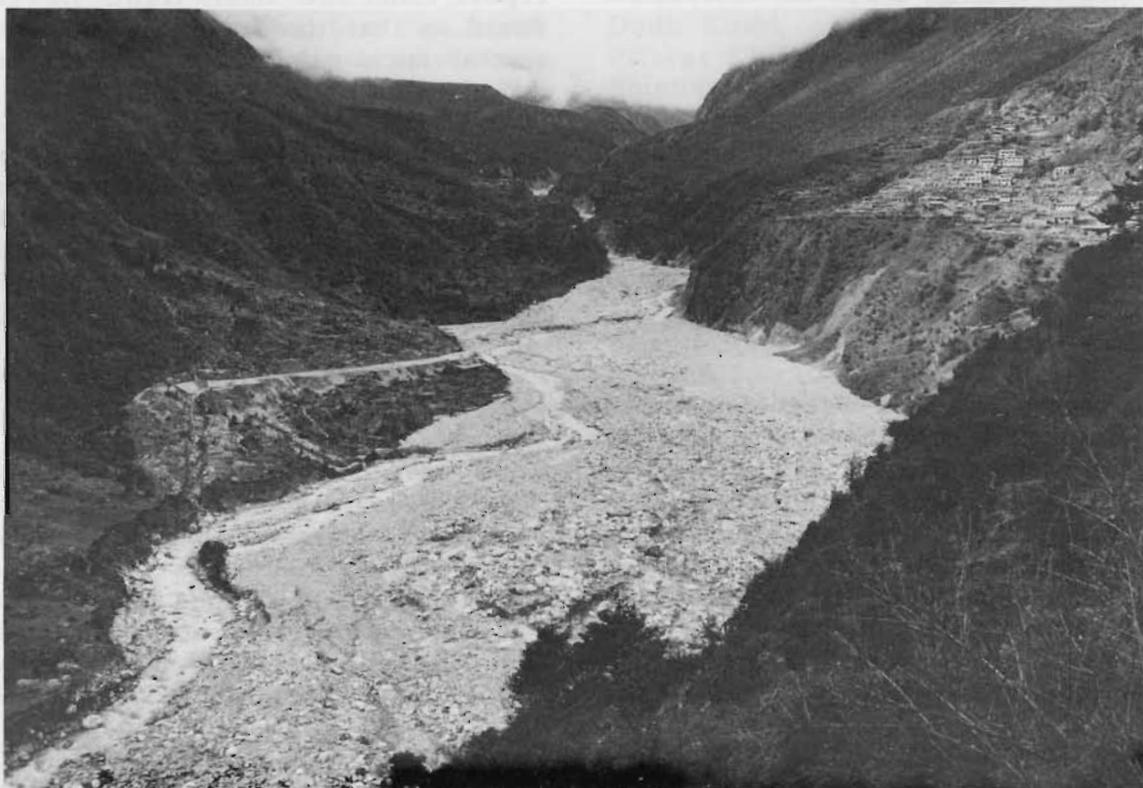
Plate 3. Nearly identical view to Plate 4, photographed after the *jokulhlaup*, 19 October 1985, by D. Vuichard. Note the extensive erosion to the debris fan and the massive accumulation of coarse alluvium in the now much widened riverbed.

Much erosion also took place on the north side of the stream. This erosion resulted in the total destruction of the weir and headrace intake, the upstream half of the headrace canal, the lower half of the penstock channel, the foundations for the power house, the tailrace, and the helicopter landing pad. In addition, the river channel, or flood plain, was extensively widened and heavily aggraded with three to seven metres of large-diameter debris. The character of the Bhote Koshi channel in this section, as well as that of the debris fan, has been totally changed. This has probably made the site unsuitable for any salvage or reconstruction action, even if it is assumed that the draining of Dig Tsho was a unique event and that there is no likelihood of future *jokulhlaup* occurring from any alternate source within the Bhote Koshi catchment. The latest report from the Small Hydel Development Board is that the feasibility of constructing several micro-power stations away from the main stream is being explored.

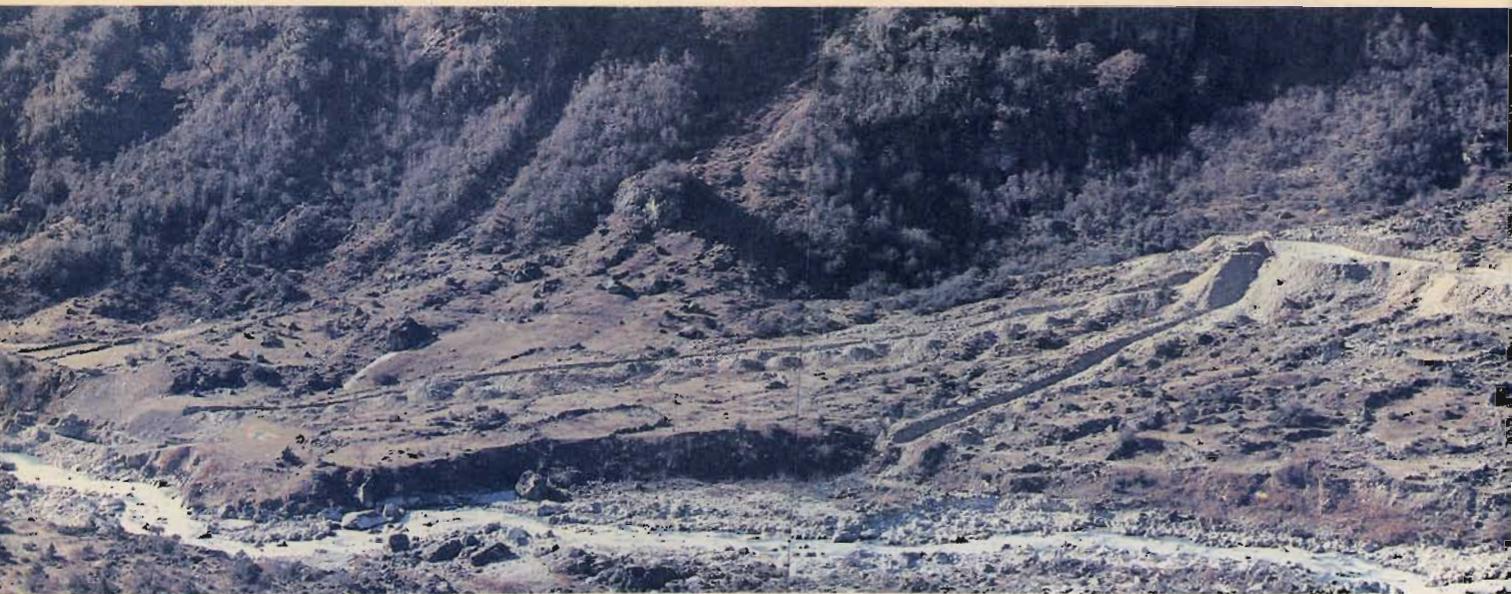
Plate 4. Panoramic view of the Namche Small Hydel Project site by Dr. Victor Galay in November 1984. The photographs are taken from the north side of the Bhote Koshi looking onto the debris cone. The headrace canal cuts conspicuously sub - horizontally across the fan. Undercutting of the fan has occurred during the preceding summer monsoon at (a) and (b).

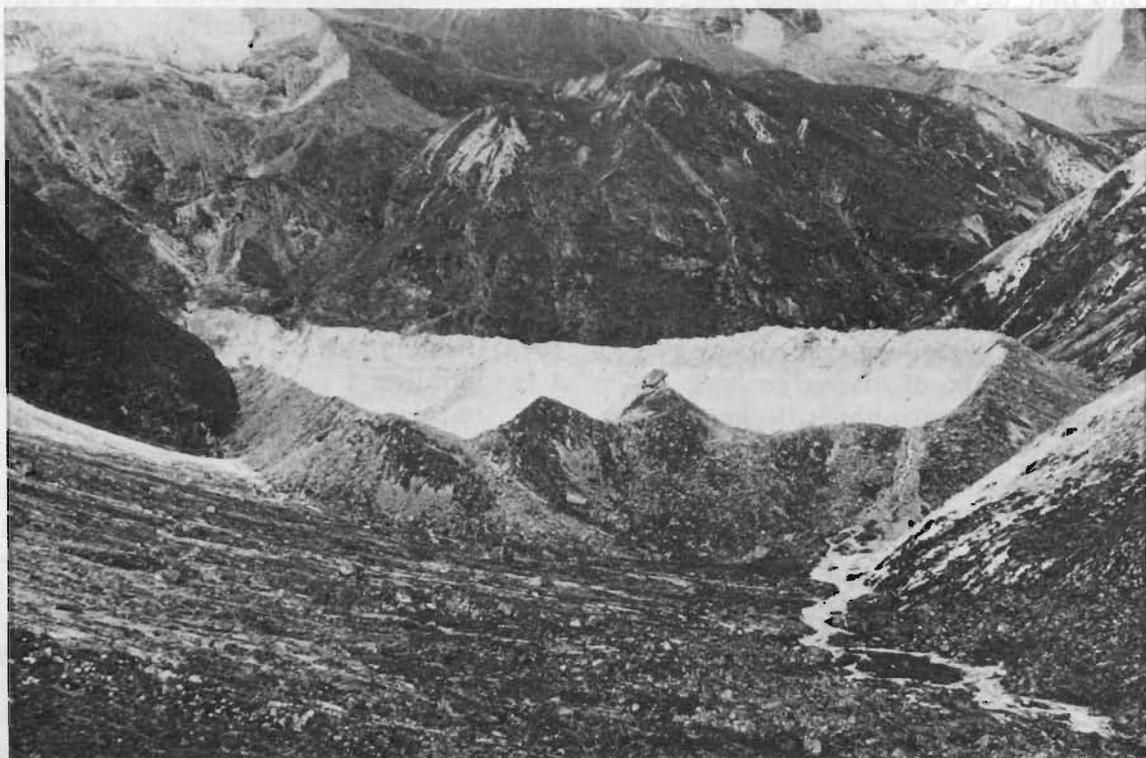
Plate 6. A wide angle view of Dig Tsho, and the intact curve of the end moraines with the small stream draining from it.
Photograph by M. Zimmermann, 3 September 1982.

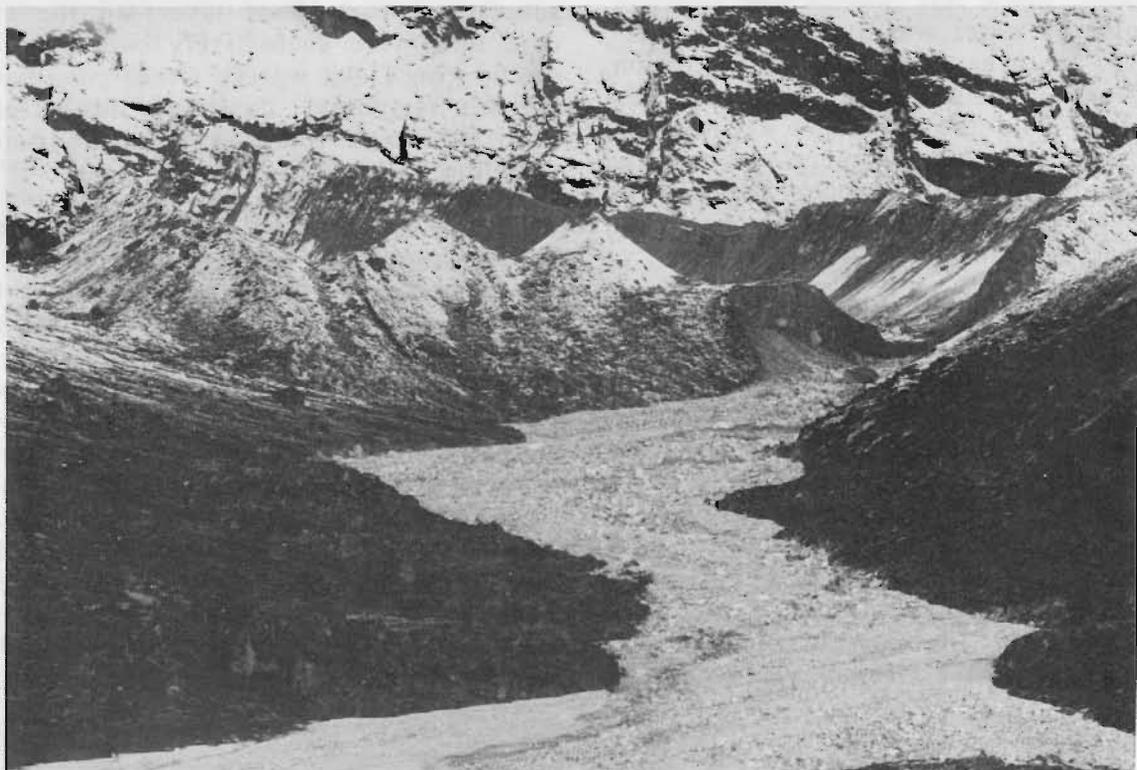
Plate 7. Similar view to 6., but taken after the 4 August 1985 *jokulhlaup* showing the breach in the end moraine of the Langmoche Glacier.
Photograph by D. Vuichard.

Whichever reconstruction is correct, both agree that the immediate cause of the Langmoche *jokulhlaup* was the sudden fall into the lake of a large mass of avalanche ice (and possibly rockfall debris) which sent a surge wave across the moraine dam. A precondition for the *jokulhlaup*, however, was that the level of Dig Tsho was at, or close to, the low point on the end moraine dam. As has been shown, this condition had prevailed for much, if not all, of the preceding several years (minimum, 1982-1985). Pradhan and Gysi concluded that within a few minutes 1 mill.m³ of water were released and, in places, the flood wall in the Bhote Koshi and Dudh Koshi exceeded 15 metres in height.

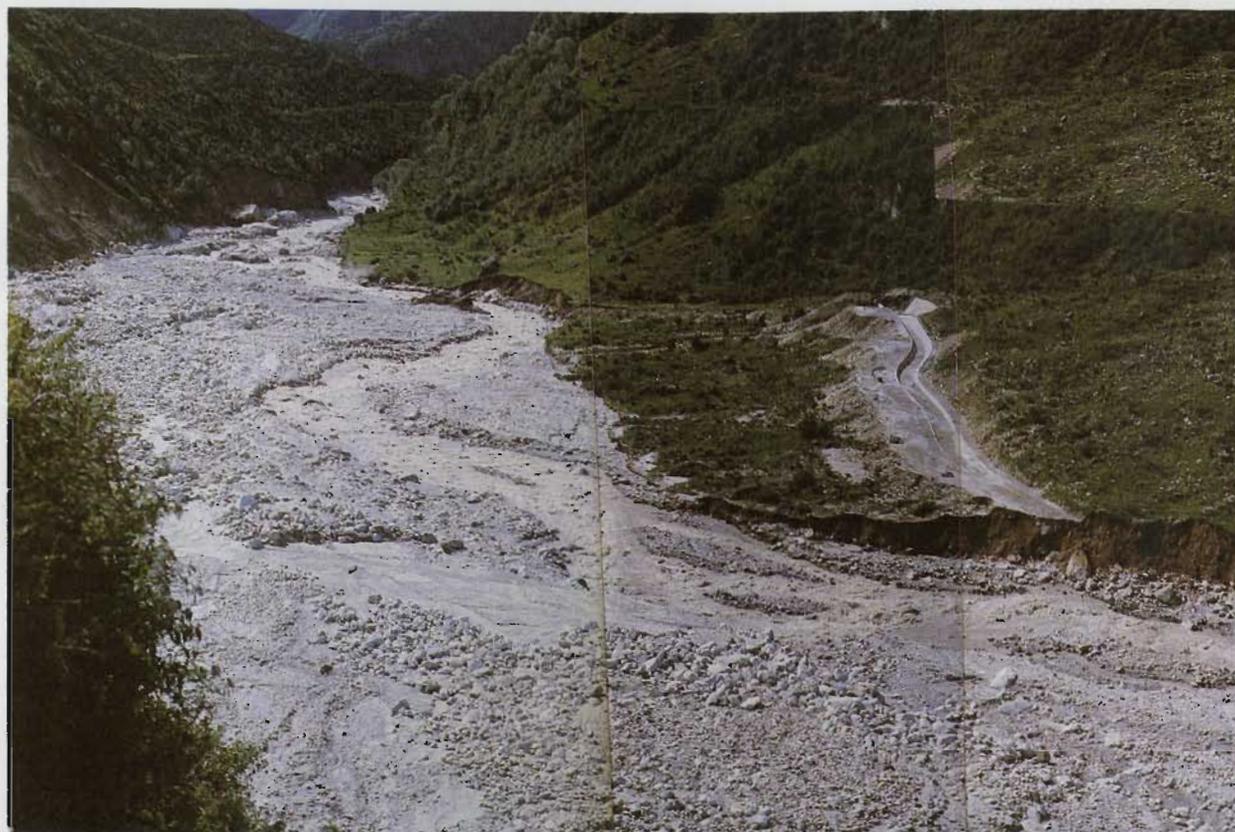
Plate 9. Channel of the Bhote Koshi in the vicinity of the hydel project after the 4 August 1985, *jokulhlaup*. Note the extensive aggradation as well as heavy erosion (of the debris fan) in the same stretch. Photograph by Dr. Victor Galay.

The local communities, of necessity, replaced the eroded sections of trail. These emergency efforts were piecemeal and uncoordinated, and the end result was less than satisfactory (Plate 9). For instance, seven acci-
