# Glacial Lakes and Glacial Lake Outburst Floods in Nepal

This report was prepared by the International Centre for Integrated Mountain Development (ICIMOD) for the Global Facility for Disaster Reduction and Recovery (GFDRR)/The World Bank.

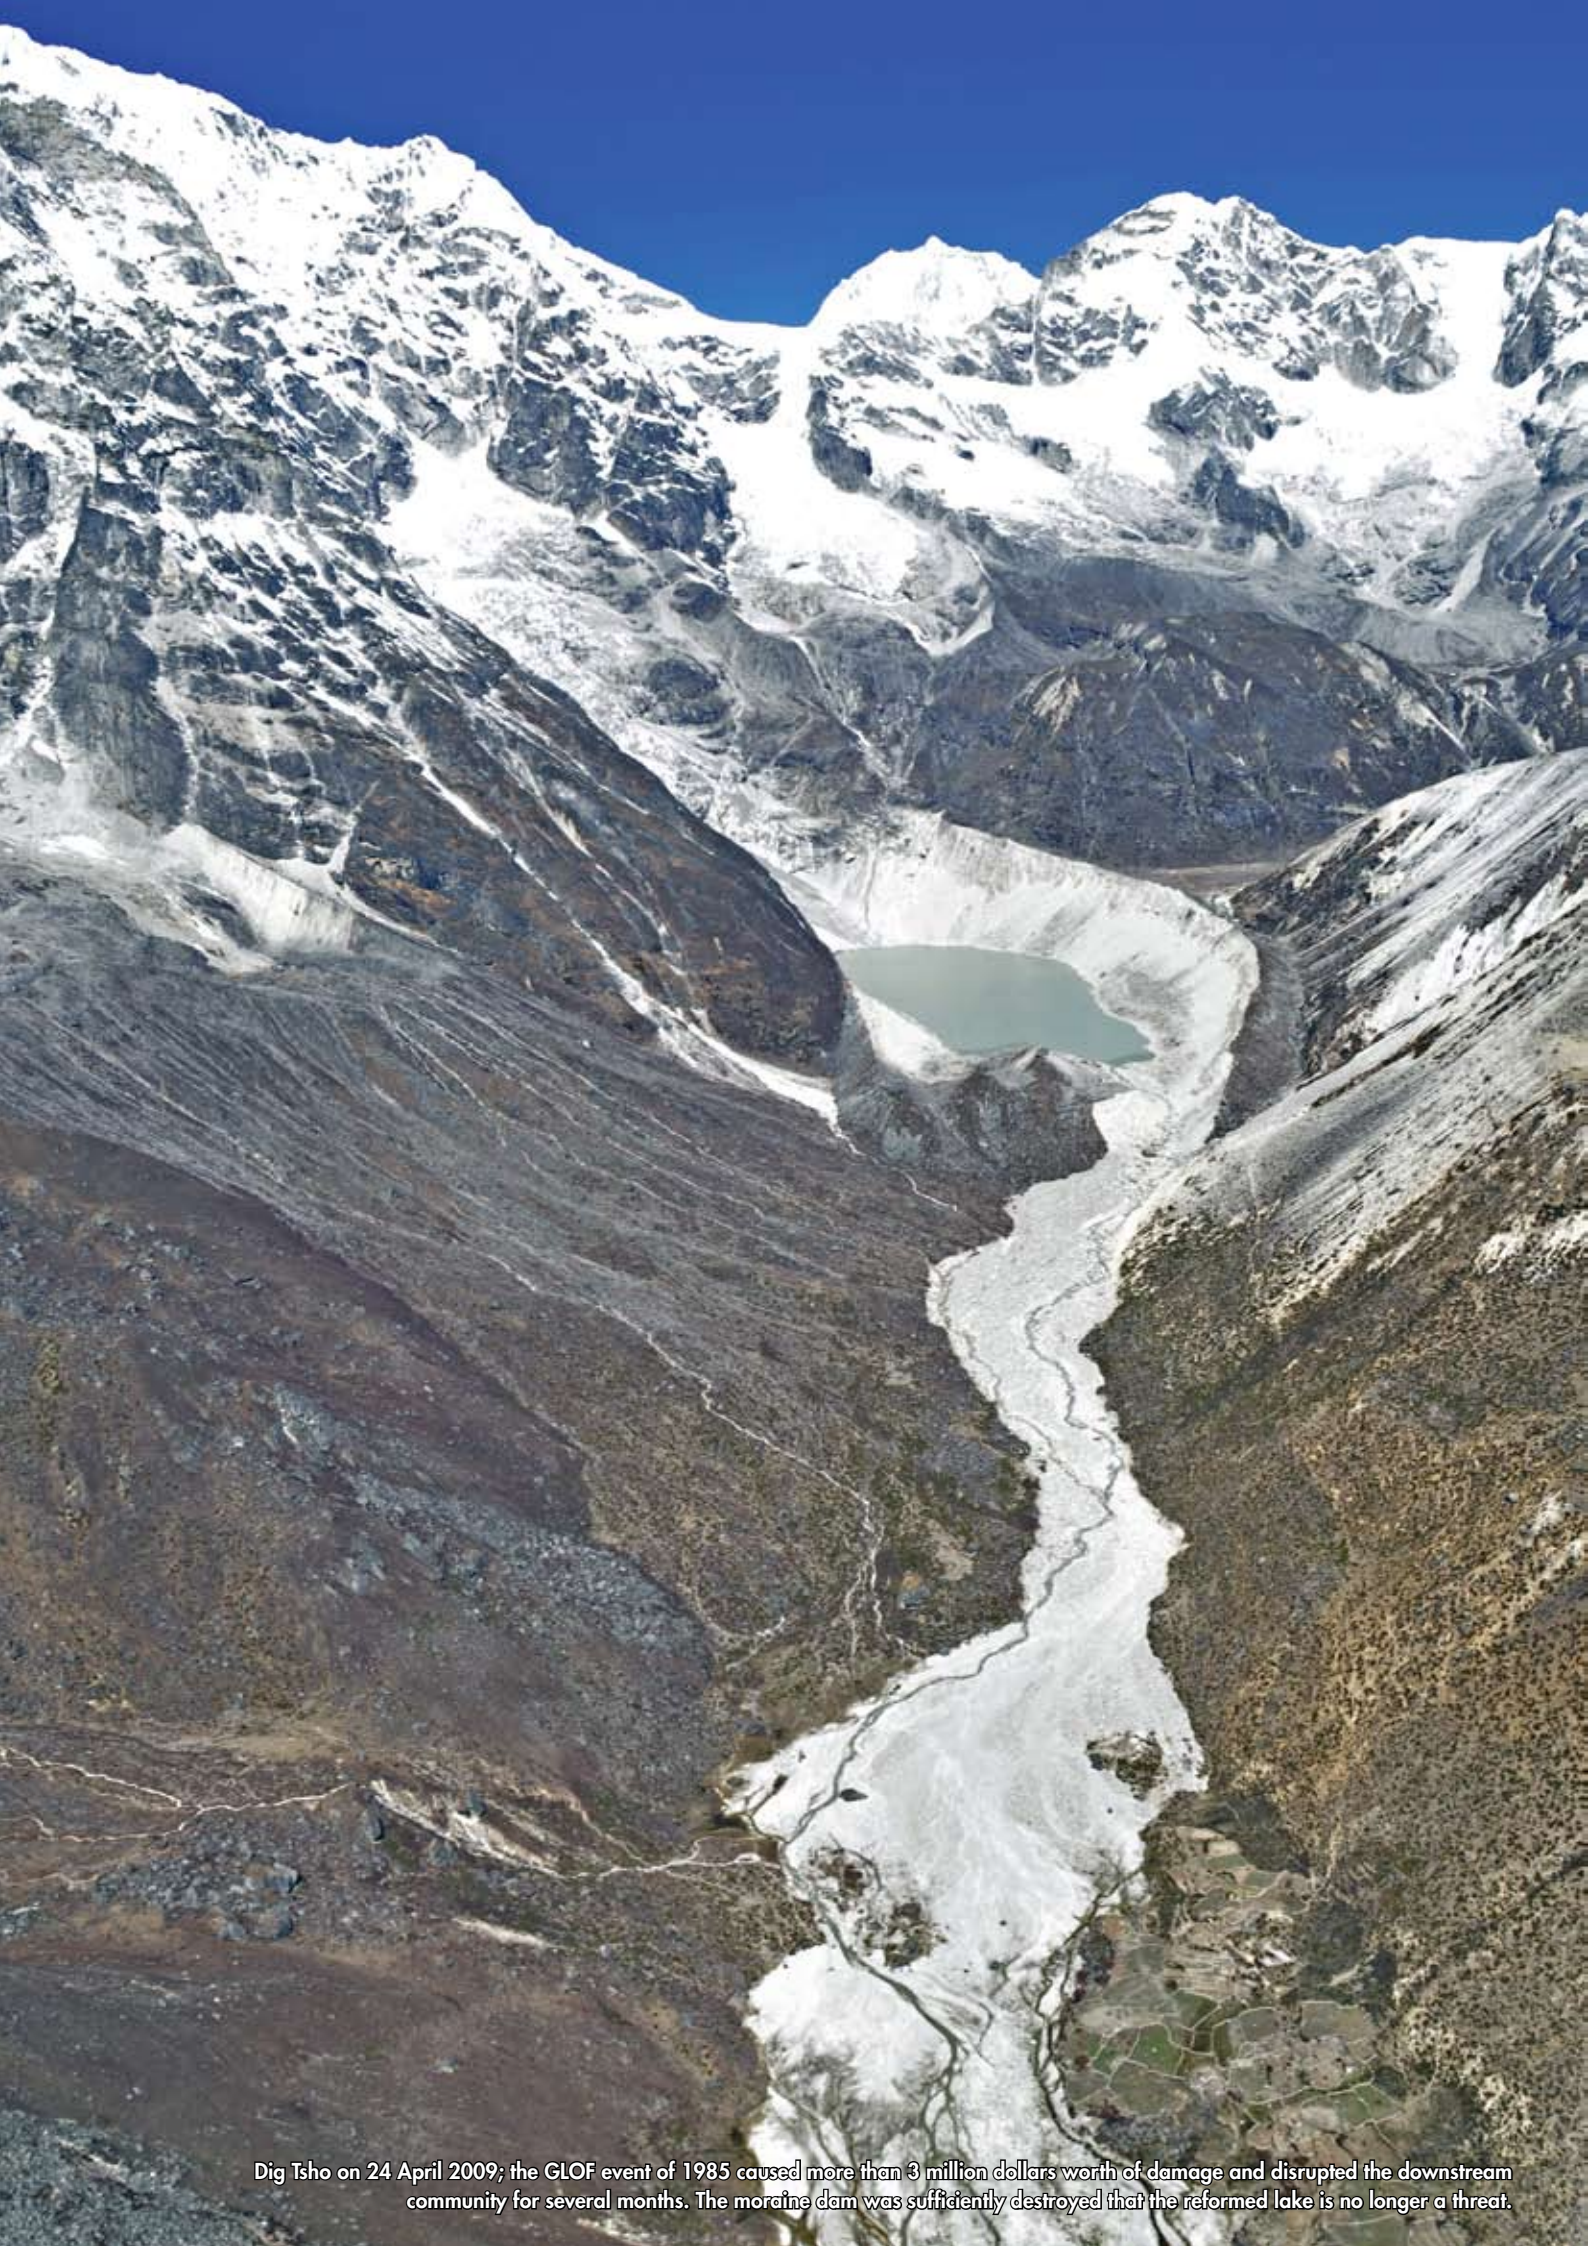
Dig Tsho on 24 April 2009; the GLOF event of 1985 caused more than 3 million dollars worth of damage and disrupted the downstream community for several months. The moraine dam was sufficiently destroyed that the reformed lake is no longer a threat.

When the end moraine dam of the Dig Tsho collapsed, the water from the lake drained into the valley downstream over a four-hour period, wreaking destruction as it went. This sudden outburst destroyed the nearly completed Namche Small Hydel facility, some 11 km downstream and caused other losses as far as 50 to 60 km downstream. Somewhat ironically, Dig Tsho was not typical of the large glacial lakes that have formed supra-glacially, but was one of the smaller 'clean-ice' glacial lakes. The outburst event was triggered by a large ice and rock avalanche that cascaded into the lake from a steep glacial surface: when it splashed into the lake it produced a surge wave. The surge overtopped the end moraine and caused it to collapse, discharging an estimated 6 - 10 million cubic metres of water into the valley below. The outbreak of Dig Tsho caused more than three million dollars worth of damage and disrupted the downstream community of Khumbu for several months. The alarm bells sounded by this outburst event put in motion a plethora of scientific investigations, including, surveys, research, and preliminary estimates of downstream vulnerability among others. The Water and Energy Commission Secretariat (WECS) of the Nepal Government, the International Centre for Integrated Mountain Development (ICIMOD), and the United Nations University (UNU) collaborated in the work that eventually produced the first detailed assessment of a GLOF event in Nepal (WECS internal report 1987; Ives 1986; Vuichard and Zimmermann 1986, 1987).

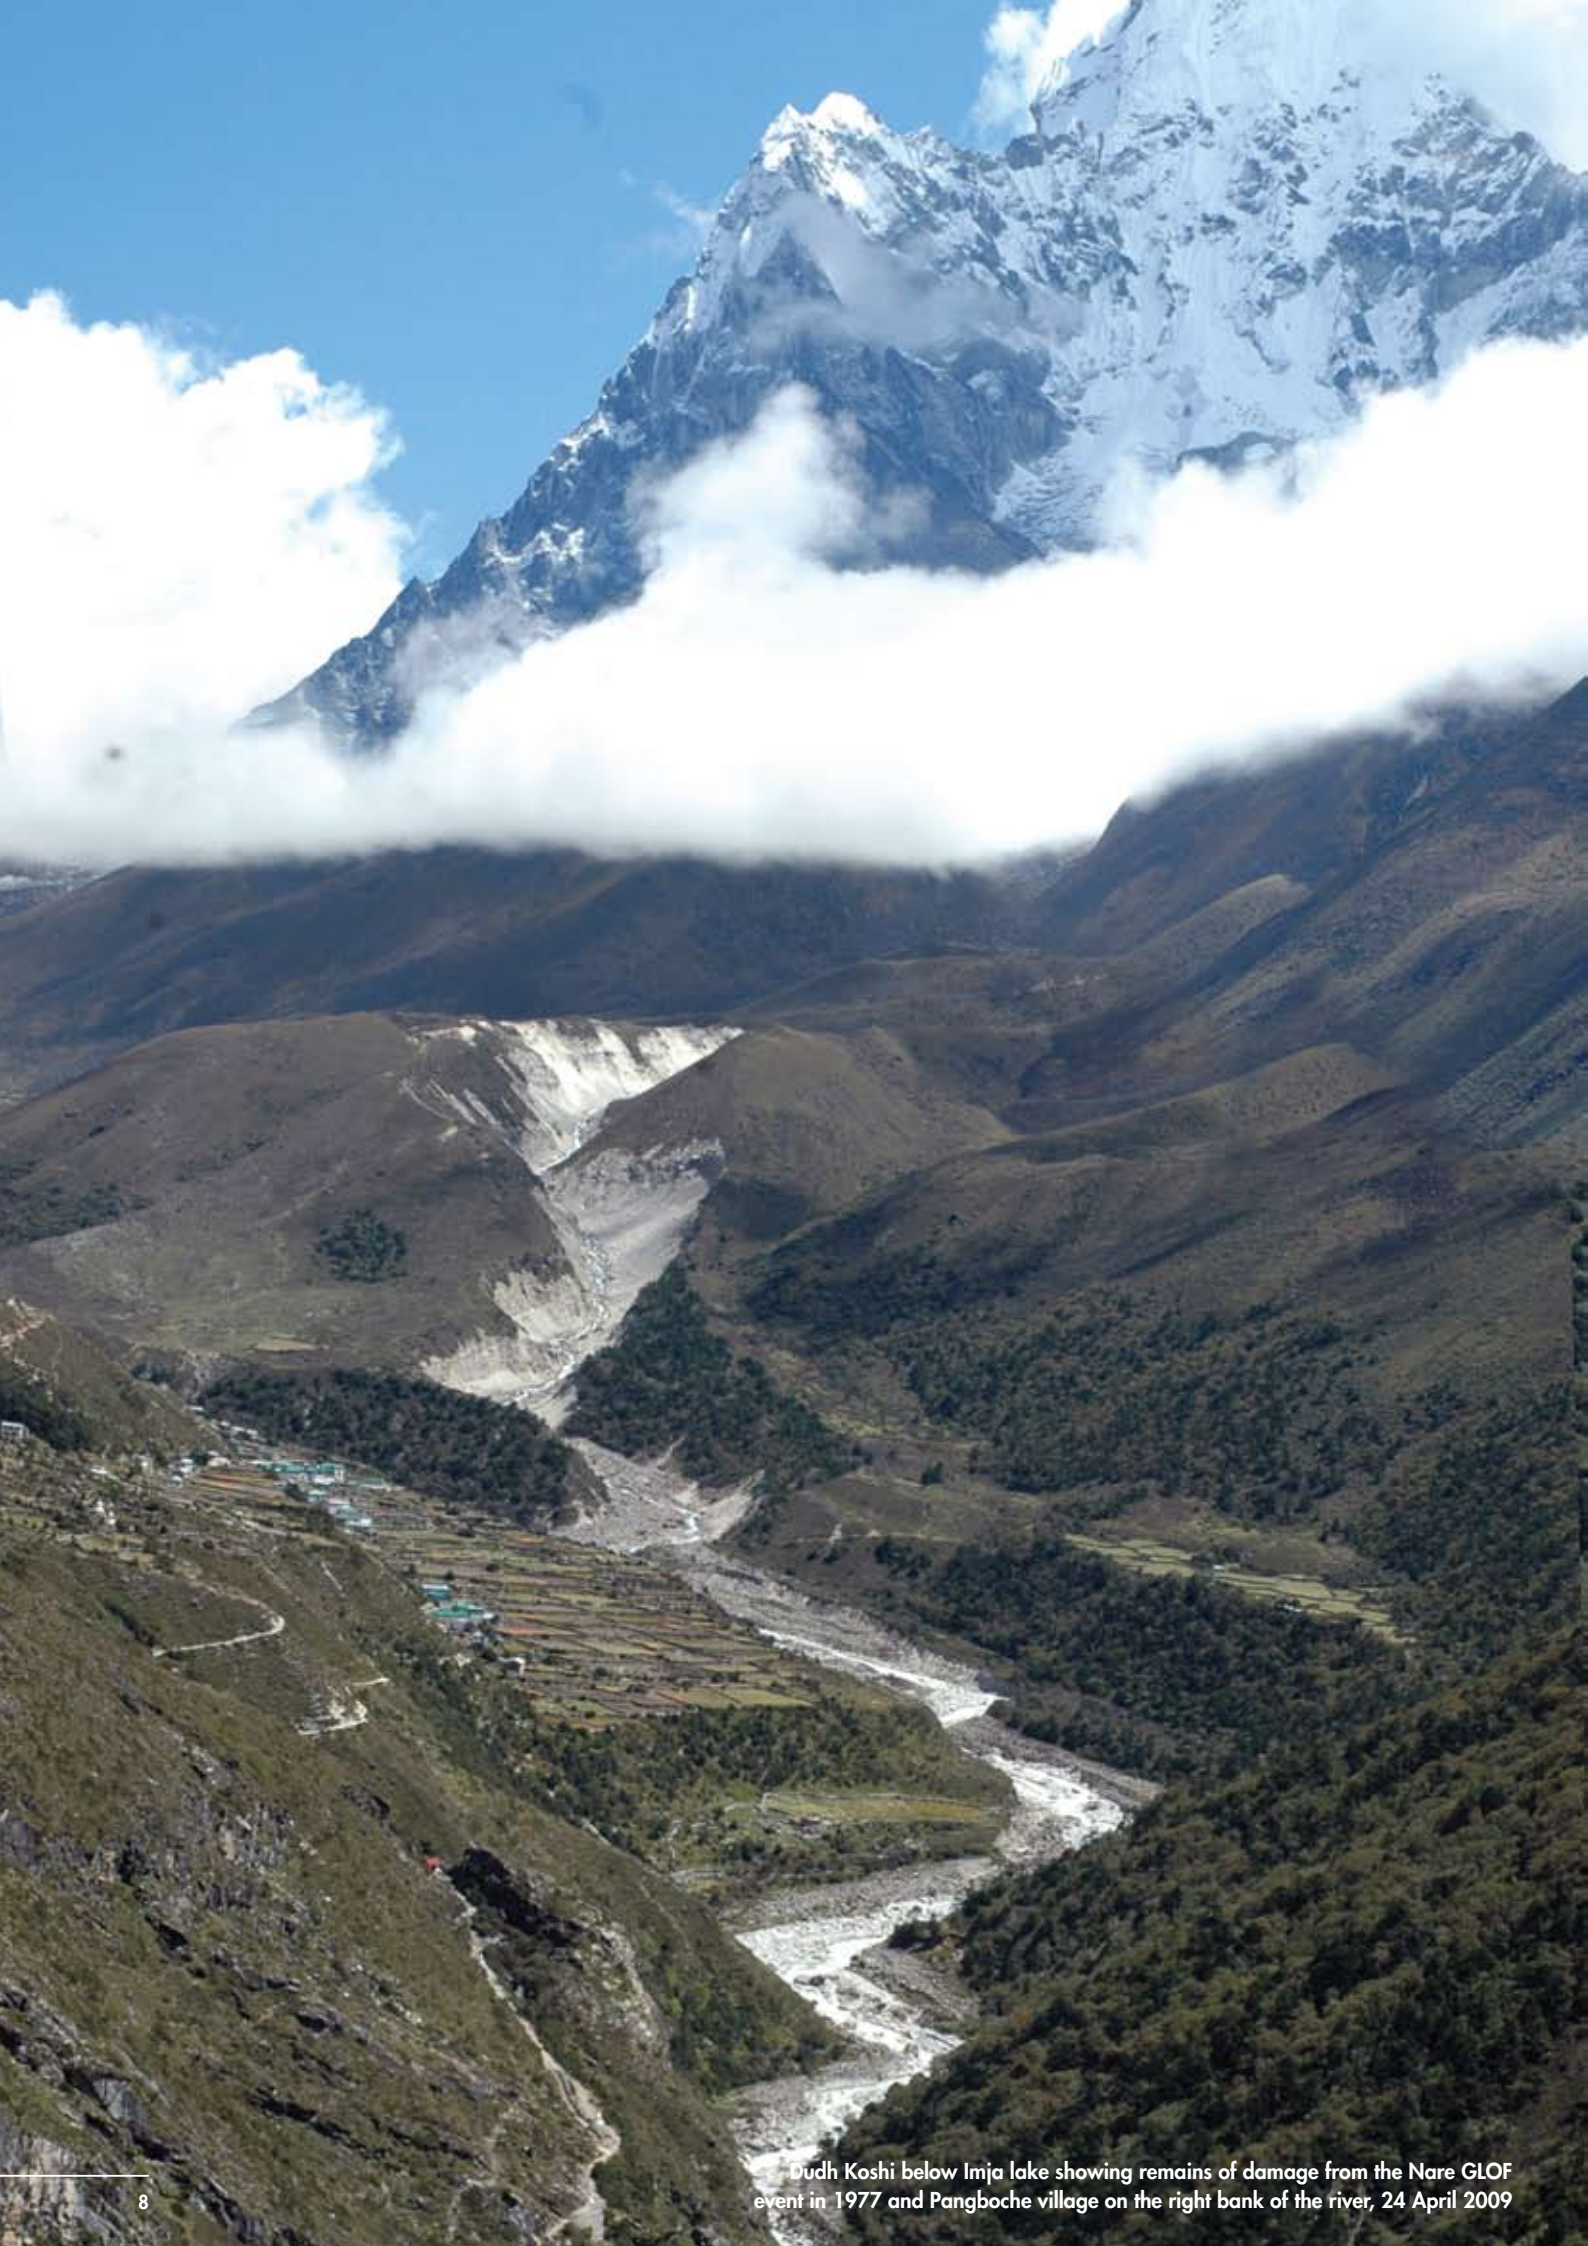
Dudh Koshi below Imja lake showing remains of damage from the Nare GLOF event in 1977 and Pangboche village on the right bank of the river, 24 April 2009

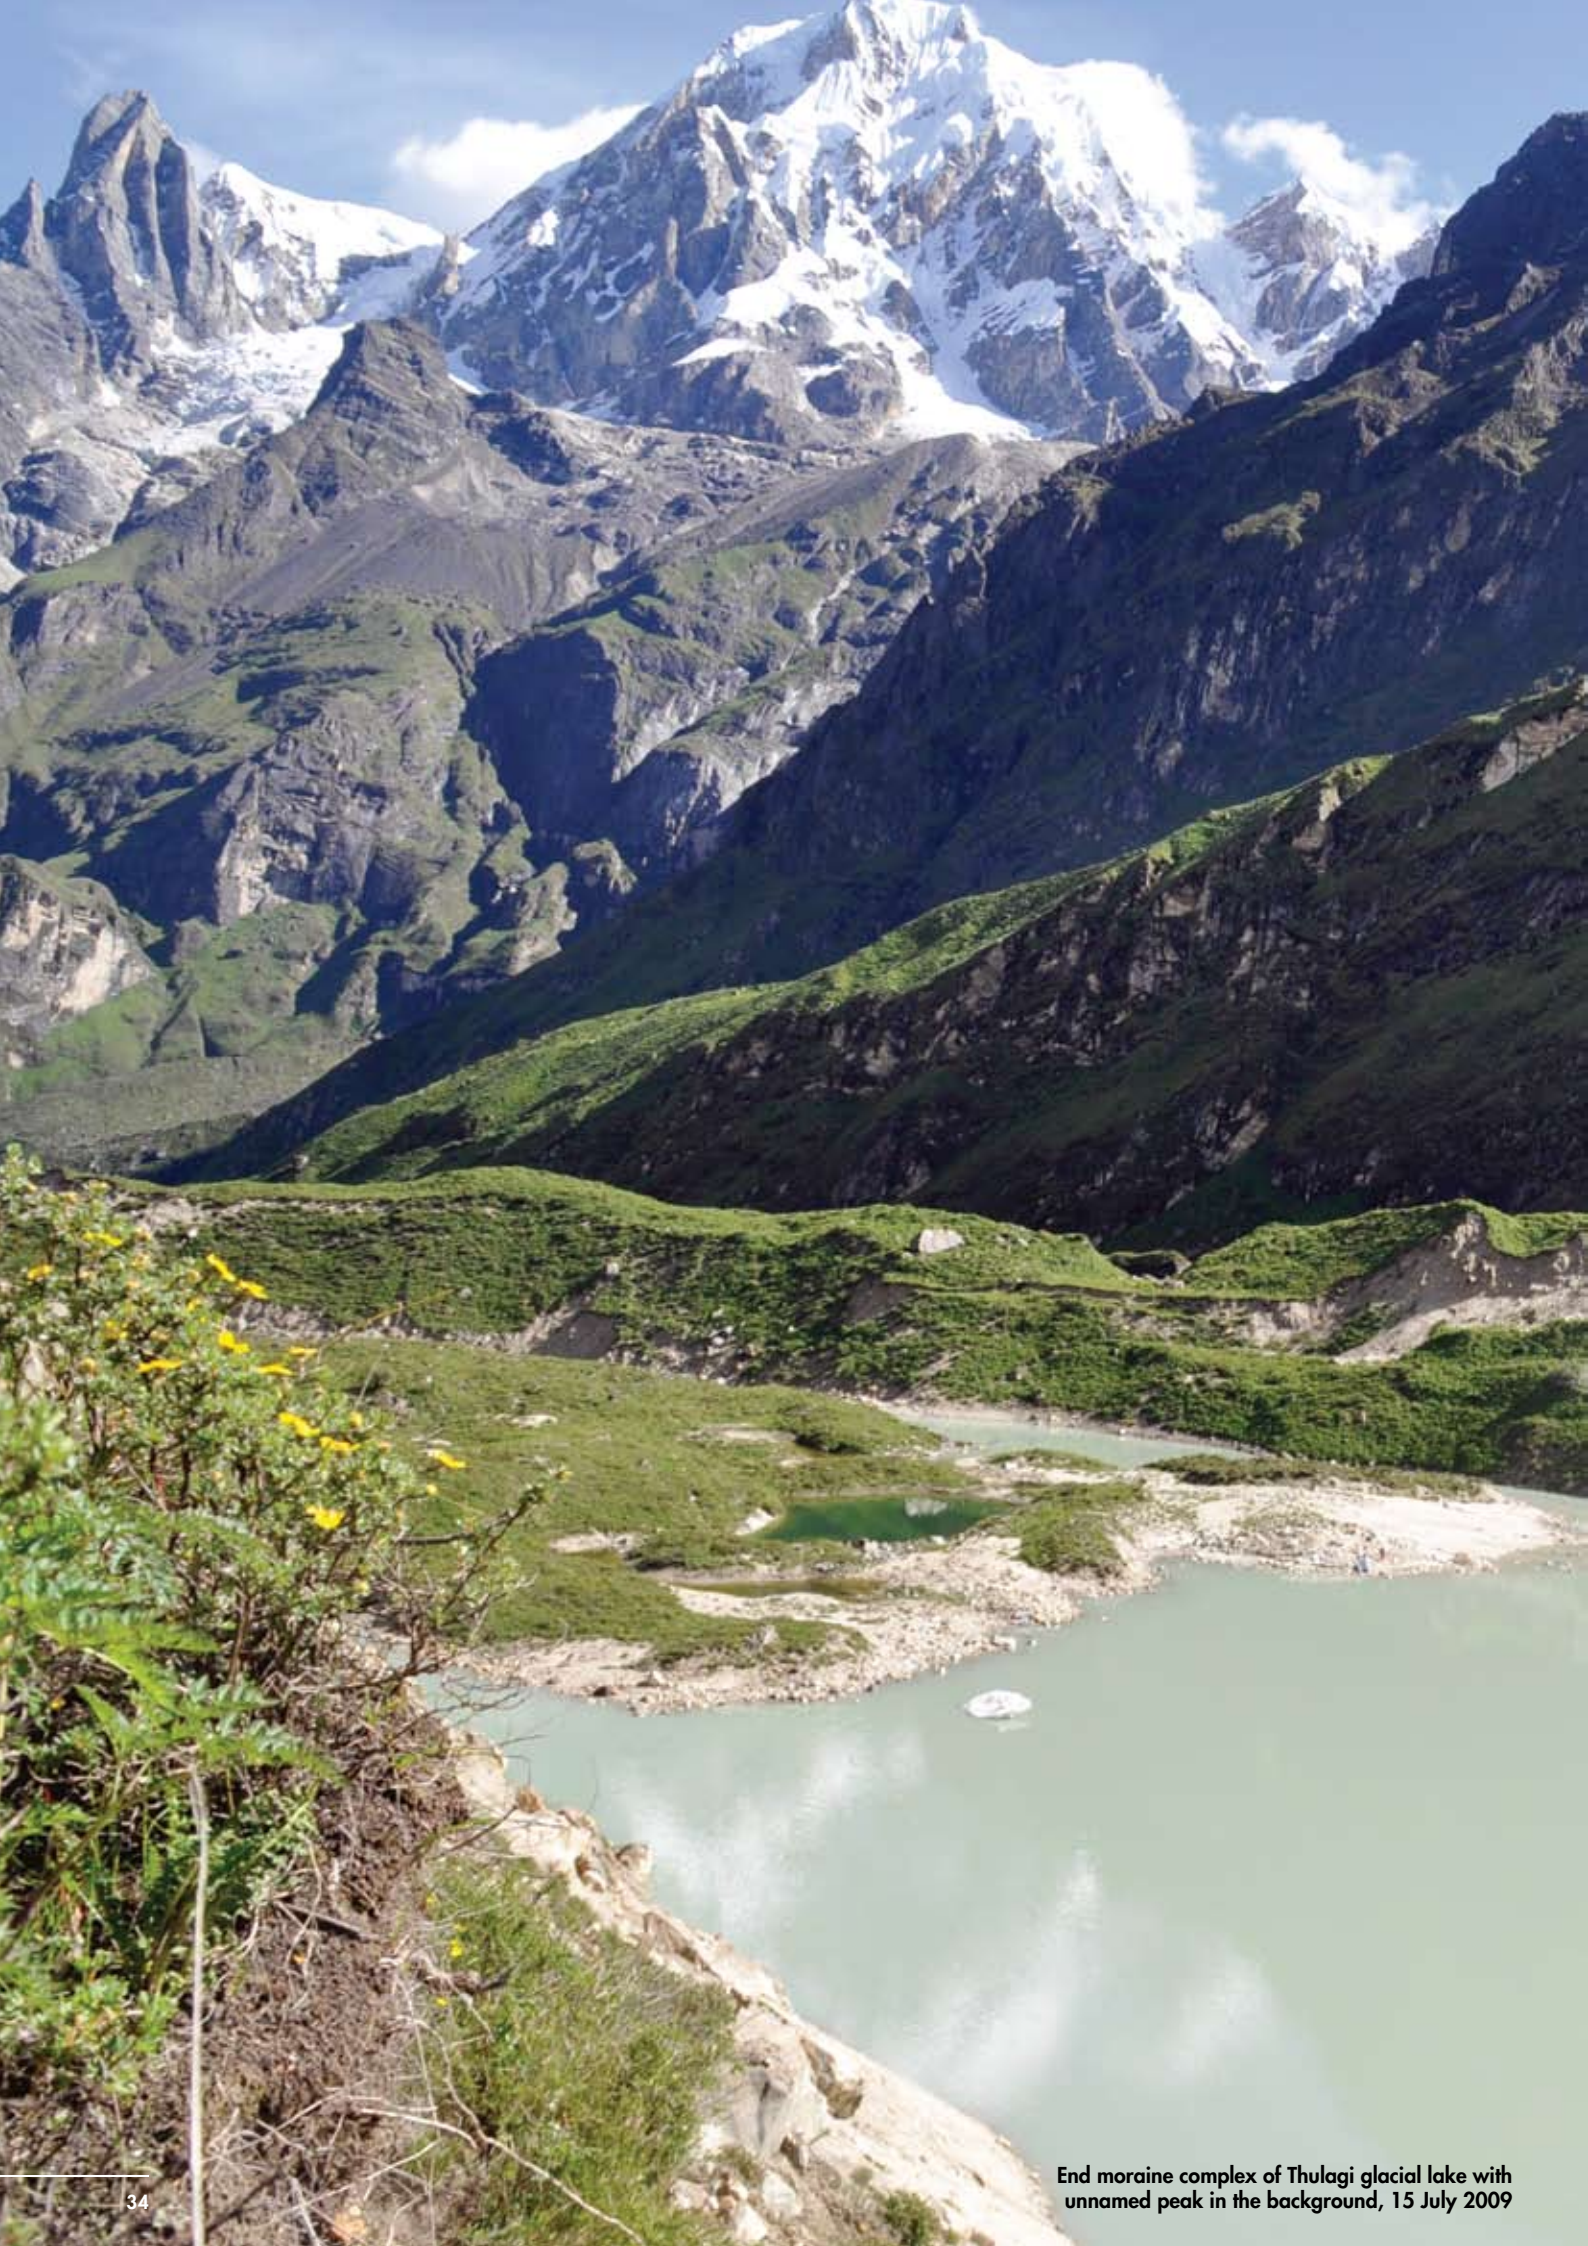
End moraine complex of Thulagi glacial lake with unnamed peak in the background, 15 July 2009

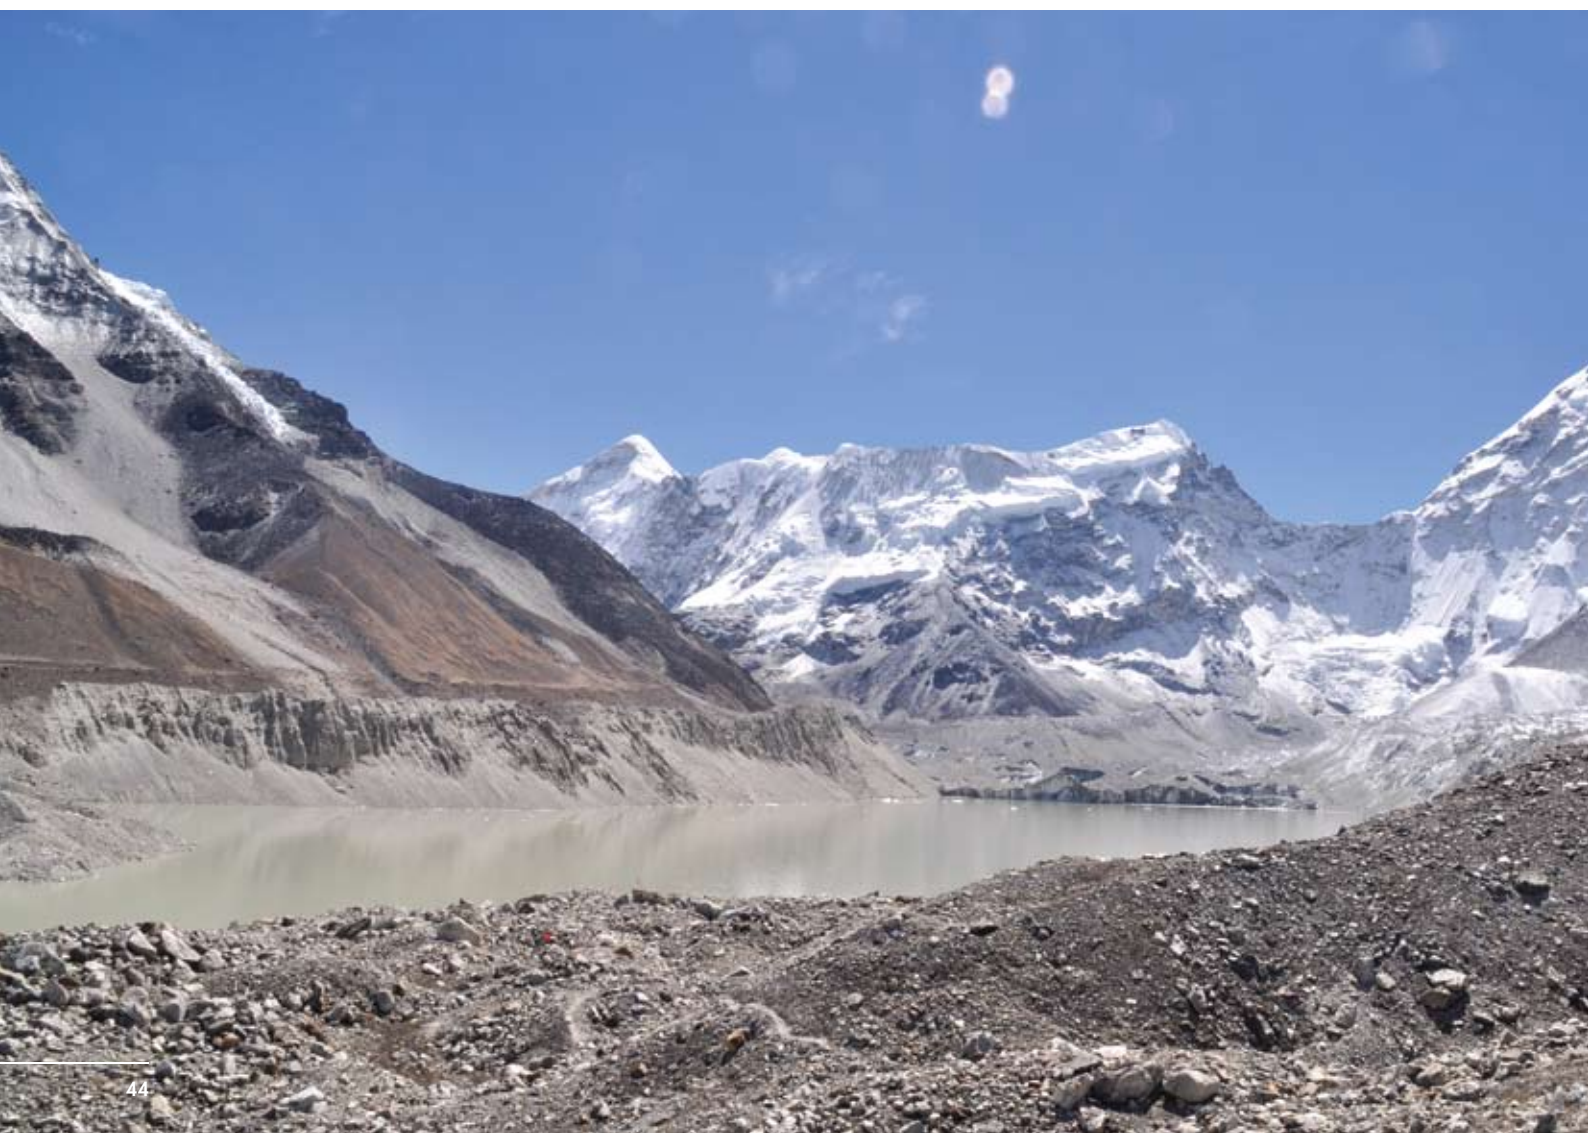
Figure 7.5: **Imja glacier terminus from a distance** (below 24 May 2009) **and closer view** (above right 23 May 2009) **showing thick debris cover and numerous transverse crevasses and collapse features**

be monitored because some portions of it are at risk of breaching since they are comparatively narrow and low and contain unconsolidated material. It is also important to note that the end moraine is subsiding as the buried ice melts, and this melting leaves behind coarse materials and potentially large voids which could also reduce stability. Further study is required to assess the likelihood of a larger than expected icefall from the glacier terminus and the potential impact of the resultant surge. In other parts of the world, temporary blockage of lake outlets through moraines due to freezing water and snow barriers or lake ice debris have led on several occasions to outbursts or related hazards. At Imja Tsho, the flow from the lake is uninterrupted, even though it freezes during the winter and an ice layer up to 70 cm thick is formed on the lake itself. This was determined from bore holes during the earlier bathymetric survey (GEN 2006).

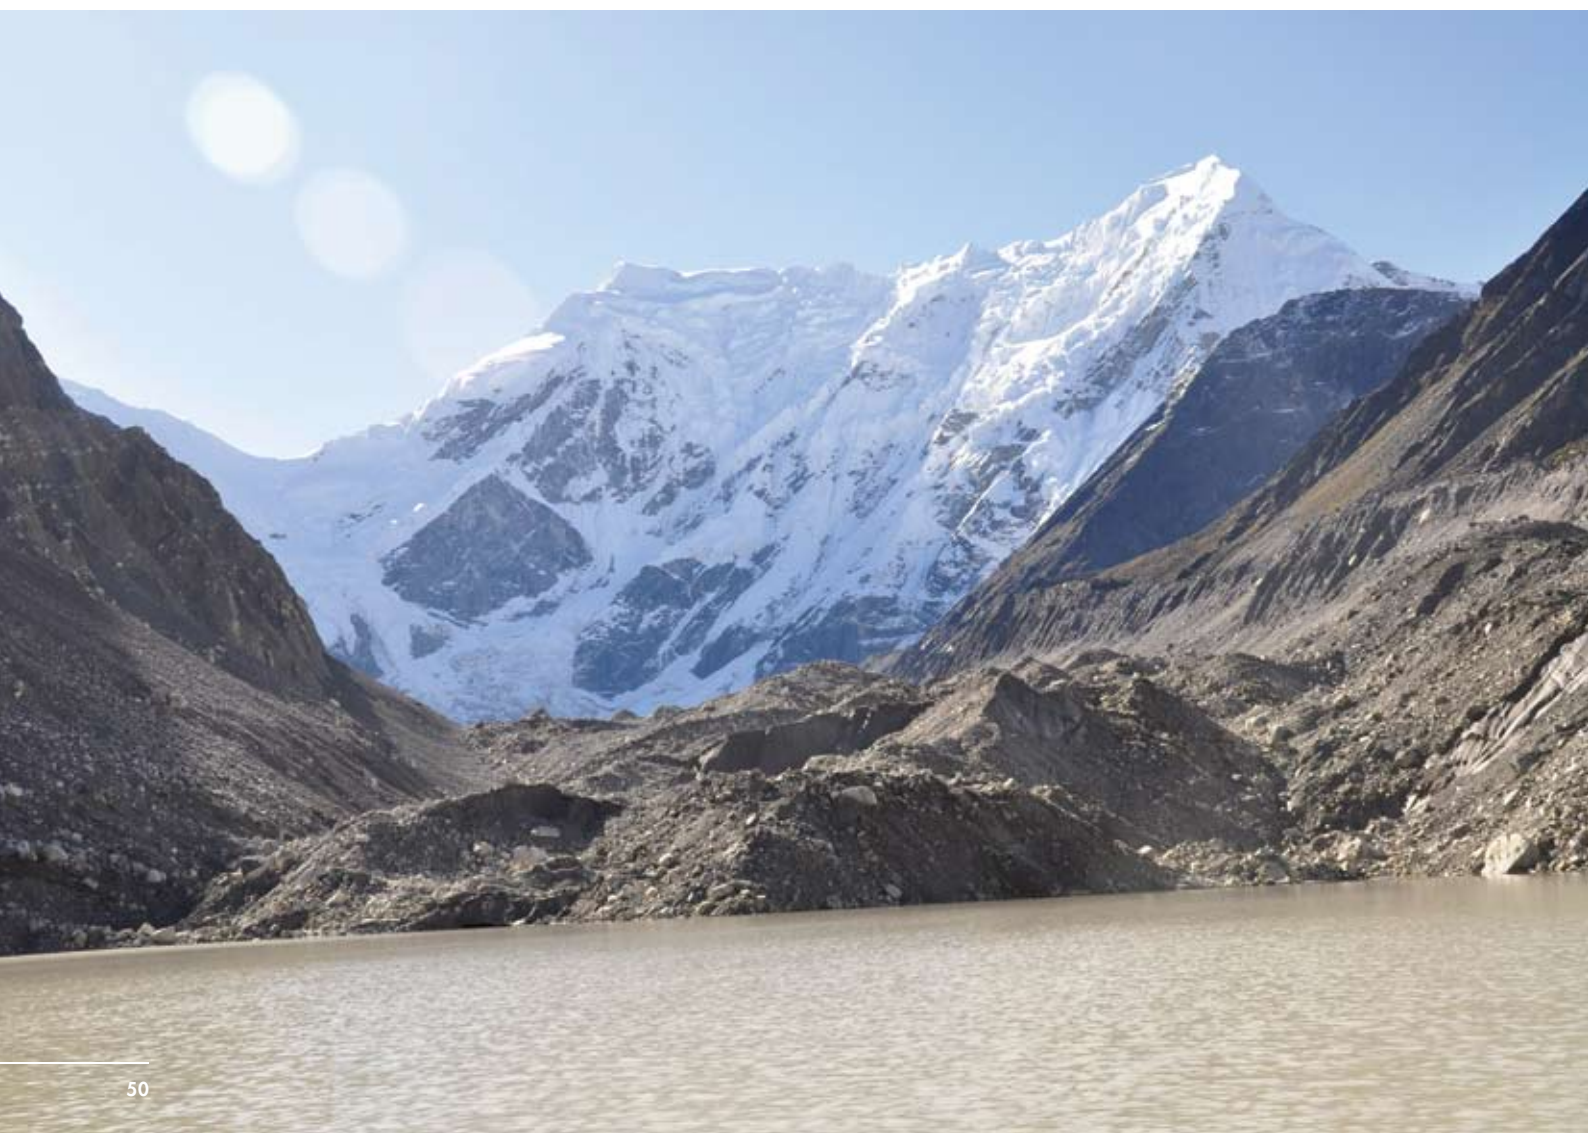
**Figure 7.9: Glacier terminus with thick debris cover in contact with the Tsho Rolpa. Thermokarsts are exposed on both the left and right lateral moraines which are also in contact with the glacier terminus, 11 September 2009**

Trakarding glacier descends into the Tsho Rolpa at 4,546 masl. In 1997, there was a nearly vertical ice wall about 30 to 40 m above the lake at the terminus; this has now been reduced to a surface slope towards the lake with a height of only a few metres.

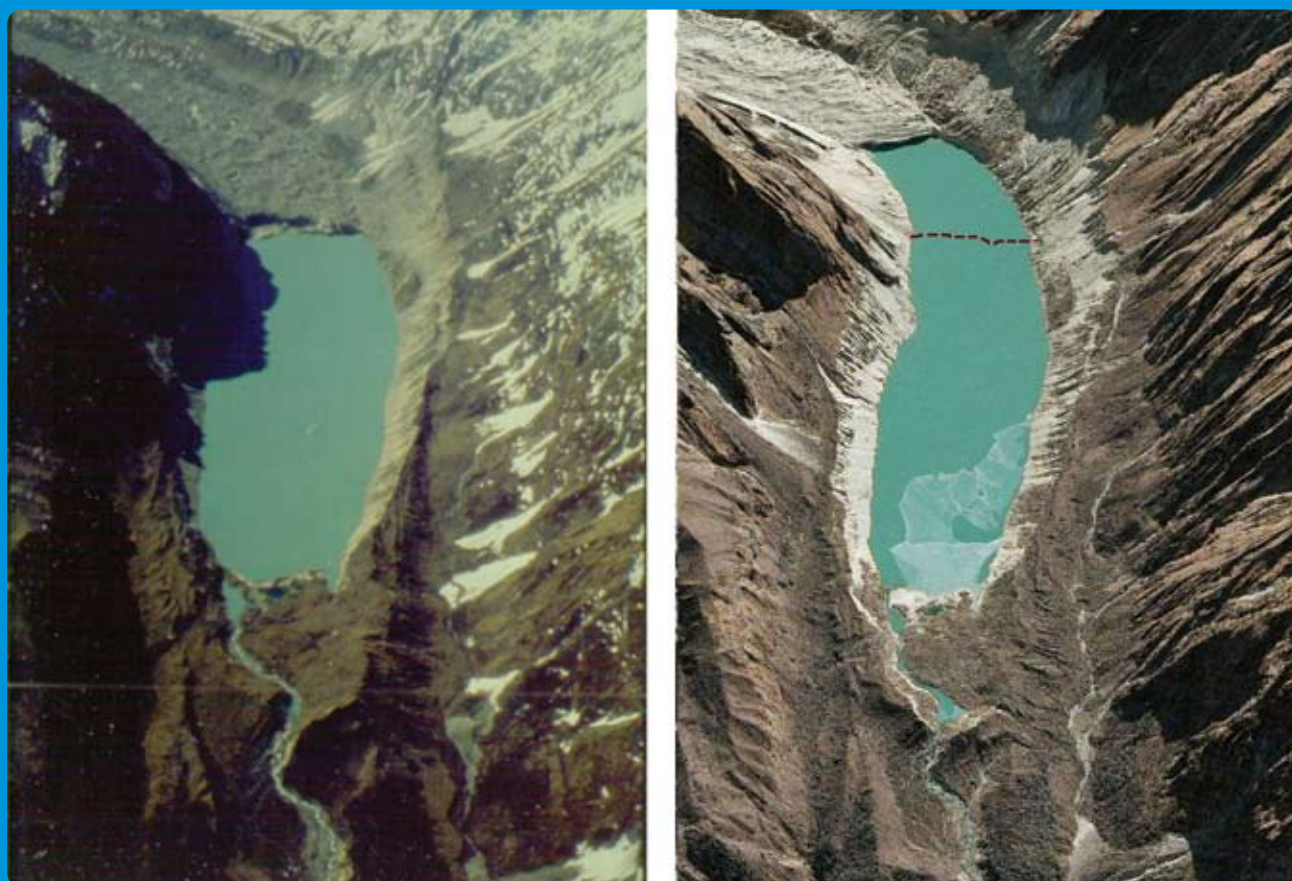
Figure 7.12: Overview of Thulagi Glacier and glacial lake in 1992 photo (left) and 2009 December Quick Bird image (right); the red line shows the expanded area

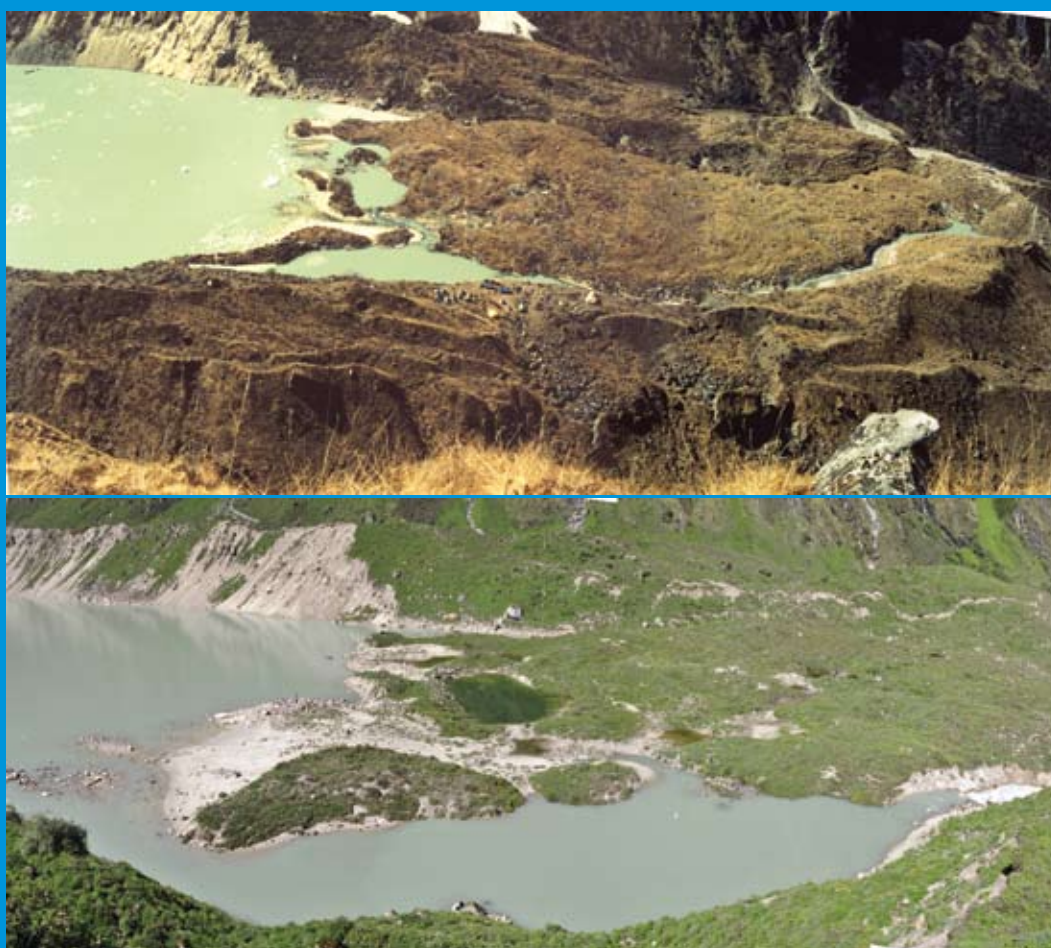
Figure 7.14: Changes in the shoreline of Thulagi Lake between 1996 (above) and 13 July 2009 (below), show the flow has now shifted towards the right lateral moraine, there are linear subsidence features on the left and right lateral moraines

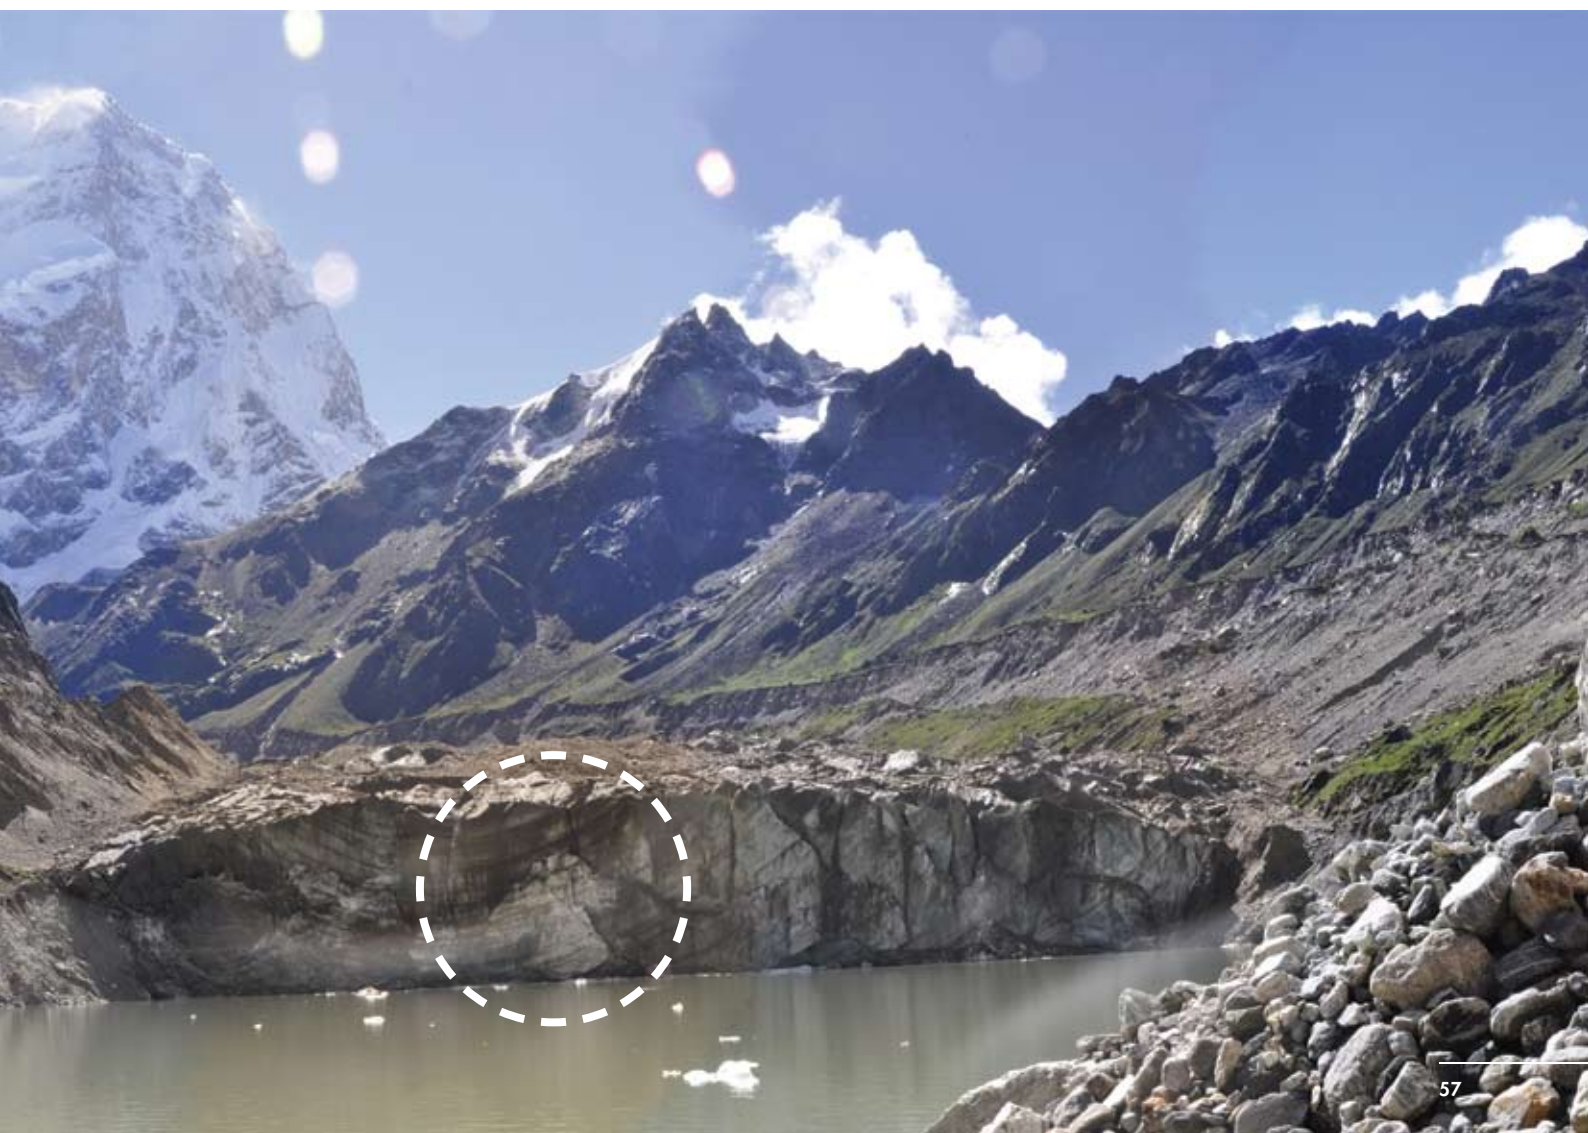
**Figure 7.16: The Thulagi Glacier terminus in contact with the lake, the glacier tongue is about 40 m high above the water surface and exhibits snow stratigraphy (circle), 22 July 2009**

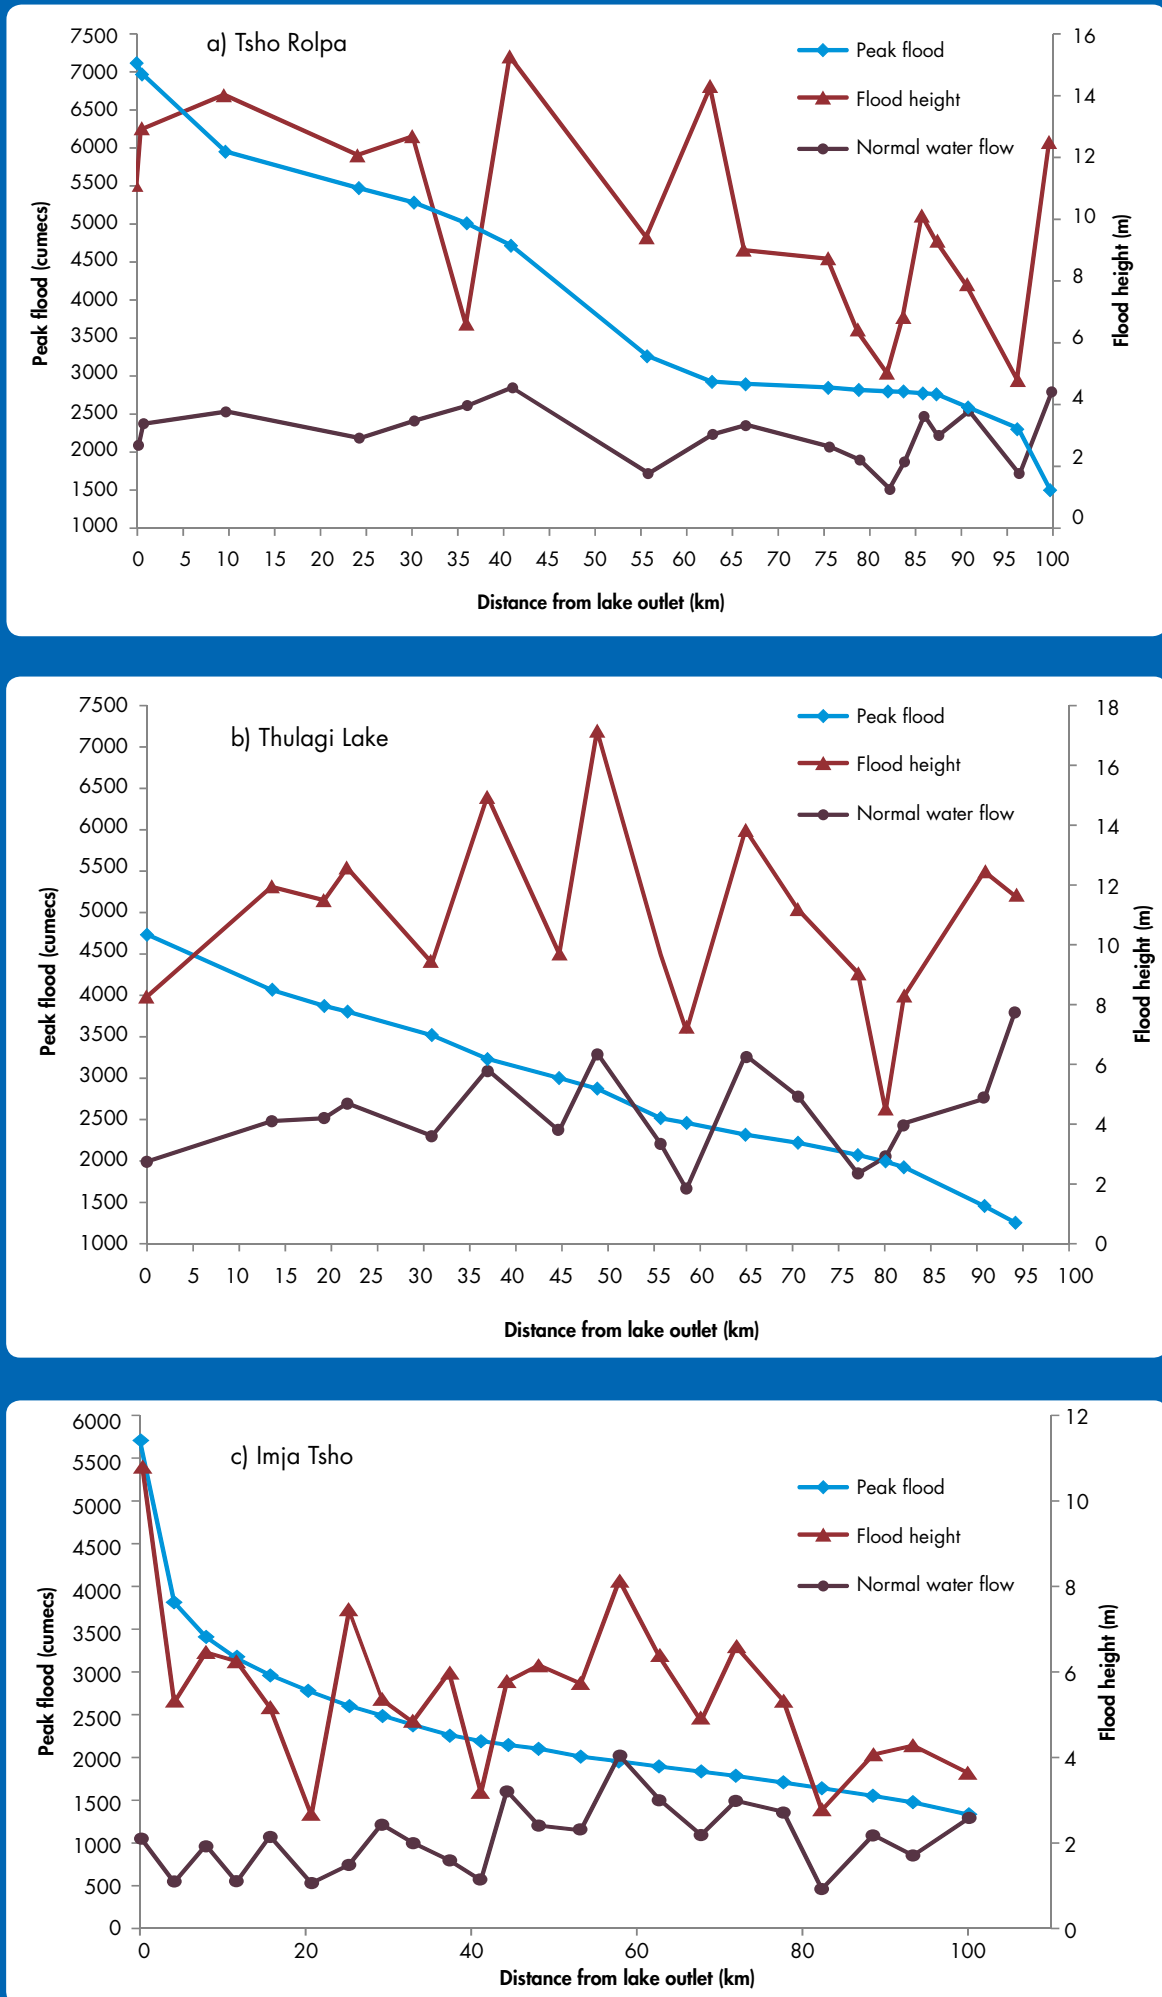
Figure 8.4: Peak flood and flood height of the three lakes
