Section 2

Field Investigations and Risk Assessment

6 Field Investigations

7 Results of the Field Investigations

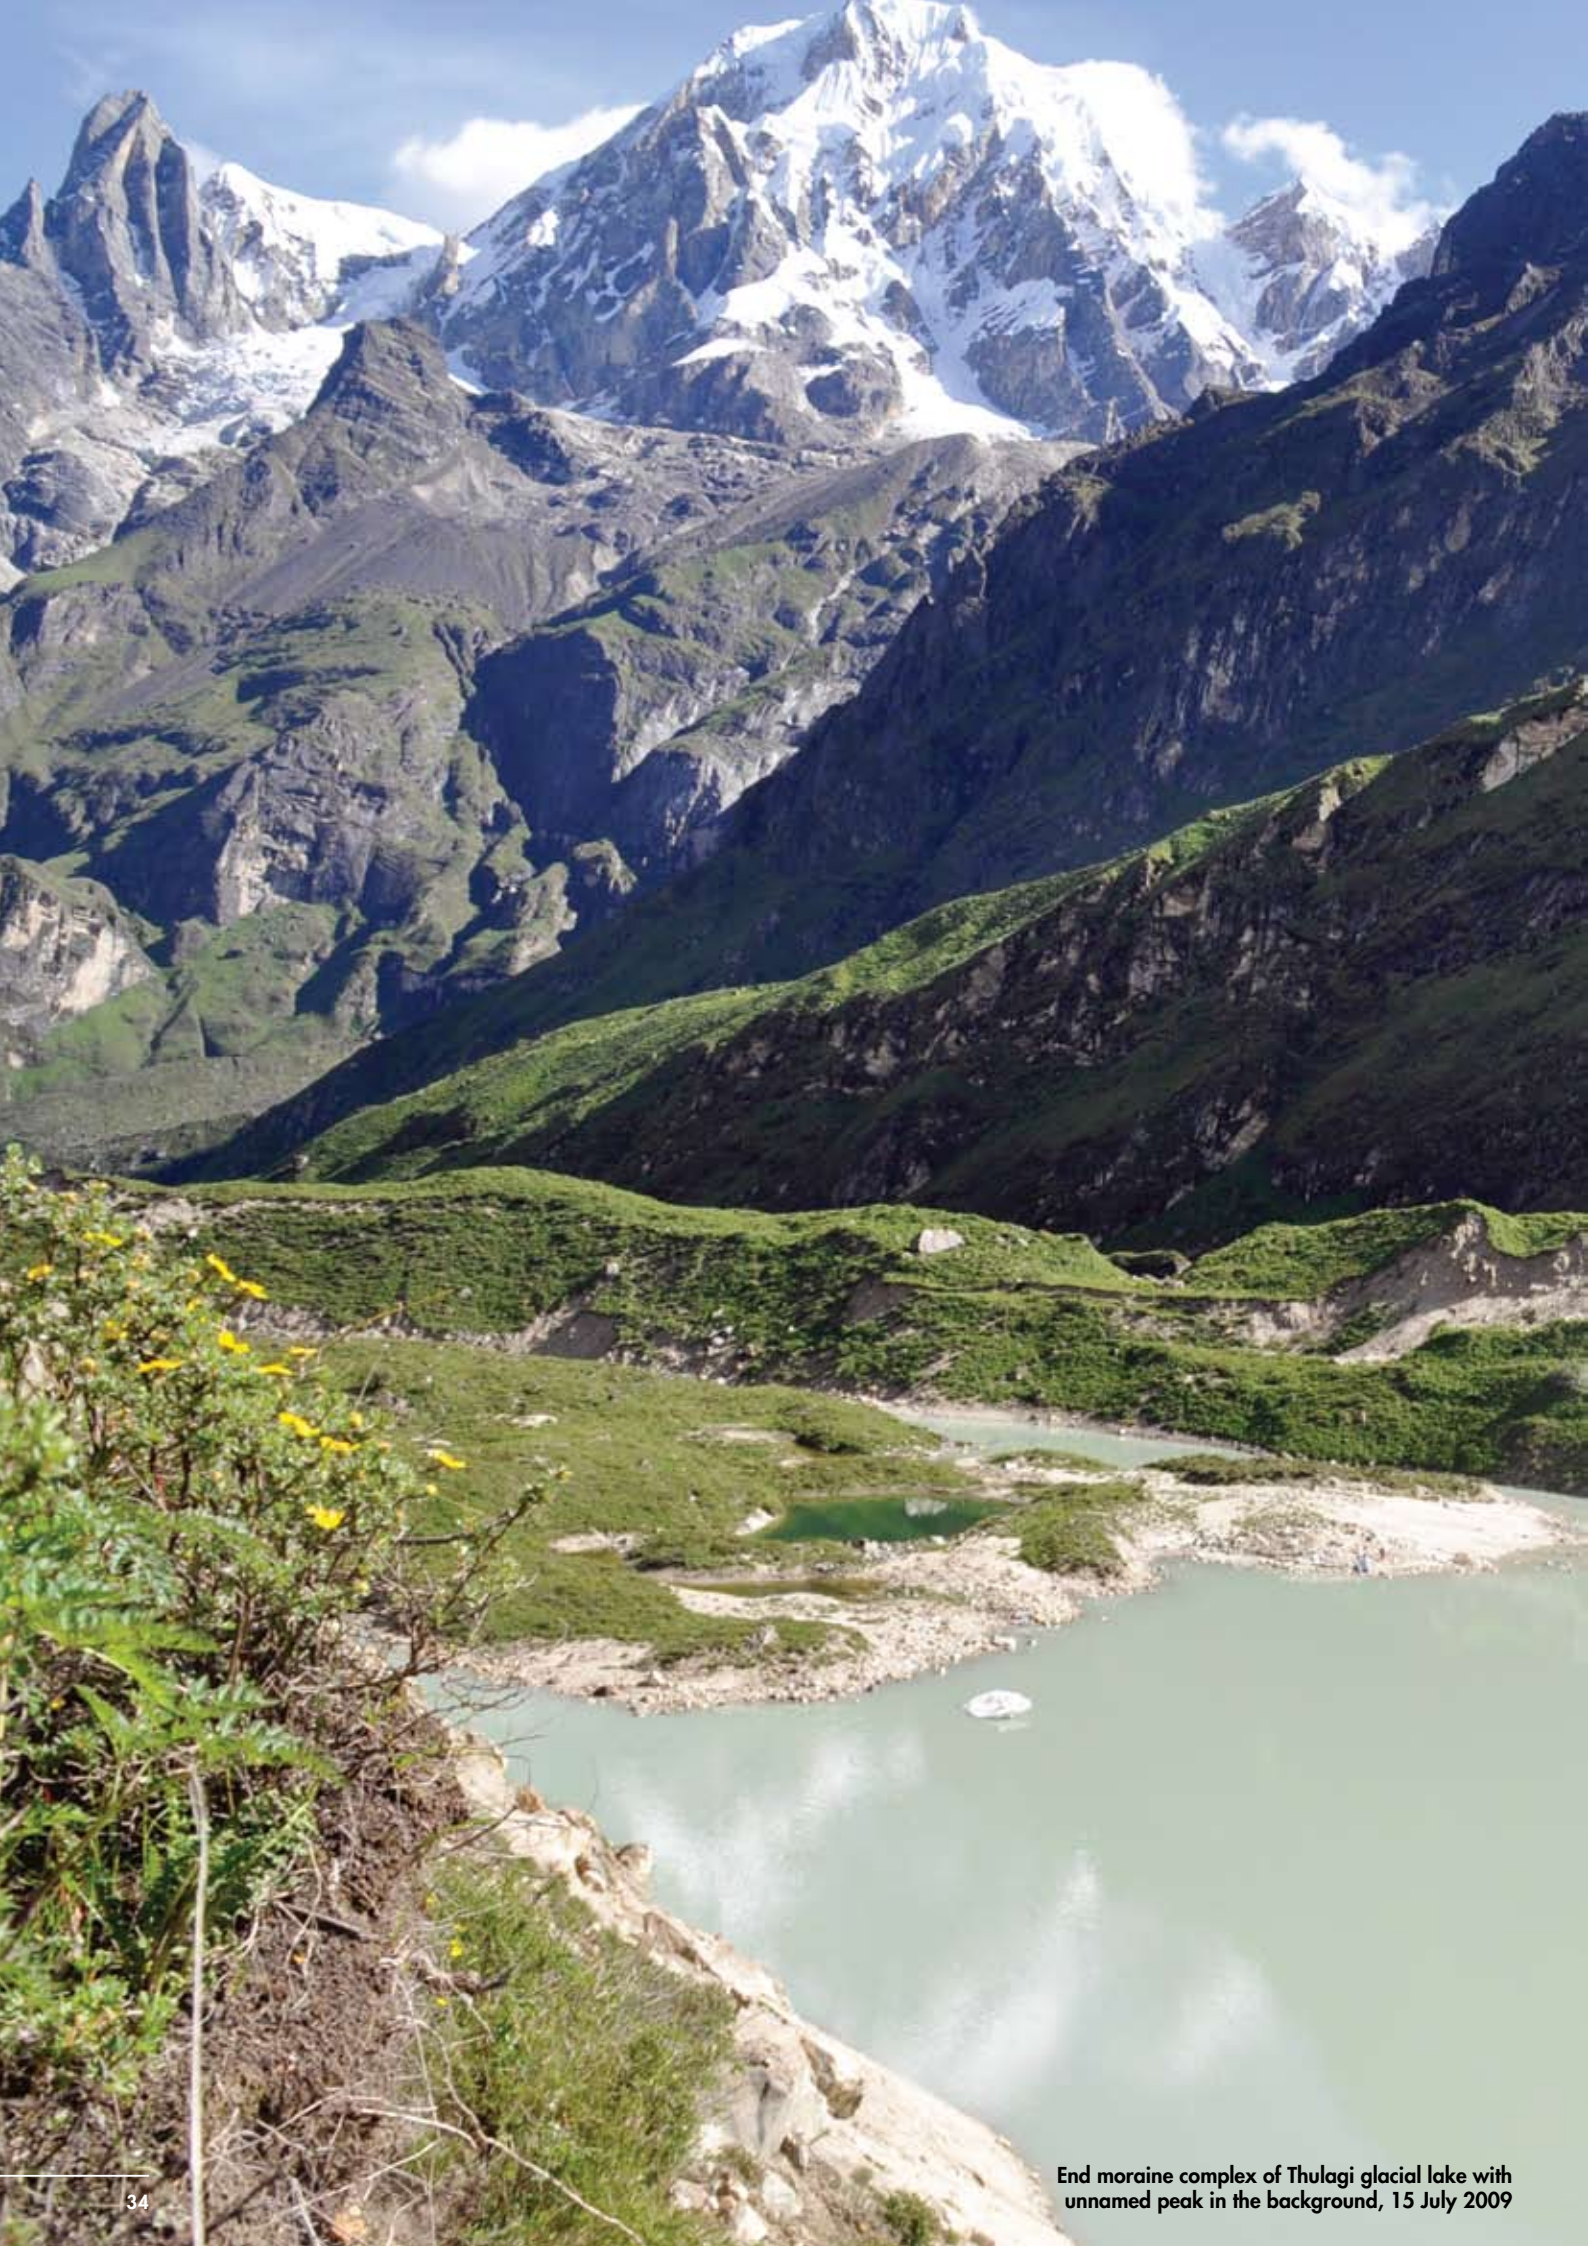
End moraine complex of Thulagi glacial lake with unnamed peak in the background, 15 July 2009

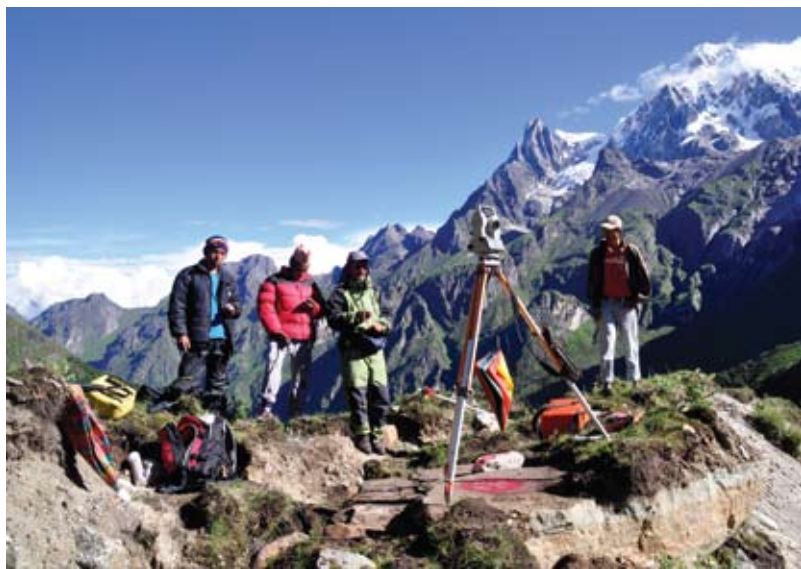
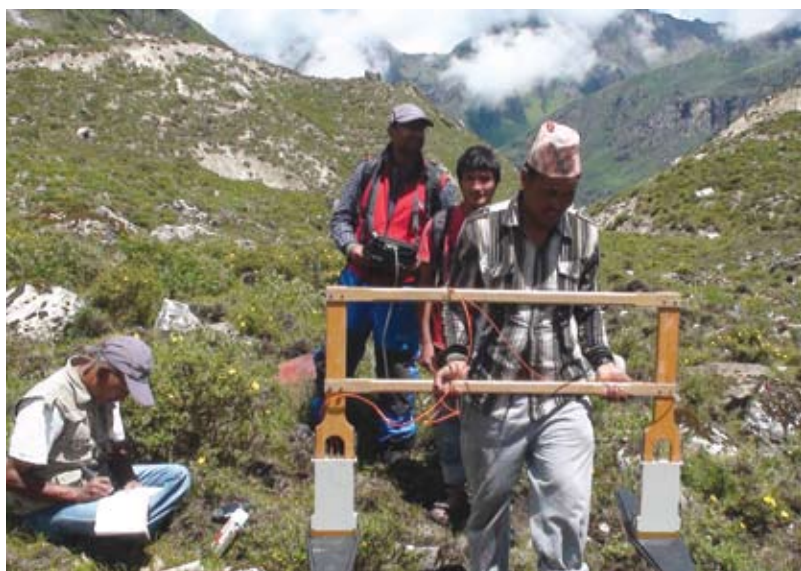
Bathymetric mapping investigation

The bathymetric survey was carried out from an inflatable boat with an outboard motor. The observations were used to estimate lake storage volume; to evaluate the lake bottom condition near the outlets; and to assess stability of the end moraines below the lake surface. The positions (X and Y coordinates or grid) of the bathymetric observation points were recorded using a GPS. Depth measurements were made using the echo-sounder equipment 'Ninglu DS 2008' in Thulagi and Tsho Rolpa, and an old-fashioned (but effective) method of dropping a weighted line in Imja Tsho (because the echo sounder was malfunctioning). The bathymetric measurements were taken 5 -10 m from shorelines for safety reasons to avoid active sliding of the inner moraine slopes. Bathymetric maps were then prepared and the surface area and storage volume of the lakes were calculated.

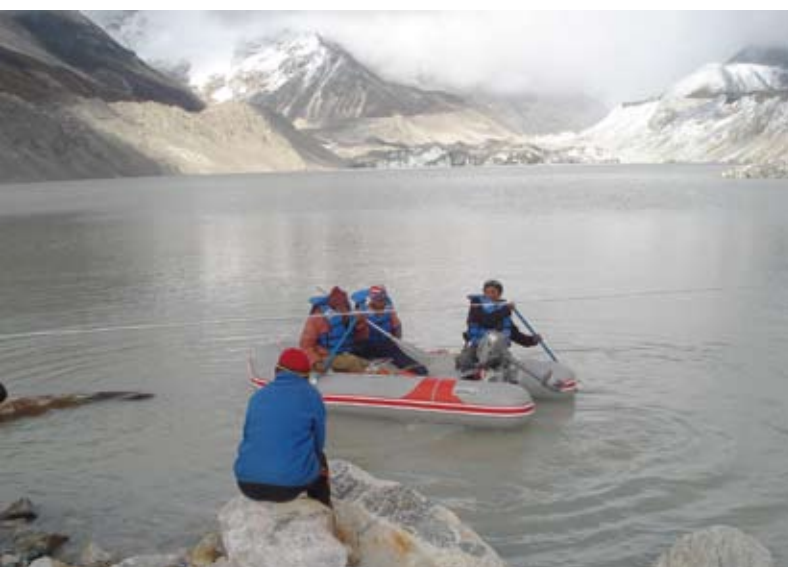
Lake discharge measurements were made using dye tracers and conductivity methods. For the dye tracer study, environmentally neutral sulphorhodamine G (SRG) tracer was introduced into the lake outlet streams for a defined period of time at a constant rate, and water samples were collected downstream at fixed time intervals. The tracer concentrations in the samples were evaluated later in the laboratory using spectro-fluorometry and the results used to calculate discharge. The salt dilution method was used to measure turbulent flow. A salt water solution was poured into the water and, after ensuring homogeneous mixing, electrical conductivity measurements were made at downstream locations at regular intervals to evaluate the salt concentrations – the discharge was then calculated.

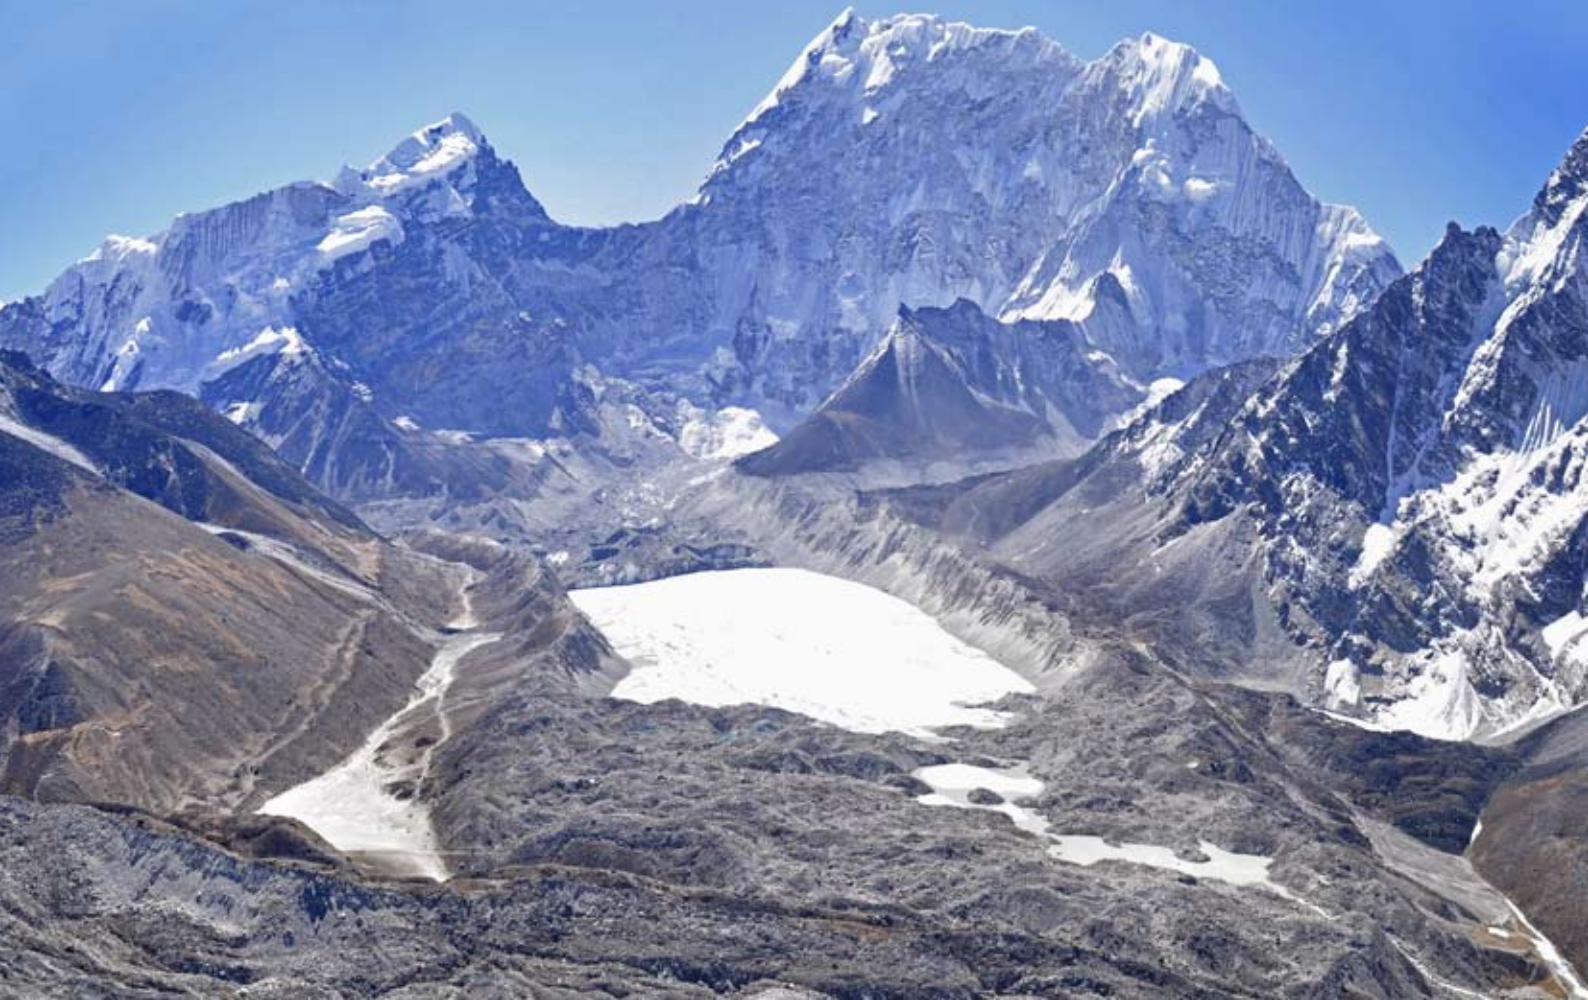
Figure 7.2: Overview of Imja Tsho showing the lake (centre), outlet channel, ponds, side valleys, and surroundings 24 April 2009

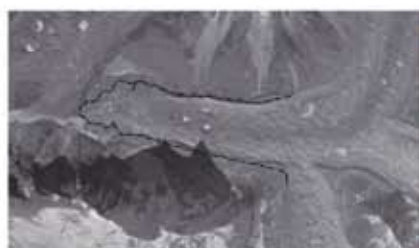
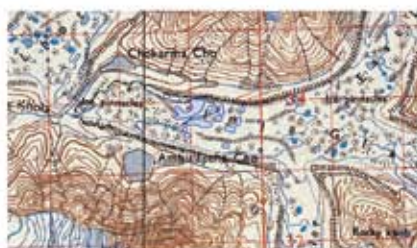
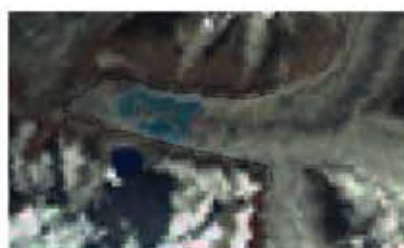
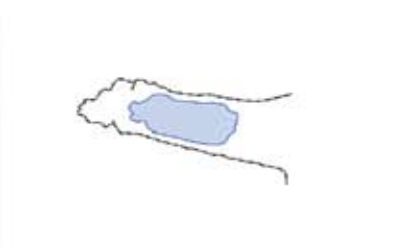
Figure 7.3: Development of Imja Tsho from 1962 to 2010 based on Corona (1962) images, Topographical Map (1967), Landsat MSS (Oct 1975), Landsat TM (April 1984, Dec 1989), Aerial photo (1992), LISS 3 (Jan 1999), Landsat ETM+ (Oct 2001, Nov 2005), ALOS PRISM (2006), AVNIR-2 (Nov 2007, Nov 2008, and Mar 2009), Field Survey (WECS 1992, DHM 1997, GEN 2002 and ICIMOD 2009), and EO1_ALI (USGS) Oct 2010)

Figure 7.3 shows the progressive development of Imja Tsho between 1962 and 2010.

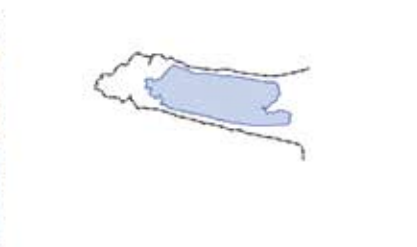
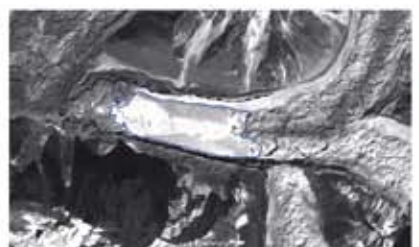
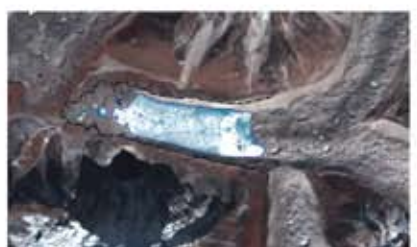
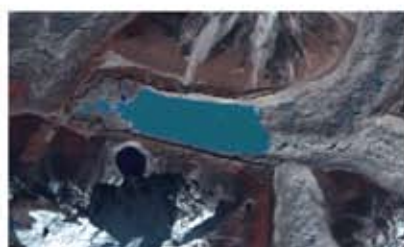
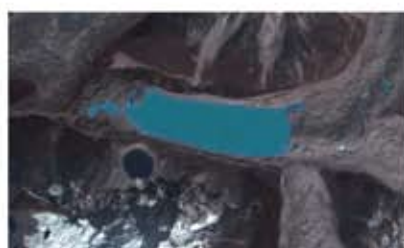
April 2002, Field Survey GEN

4 December 2006, ALOS PRISM

20 November 2007, AVNIR-2

24 November 2008, AVNIR-2

May 2009, Field Survey ICIMOD

4 October 2010, EO1_ALI (USGS)

The contemporary expansion of Imja Tsho is primarily towards the east as the relatively warm lake water melts back into the glacier and accentuates the collapse of blocks of ice from the cliffs that form its terminus. (Yamada 1992; DHM 2001a; Sakai et al. 2005; GEN 2006; and present study). The western margin of the lake close to the end moraine has also expanded, although the position of the outlet has remained more or less unchanged. Watanabe et al. (1994) reported a rapid westward expansion towards the end moraine between 1989 and 1994. Shifting of the outlet channel was also reported (Watanabe 2009). This is not supported by Yamada (1992) nor by the present field investigation, and no significant change between 1992 and 2009 can be detected from the satellite images (Figure 7.4).

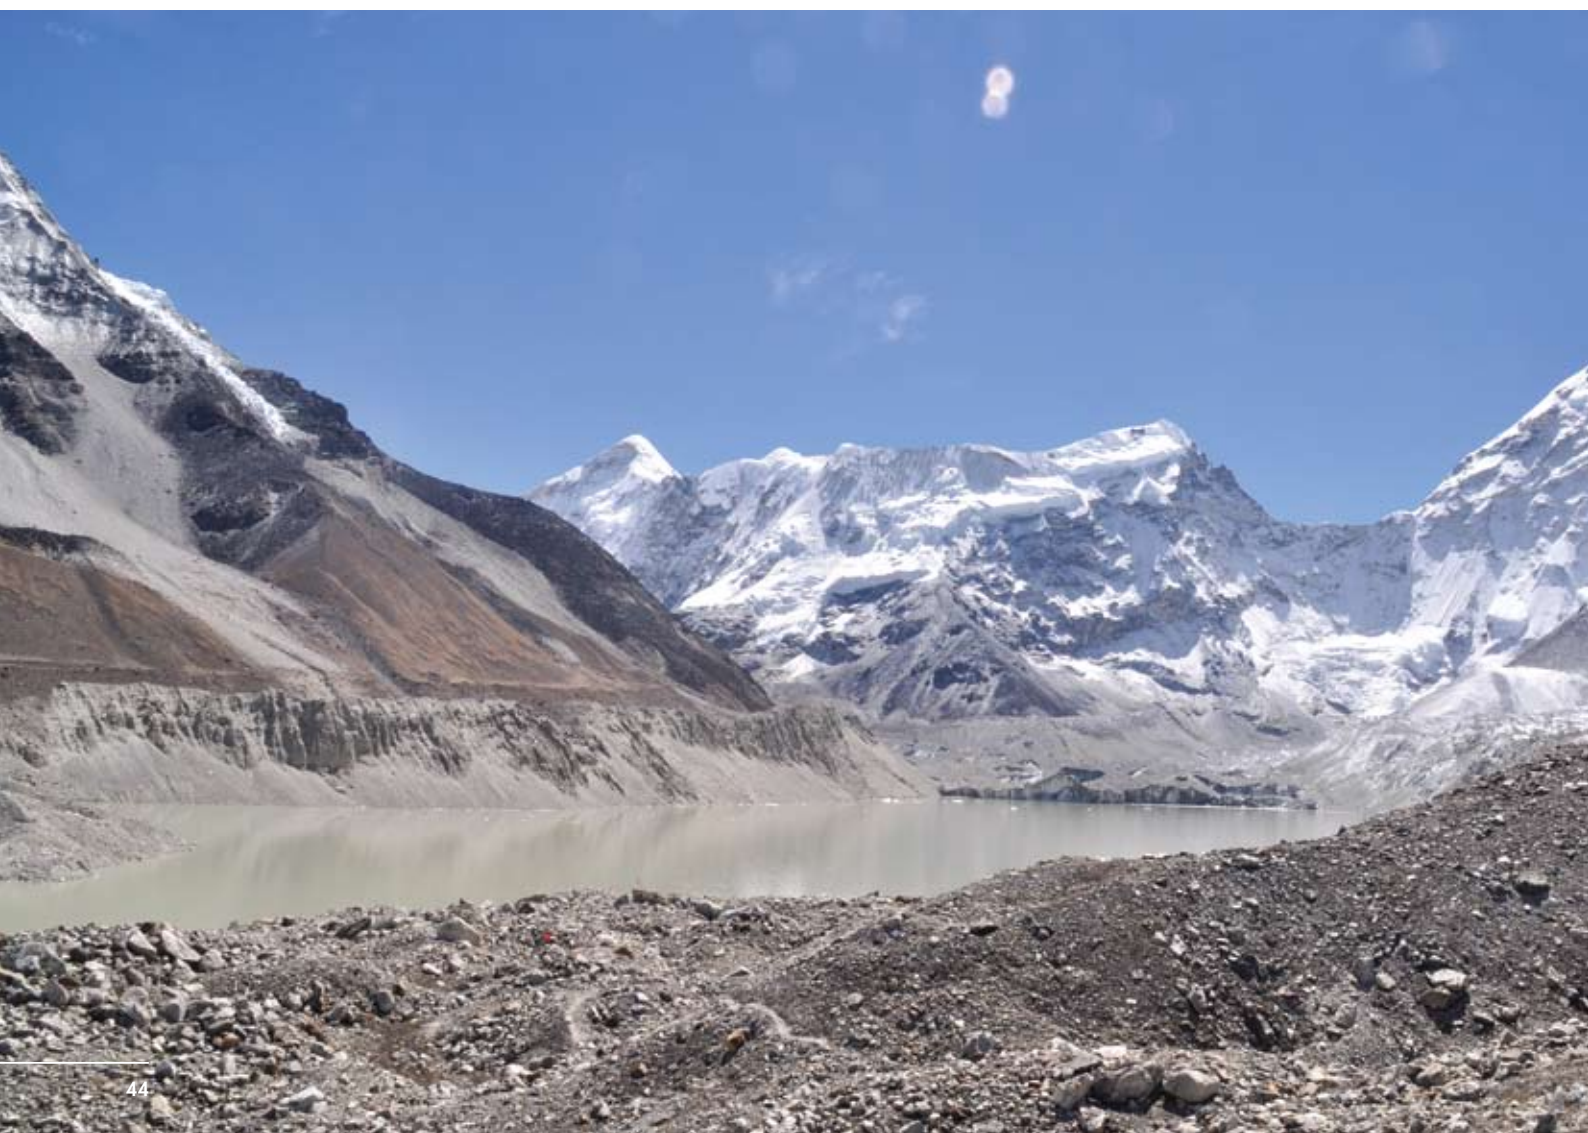
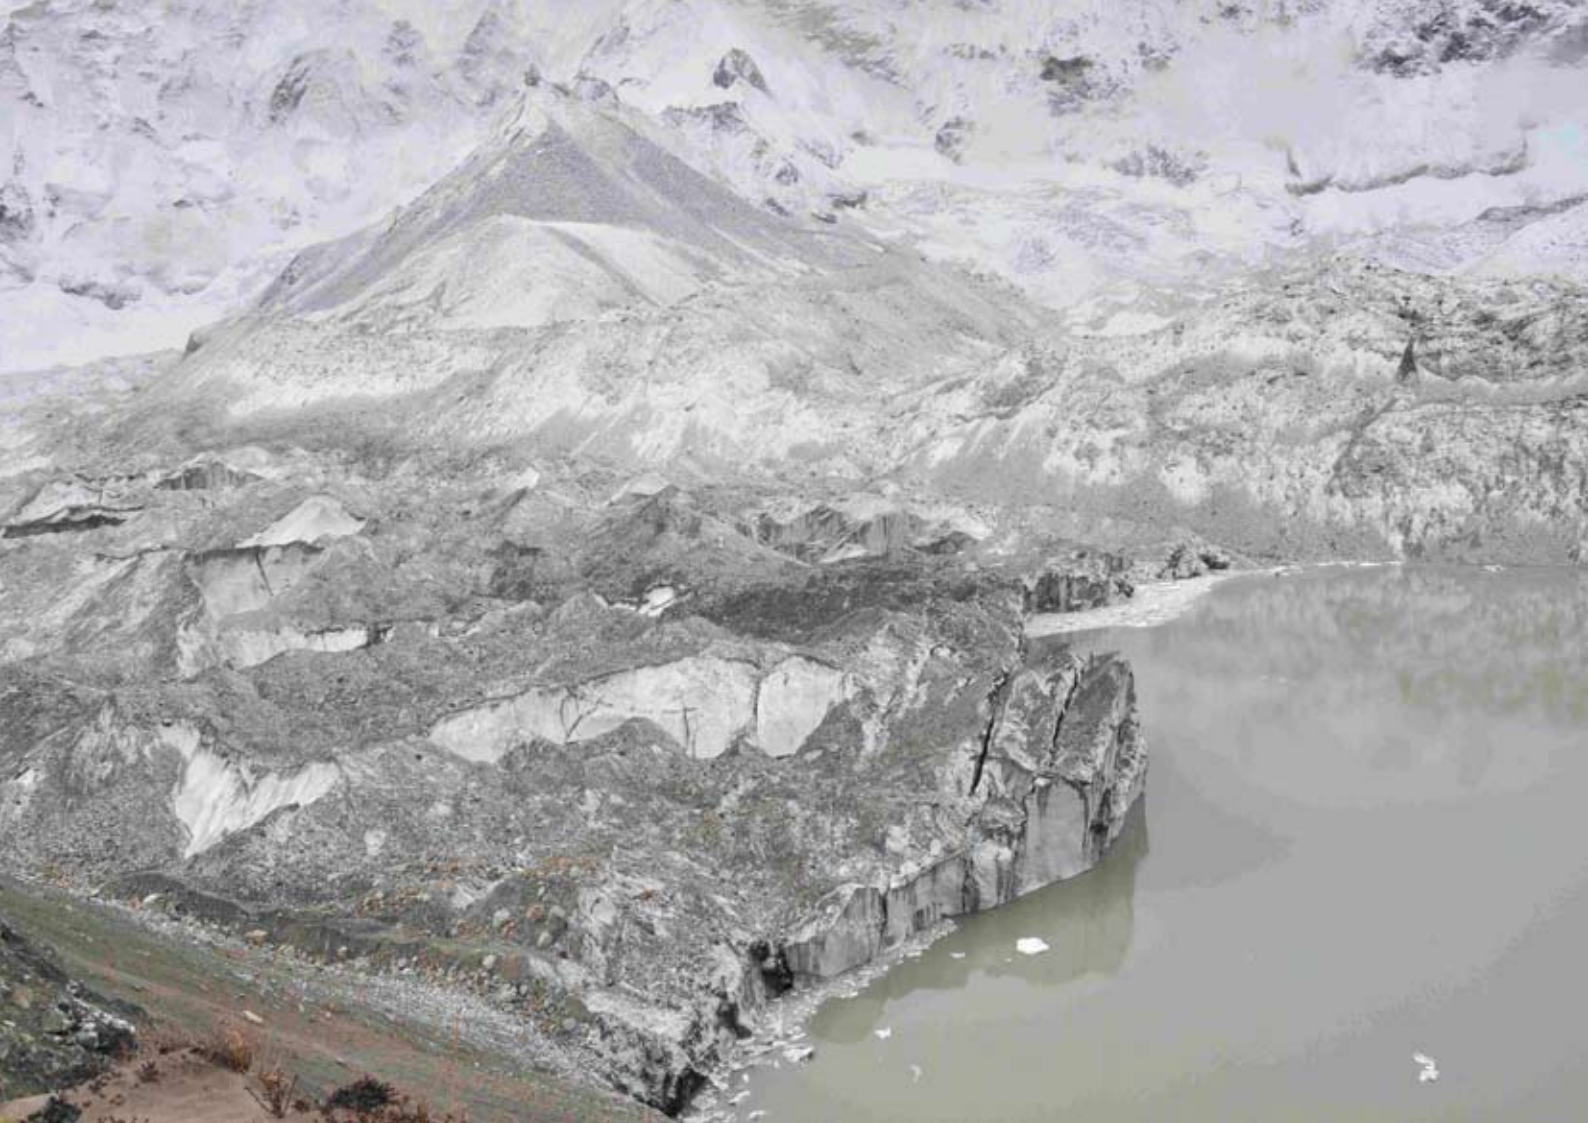
Figure 7.5: **Imja glacier terminus from a distance** (below 24 May 2009) **and closer view** (above right 23 May 2009) **showing thick debris cover and numerous transverse crevasses and collapse features**

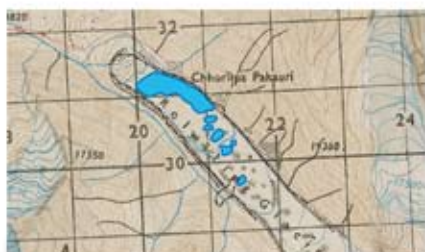
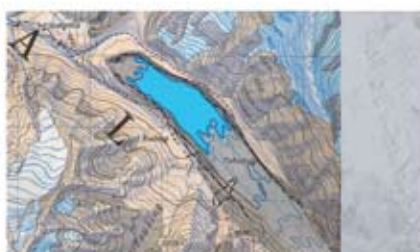
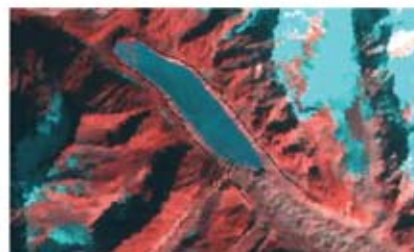
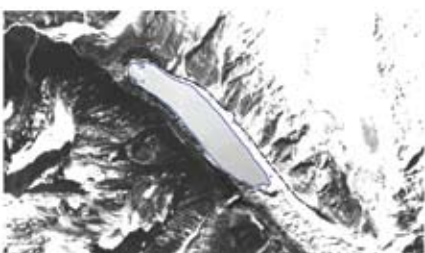
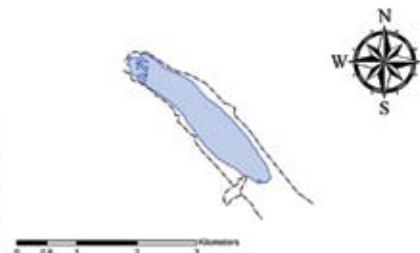
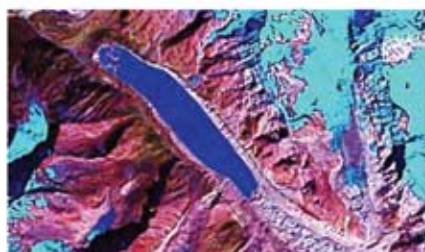
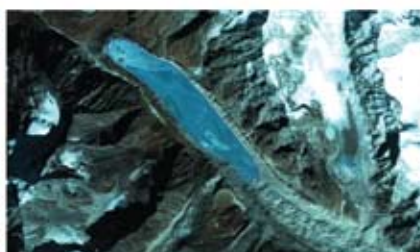
1957-59, Survey of India Topography Map

1960 - 68, Schneider Map

17 December 1991, Landsat TM

20 October 1992, Aerial Photo

1993-94, Field Survey WECS

30 October 2000, Landsat ETM+

19 January 2007, AVNIR-2

Development of Tsho Rolpa is shown in Figure 7.7. During the late 1950s, Tsho Rolpa existed only as a group of six small supra-glacial ponds. Between 1957 and 1959 its area was about 0.23 sq.km. The lake grew continuously from the beginning of the 1960s and by the 1990s it had enlarged to such an extent that it was considered to be on the verge of breaching its end moraine. Satellite images (MOS1 MESSR) showed that it had grown to 1.27 sq.km by 1990 and 1.55 sq.km by 1999. Mitigation work was completed in 2000; this included construction of a gated outlet channel that

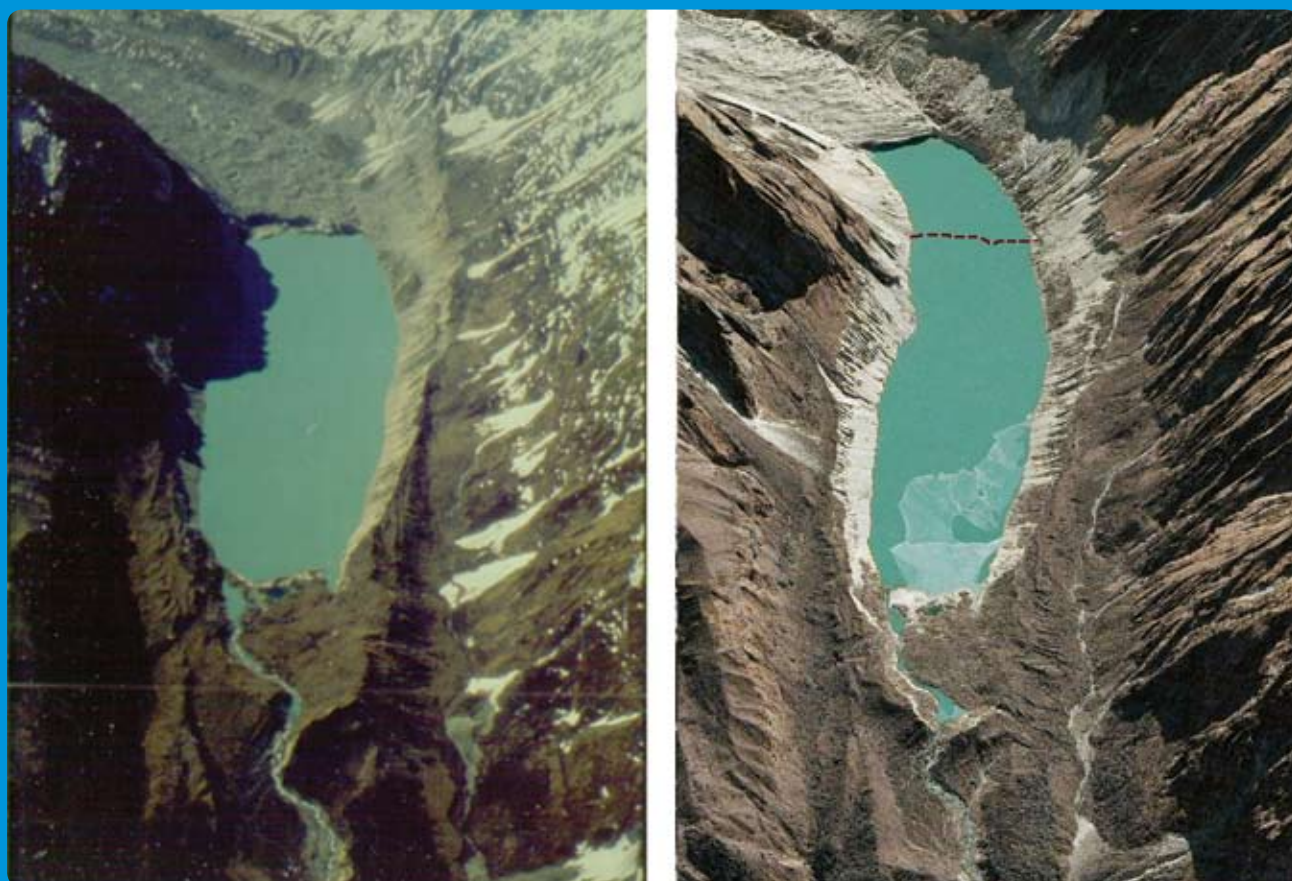
Figure 7.12: Overview of Thulagi Glacier and glacial lake in 1992 photo (left) and 2009 December Quick Bird image (right); the red line shows the expanded area

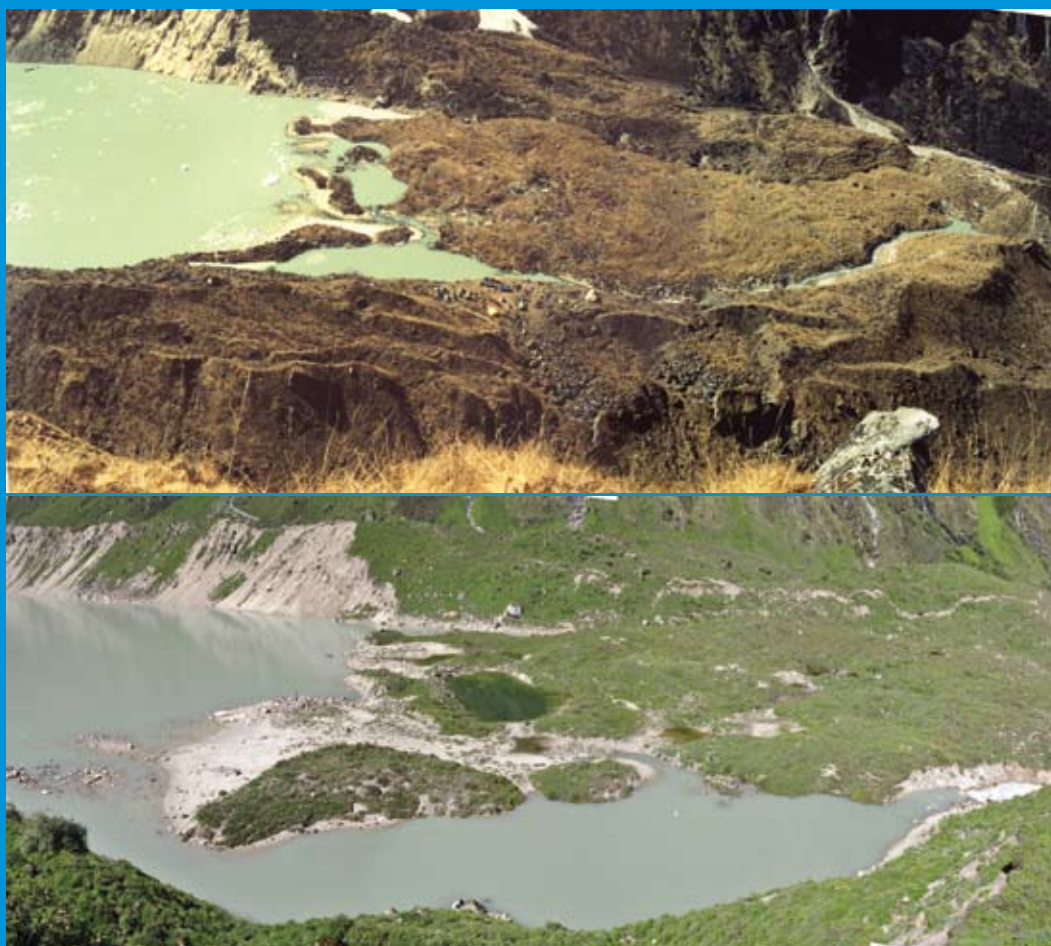
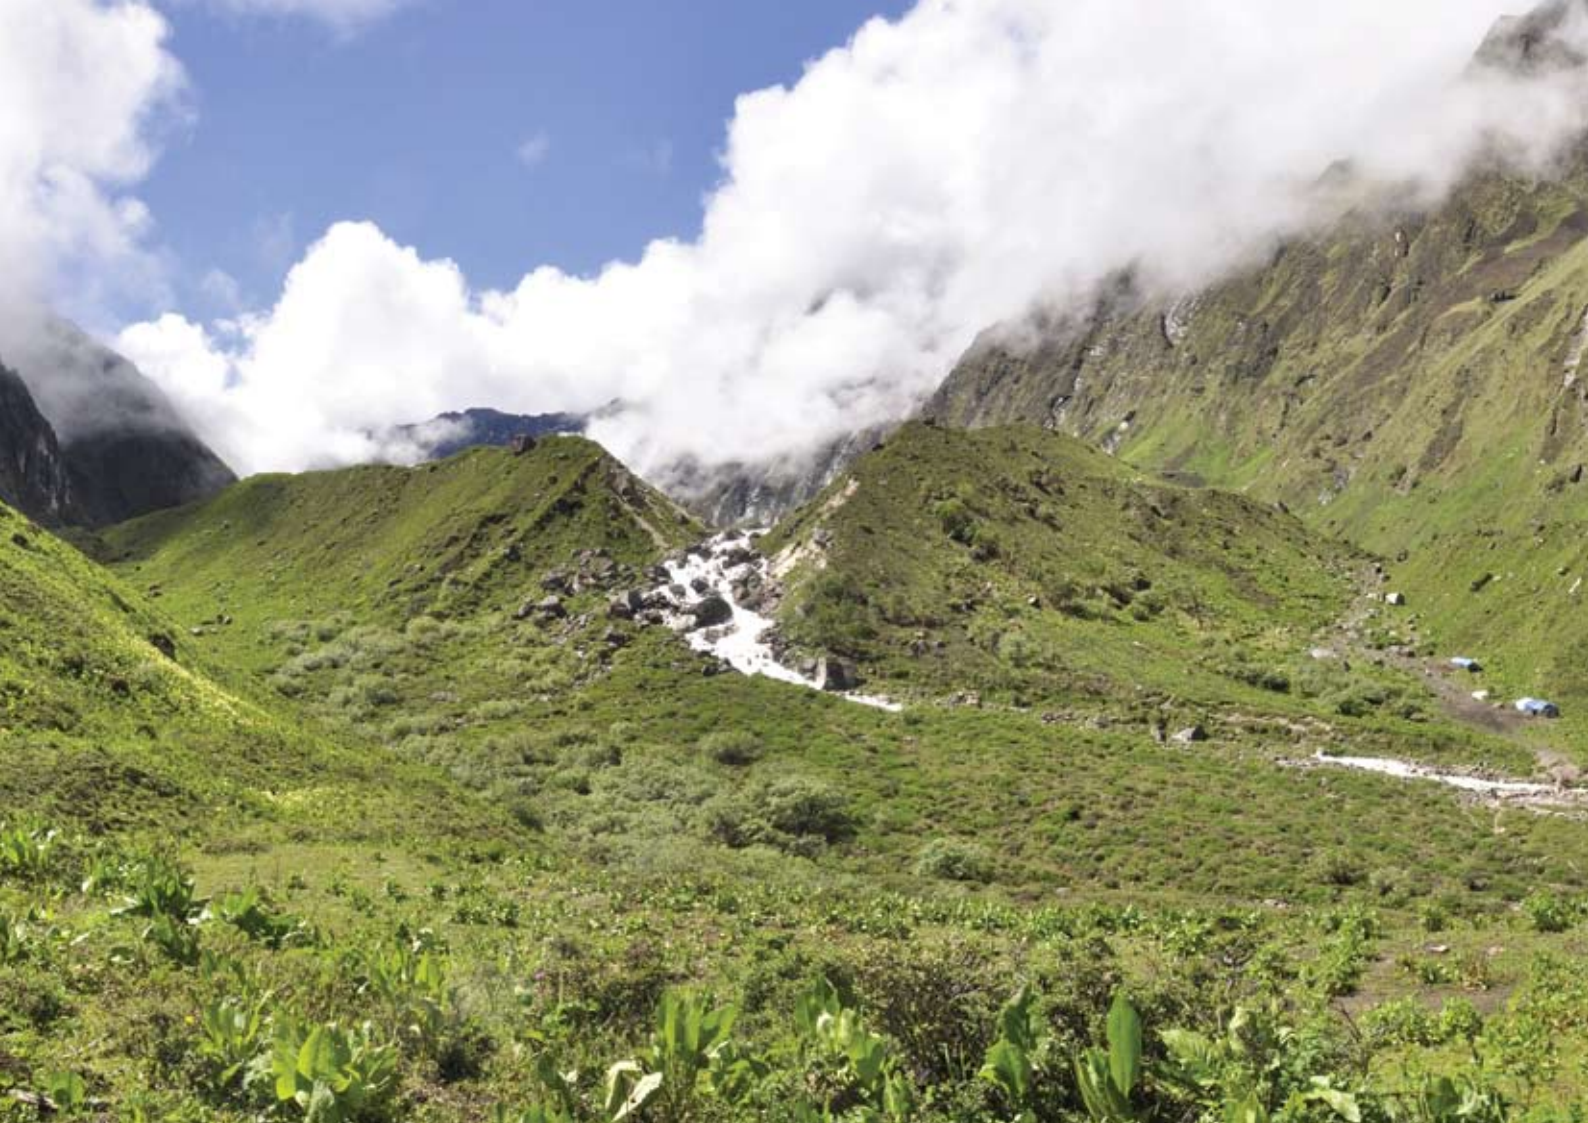
Figure 7.14: Changes in the shoreline of Thulagi Lake between 1996 (above) and 13 July 2009 (below), show the flow has now shifted towards the right lateral moraine, there are linear subsidence features on the left and right lateral moraines

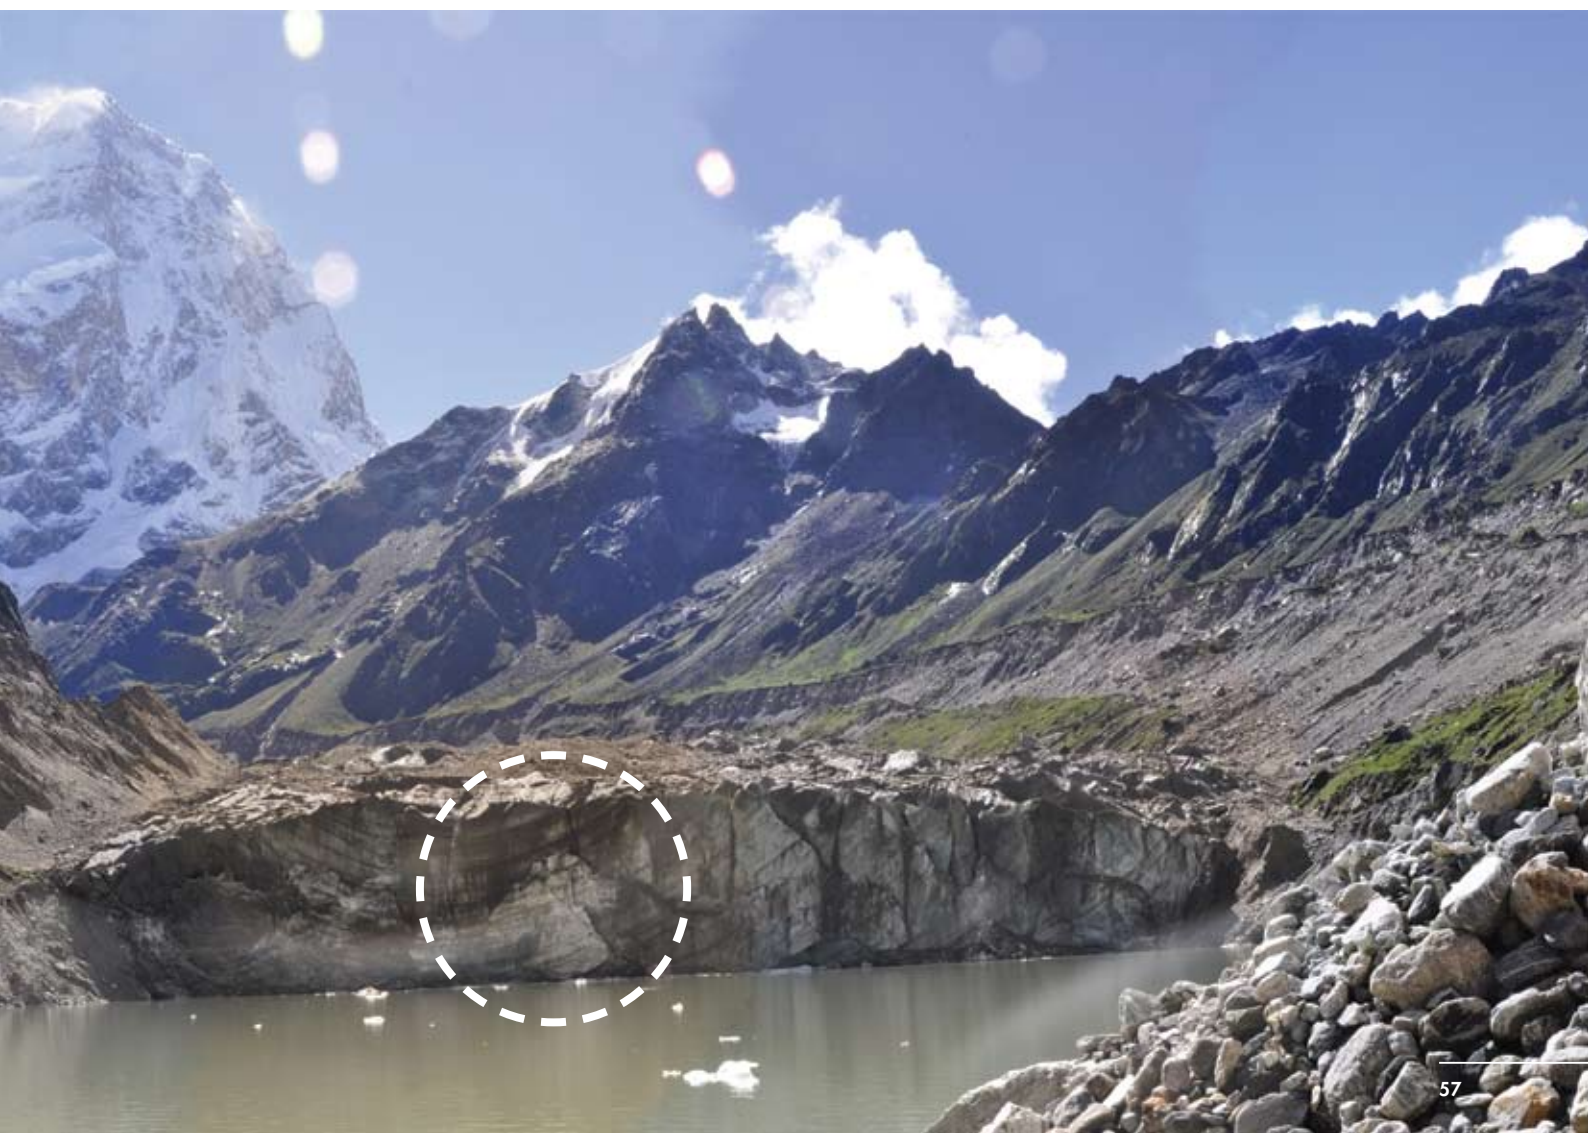
Figure 7.16: The Thulagi Glacier terminus in contact with the lake, the glacier tongue is about 40 m high above the water surface and exhibits snow stratigraphy (circle), 22 July 2009

Thulagi Glacier is a long, debris-covered glacier with a 40 m high terminal cliff. Even though ice calving is a regular phenomena, the surge that these calvings could produce are not deemed sufficiently large to trigger a GLOF event by the surge waves observed during the field study. Temporary blockage of the lake outlet by freezing water and snow barriers, or lake ice debris, appears unlikely, as indicated by the uninterrupted flow of the lake even during winter when the lake surface freezes. Lake drainage continues despite an average ice thickness of 0.4 m, as indicated by bore holes made through the ice during earlier bathymetric observations (WECS 1995c).

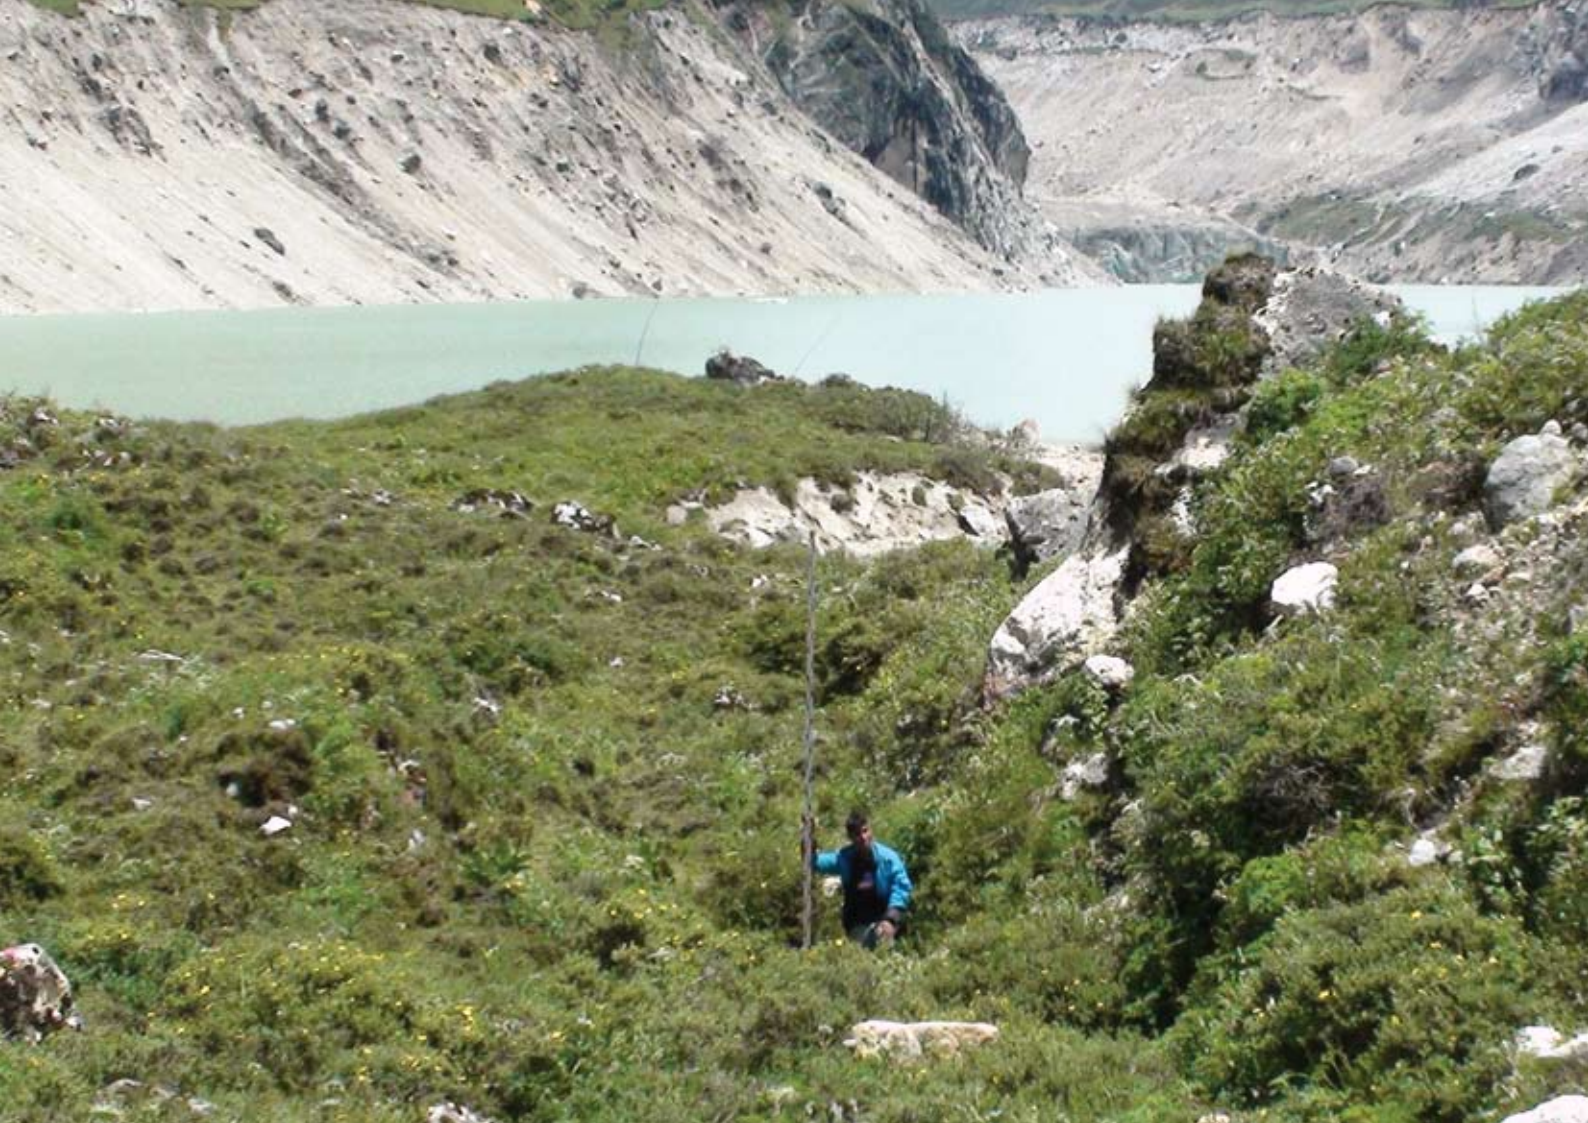
Figure 7.17: **Contact of the lateral and end moraine complex with extensive linear features and sink holes at Thulagi Lake, 24 July 2009**

The end moraine areas of all three lakes had linear cracks (Figure 7.17) that were more pronounced at the junction with the lateral moraines. The steep inner slopes are undercut by the surface currents in the lakes, and are also collapsing gradually as a result of ice melting within the moraine.
