Section 2

Field Investigations and Risk Assessment

6 Field Investigations

7 Results of the Field Investigations

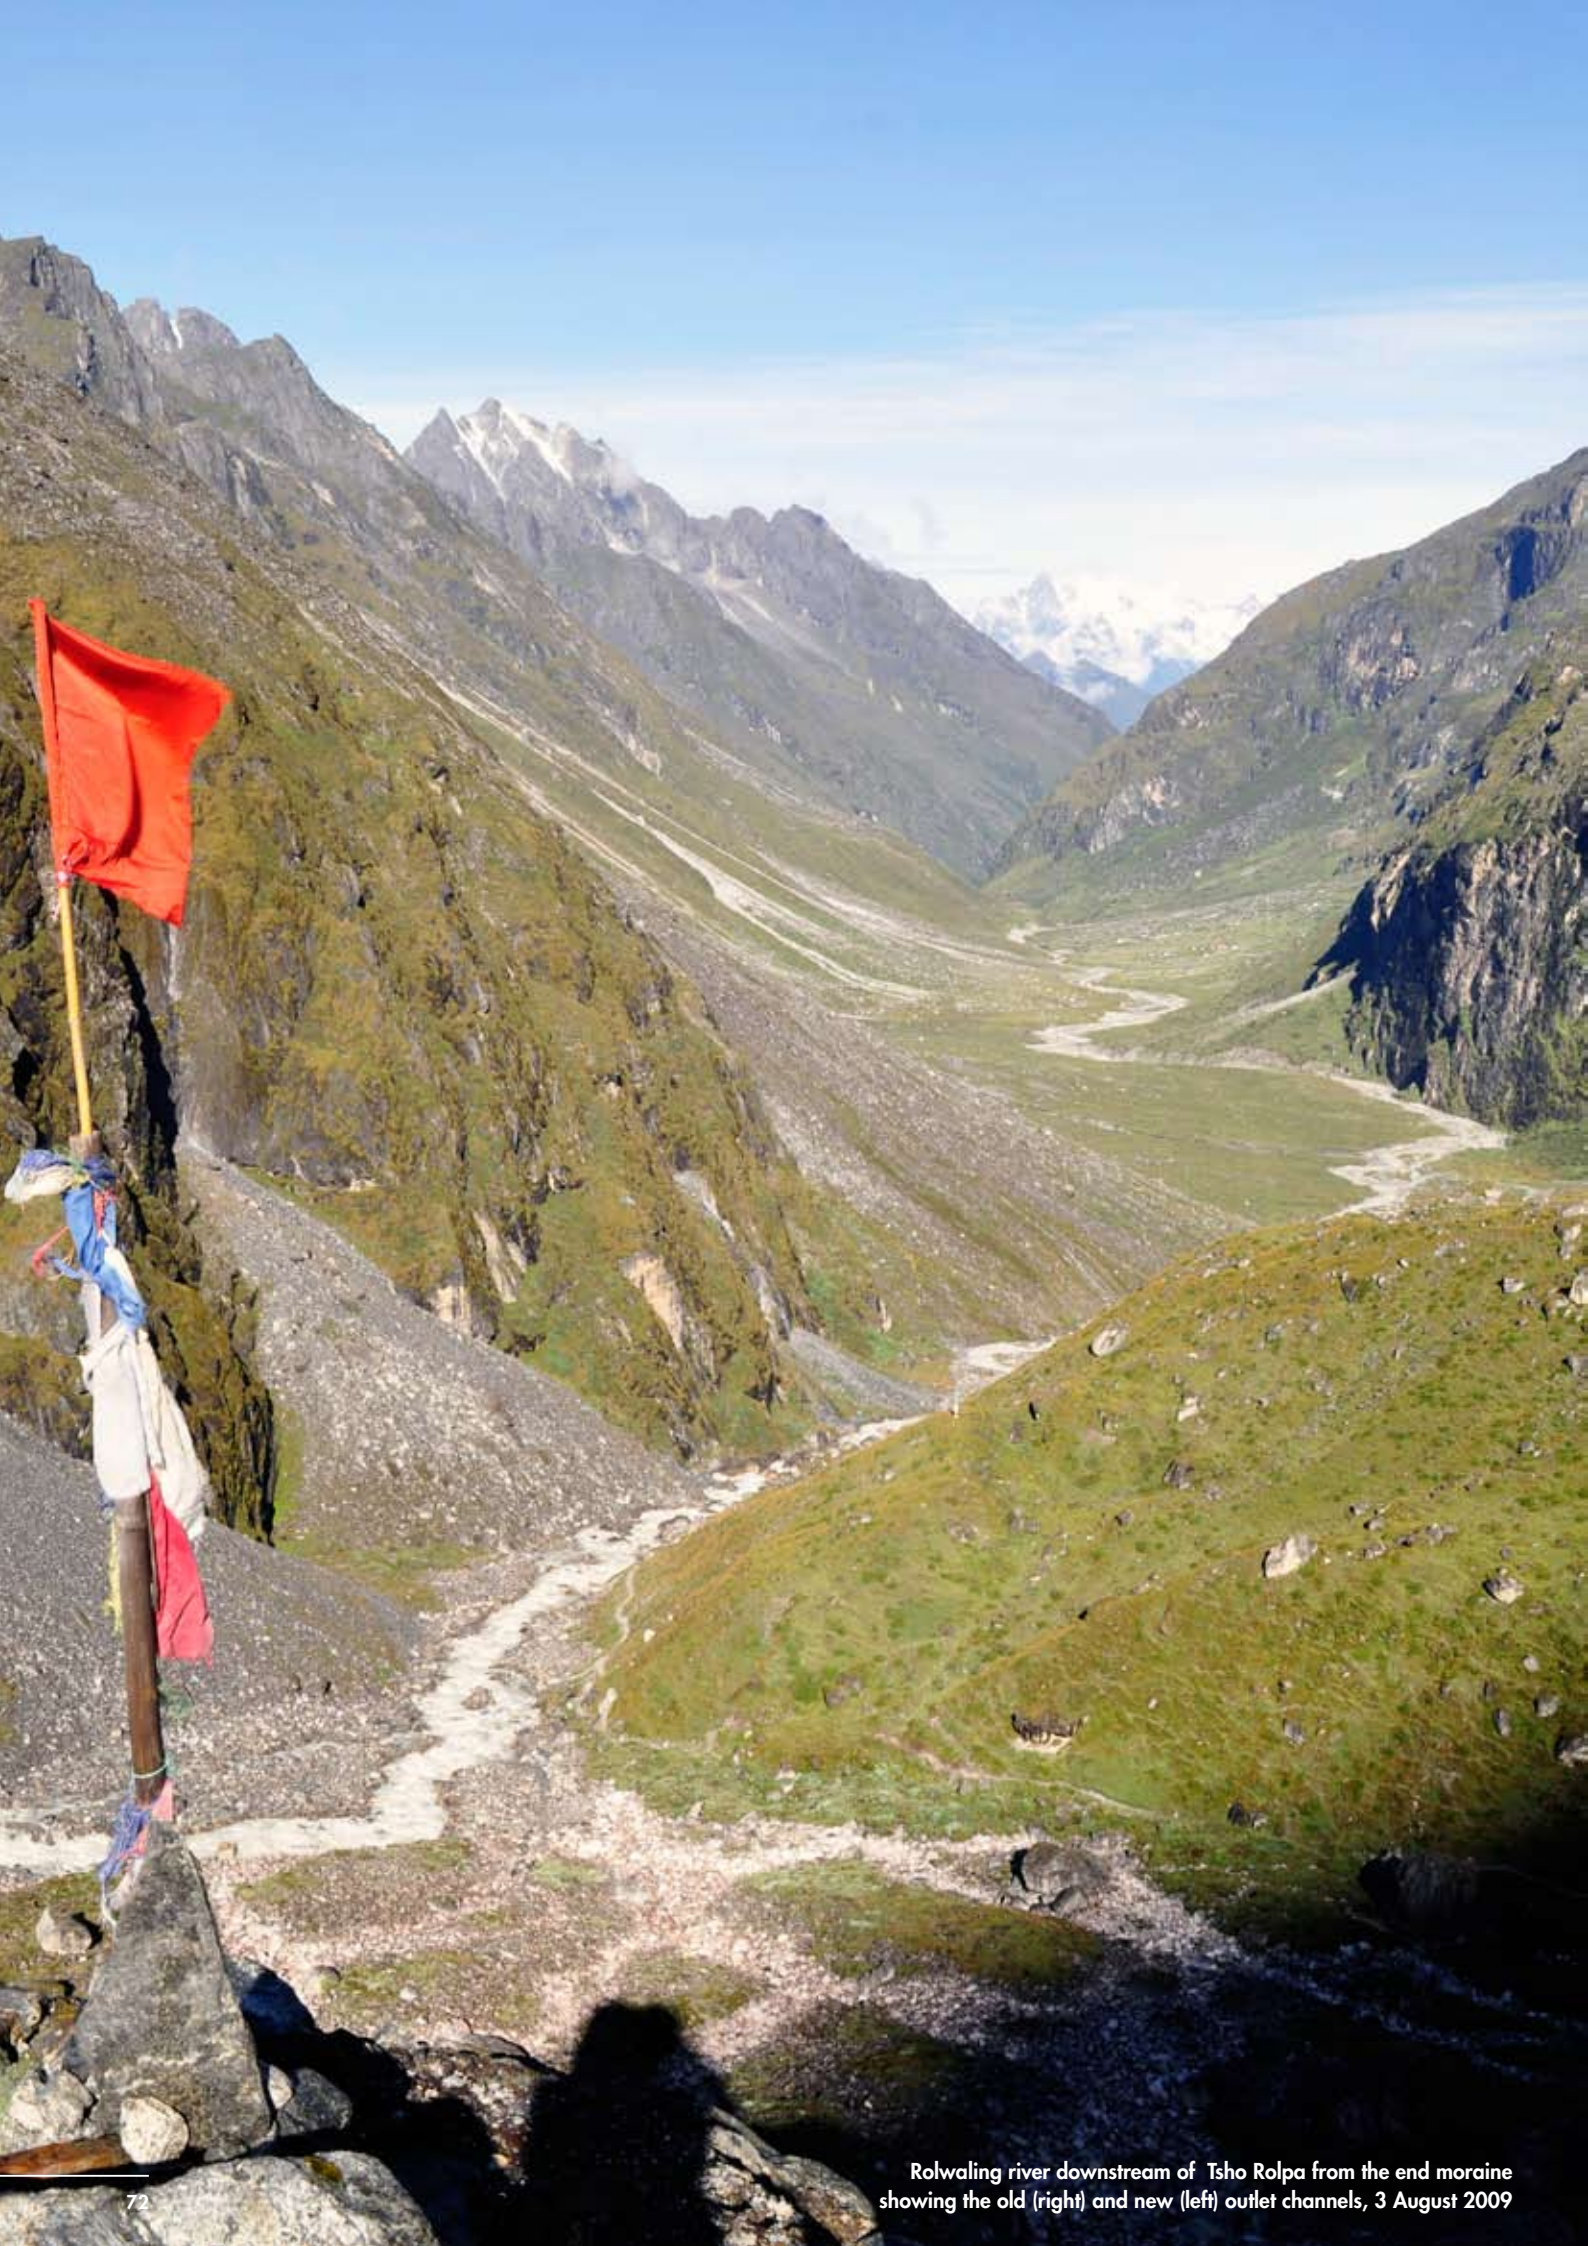
Rolwaling river downstream of Tsho Rolpa from the end moraine showing the old (right) and new (left) outlet channels, 3 August 2009

Temporary blockage of the lake outlet over the moraines by freezing water and snow barriers, or lake ice debris is very unlikely because the lake outlet has a wide artificial channel through the moraine dam that functions as a spillway. During the field investigation, the team noted that the gated artificial outlet channel was functioning satisfactorily, but they also noted vibrations in the anchor blocks as well as subsidence in the gabion walls. These two features should be monitored regularly.
