Article

Assessing the Prospects of Transboundary Multihazard Dynamics: The Case of Bhotekoshi–Sunkoshi Watershed in Sino–Nepal Border Region

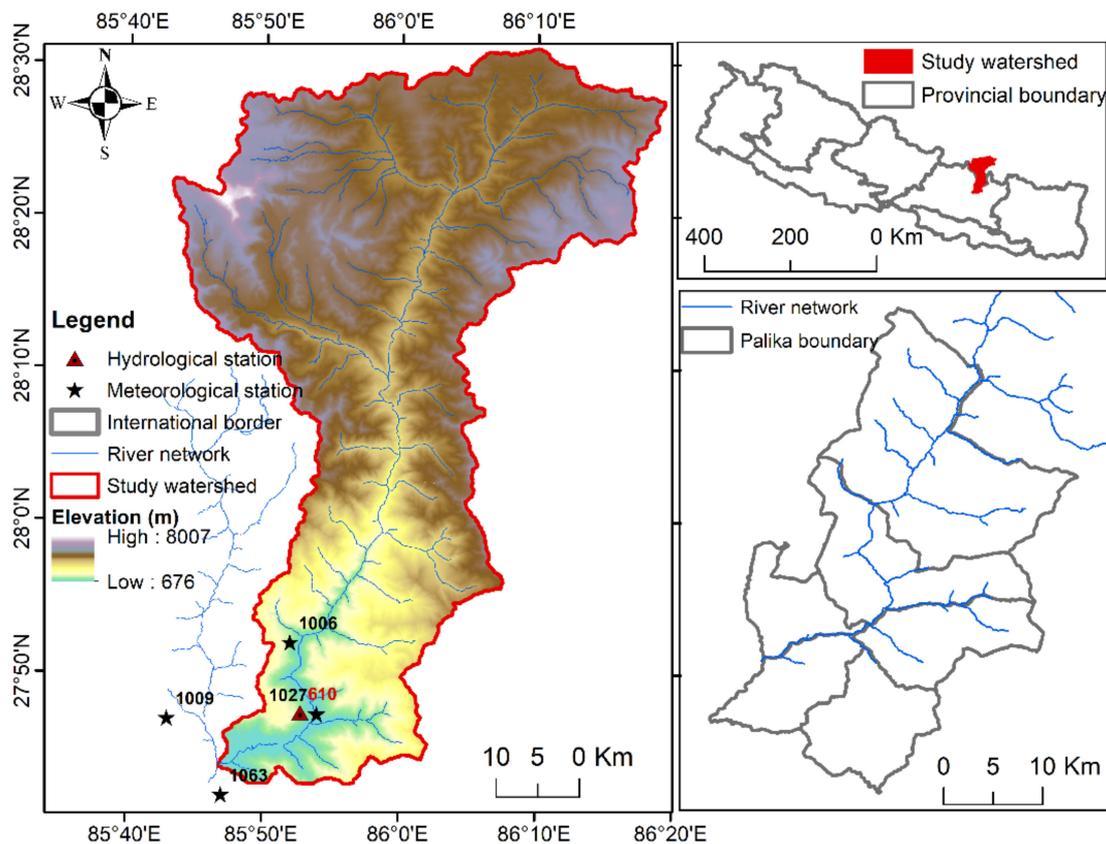
Figure 1. Location, topographic, and administrative details of the Bhotekoshi–Sunkoshi watershed.

The BSW above the confluence with Balefi River (located outside the boundary of the BSW as shown in Figure 1) covers an area of 2558 km² that extends between 27°42'41"–28°31'05" N latitude and 85°42'59"–86°19'37" E longitude (Figure 1). Of the total catchment area, 22.5% lies in Nepal and the rest in the Tibet autonomous region of China. The climate in the BSW varies from temperate to polar [30]. Administratively, there are six Palikas

(local administrative units) that fall partially or fully within this portion of the BSW in Nepal (Figure 1, Table 1). They are Bhotekoshi, Bahrabise, Sunkoshi, Balefi, Tripurasundari, and Lisangkhu Pakhar. The proportion of the Palika area within the watershed is shown in Table 1.

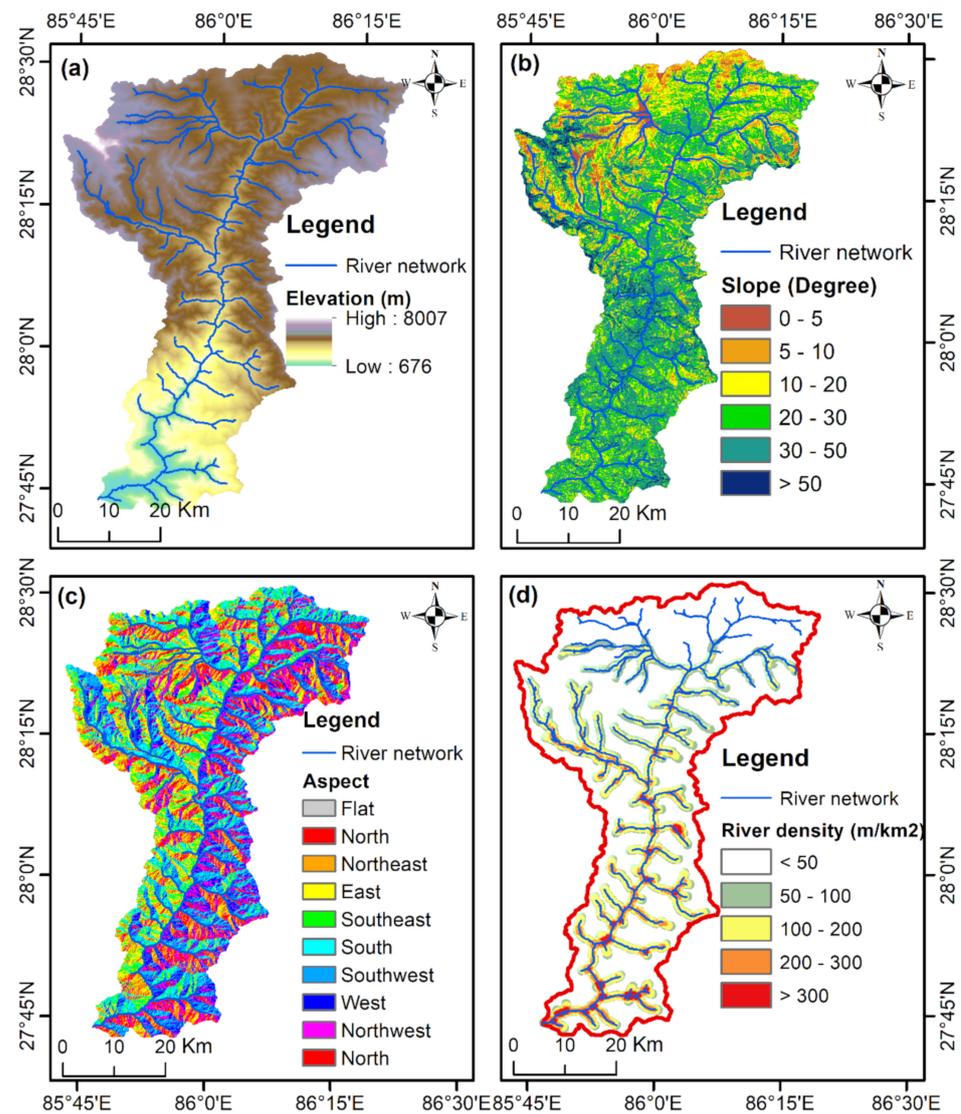
Figure 2. Topographical characteristics: (a) elevation, (b) slope, (c) aspect, (d) river density.

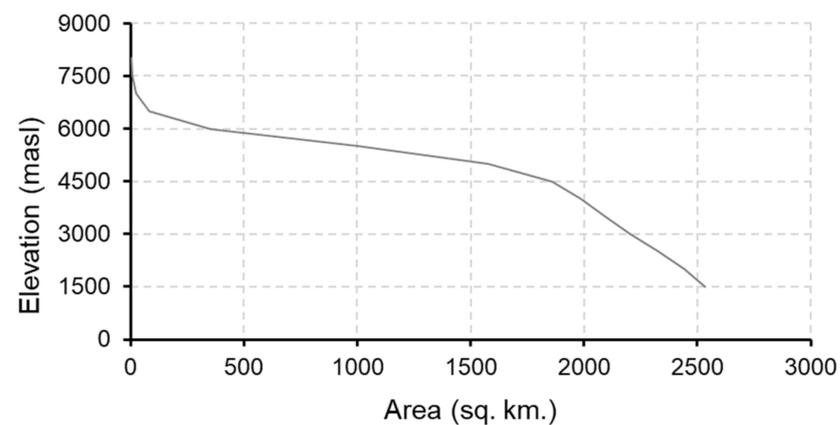
Figure 3. Hypsometric curve of the Bhotekoshi-Sunkoshi watershed.

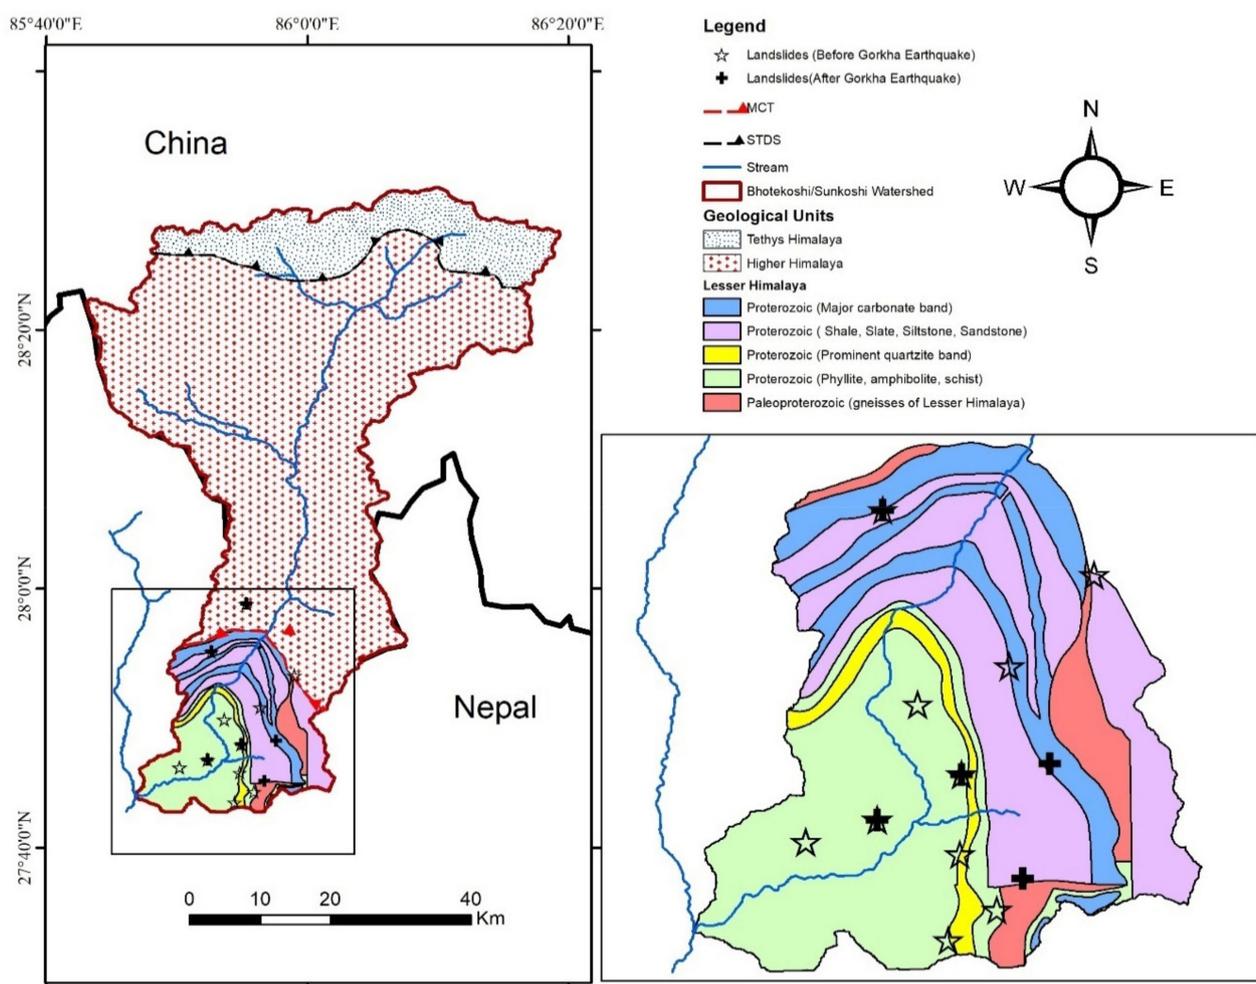
Figure 4. Geological map of the study area (modified from: [48,49]).

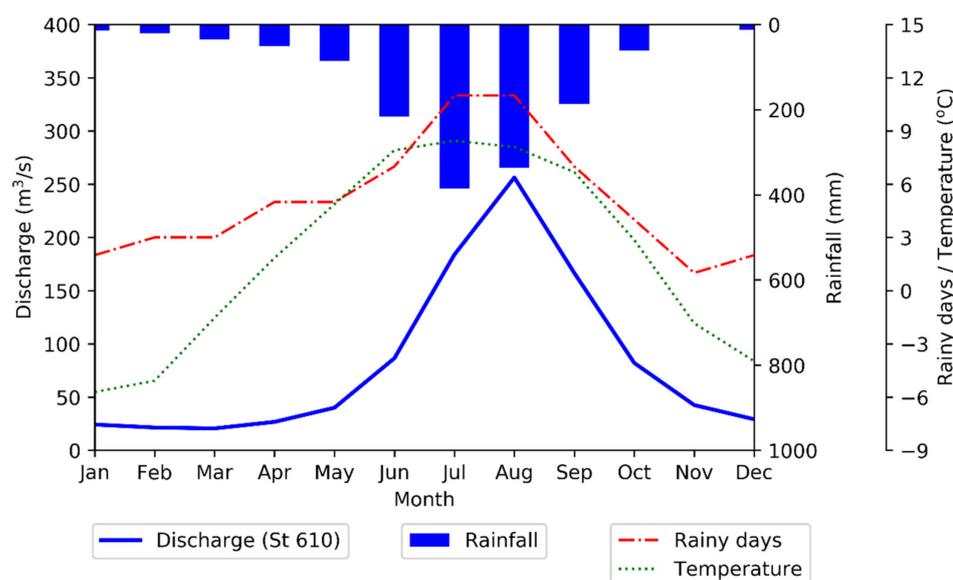
Figure 5. Mean monthly discharge at Bahrabise station (Station no.: 610) and basin-averaged mean monthly rainfall (inverted y-axis at right), and rainy days and average temperature (offset right axis) of the study area. Monthly discharge data for Bahrabise station is computed from the data maintained by the Department of Hydrology and Meteorology (DHM), basin-averaged rainfall and rainy days are computed from the CHIRPS data using 94 grid points and basin-averaged temperature is computed from the WorldClim data.

The hydrological characteristics of the study area are shown in Figure 5. The spatially averaged values of the mean monthly climatic variables (rainfall, rainy days, and temperature) clearly show significant intra-annual variability. In particular, a strong seasonality in rainfall could be observed, with almost 80% of the average annual rainfall being received during the rainy season. Due to a large altitudinal variation across the study area, there are significant temperature differences between the highest temperature (over 23 °C) at lower regions during July and the lowest temperature (below –20 °C) at upper region of the study area during January. An average of 30 °C variation of temperature could be seen across the study throughout the year. The river valley is warmer and drier compared to the hill slopes. The monthly rainfall is above 350 mm (rainy days ~11 days) during July and August, accompanied by the highest air temperature (about 8 °C, varying from –4.5 °C in the upper region to 23 °C in the lower region). Generally, the heaviest rainfall is accompanied by the greatest average temperature. The monthly variation of the river discharge at Bahrabise shows a peak value during August. July and August are the two months when a peak instantaneous discharge could happen upon heavy rainfall upstream of the study area. We found that 10–13% of the annual rainfall is contributed by a single day's rainfall, which clearly indicates high-intensity, short-duration rainstorm events are recurrent across the study area. Considering the maximum consecutive seven-day rainfall for every year between 1981–2019, this study finds that about 20% of the total annual rainfall occurred during the consecutive seven-day period. Under such a scenario, the soil of the hillslopes becomes completely saturated, and there are high chances of the failure of unstable slopes. After the 2015 Gorkha earthquake, more than 2000 landslides (small to large) occurred along the corridor of Bhotekoshi–Sunkoshi River [53].

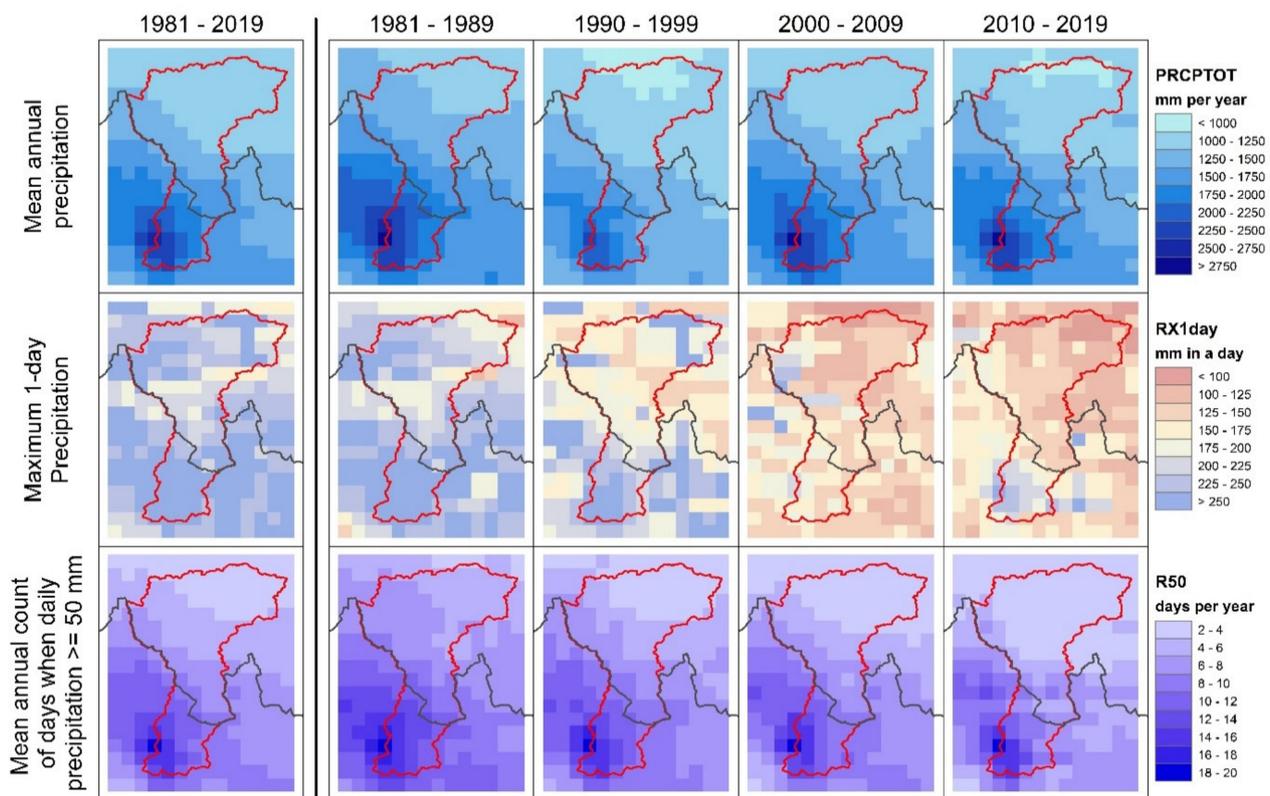
Figure 6. Spatial distributions of mean annual precipitation (at top panel), maximum 1-day precipitation (at middle panel) and mean annual count of days when daily precipitation ≥ 50 mm (at bottom panel) for the entire selected period (1981–2019 at the left), and for different four decades: 1981–1989, 1990–1999, 2000–2009, and 2010–2019 (left to right, respectively). The daily precipitation data are obtained from CHIRPS dataset at a spatial resolution of 0.05° (~ 5 km).

Figure 6 shows spatial distributions of mean annual precipitation, maximum one-day precipitation, and mean annual count of days when daily precipitation ≥ 50 mm for different four decades and the entire period (1981–2019). The mean annual precipitation (1981–2019) varies from about 1000 mm at upper region to 2700 mm at lower region of the study area with a basin-averaged value of 1450 mm. The lower region of the study area (meaning the Nepal–China border to river confluence at Balephi) receives high rainfall compared to the upper region. We chose two extreme precipitation indices (RX1day and R50) because they provide information about the locations susceptible to the high-precipitation and likely rainfall-induced geohazards. There are some locations where the number of days in a year with daily precipitation ≥ 50 mm (R50) is above 18 days across the lower region of the study area, meaning the location is highly susceptible to soil erosion, landslides, and resulting debris flow. There are not any particular decadal trends for selected extreme precipitation indices and annual precipitation. In general, the tendency shows a constant to slightly decreasing precipitation amount and extreme precipitation indices (average value). However, the yearly fluctuations are significant, and the decreasing tendency is mostly found in upper region of the study area. The lower region of the study area receives frequent heavy rain (i.e., R50) and recently most of the landslides have been recurrently occurring around this area.

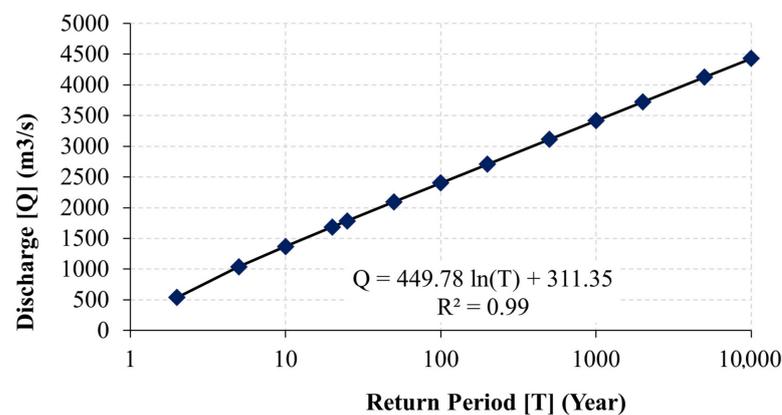
Figure 7. Floods of various return periods based on Gumbel distribution at Bahrabise station (index: 610).

We further characterized the average annual as well as seasonal discharge and their trends over the years based on the observed discharge at the outlet of the watershed (Bahrabise, index: 610). The average annual discharge of 1965–2006 is $81.1 \text{ m}^3/\text{s}$, with variations over the months from $20.6 \text{ m}^3/\text{s}$ (in March) to $255.4 \text{ m}^3/\text{s}$ (in August). The recorded average monthly discharge for the month of highest flow varies from 145.7 to $846.5 \text{ m}^3/\text{s}$. Furthermore, the instantaneous flood time series for the 35 years spanning from 1965 to 2006 ranges from 292 to $1030 \text{ m}^3/\text{s}$, with an average value of $614 \text{ m}^3/\text{s}$. Flood frequency analysis using Gumbel distribution showed that floods of the return periods 100, 500, 1000, and 10,000 floods at the outlet of the watershed are $2401 \text{ m}^3/\text{s}$, $3112 \text{ m}^3/\text{s}$, $3417 \text{ m}^3/\text{s}$, and $4430 \text{ m}^3/\text{s}$, respectively (Figure 7).

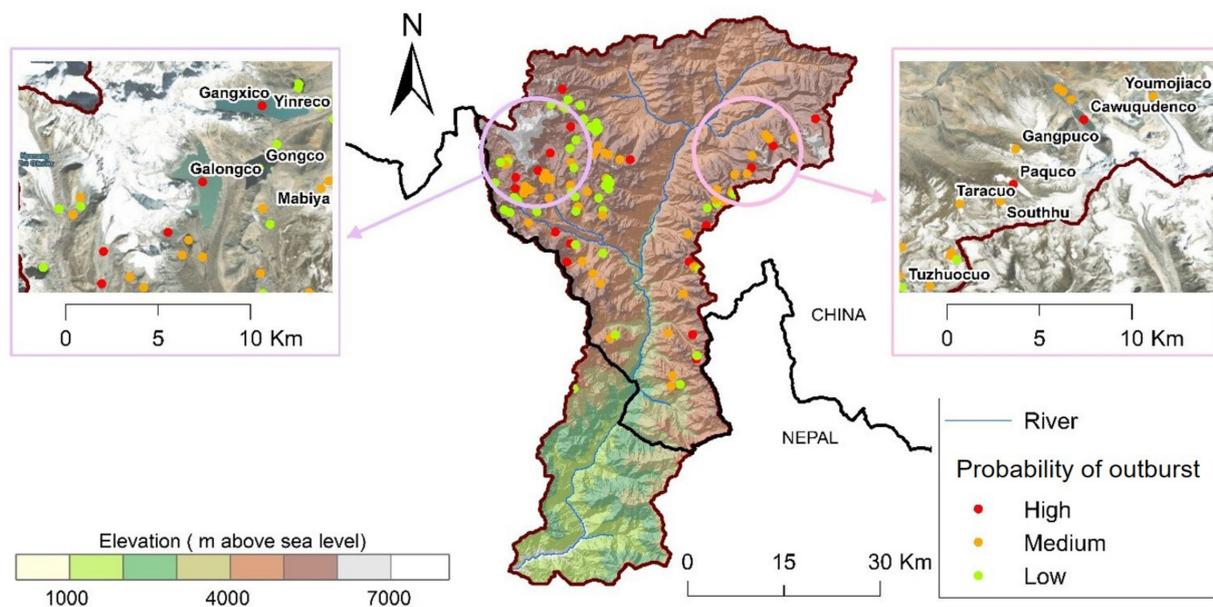
Figure 8. Location of glacial lakes (count = 108) across the study area and their probability of flood shown in three levels: high, medium, and low. The shaded is topography and hill shade. The elevation of these glacial lakes ranges from 4102 m asl (meters above sea level) to 5615 m asl. There are 17 glacial lakes with high probability of flooding. Two insets are representative areas superimposed with google image as a base map.

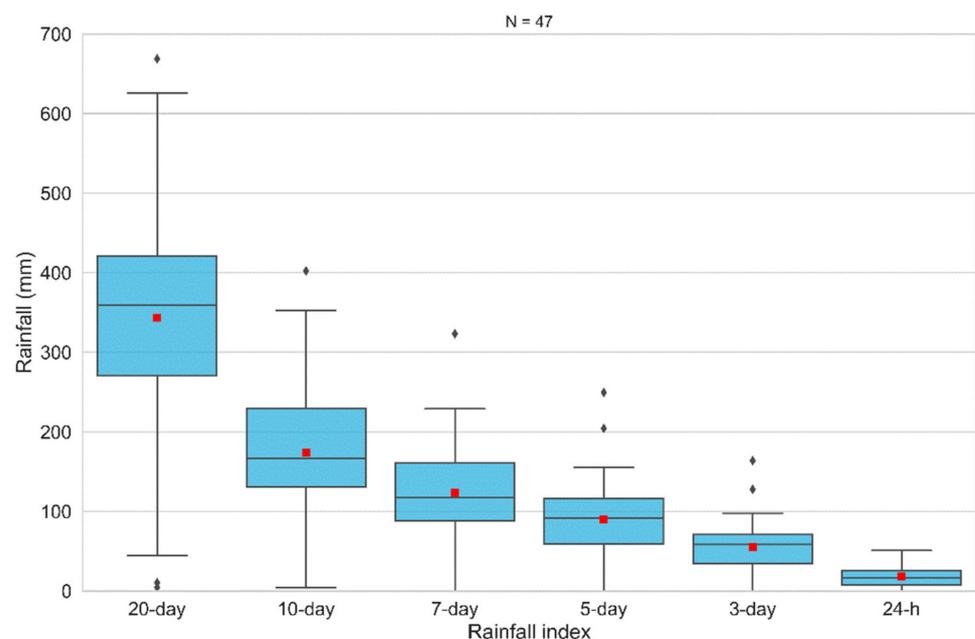
Figure 9. Boxplot showing the variation of different rainfall index based on cumulative rainfall (20-day, 10-day, 7-day, 5-day, 3-day and 24-h) before the occurrence of landslide based on daily rainfall data. No. of landslides (n) used in this study is 47 that occurred inside the study basin around Nepal side. Red square indicates the average value and boxplot shows quantiles (Q1 and Q3), median (Q2) and range of variation.

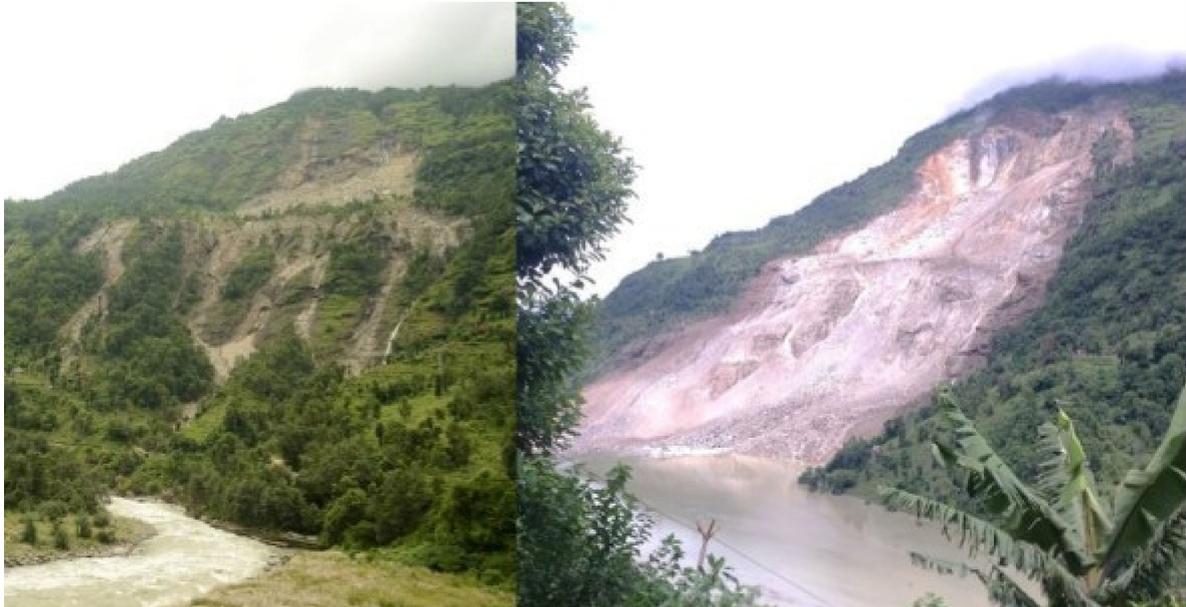
Figure 10. Jure landslide site. The photo on the left (Image credit: Narendra Khanal) shows the site after a small movement of earth in June 2013. On the right, the same site after the devastating landslide on 2 August 2014. The lake formed by the landslide dam can be observed in right image.

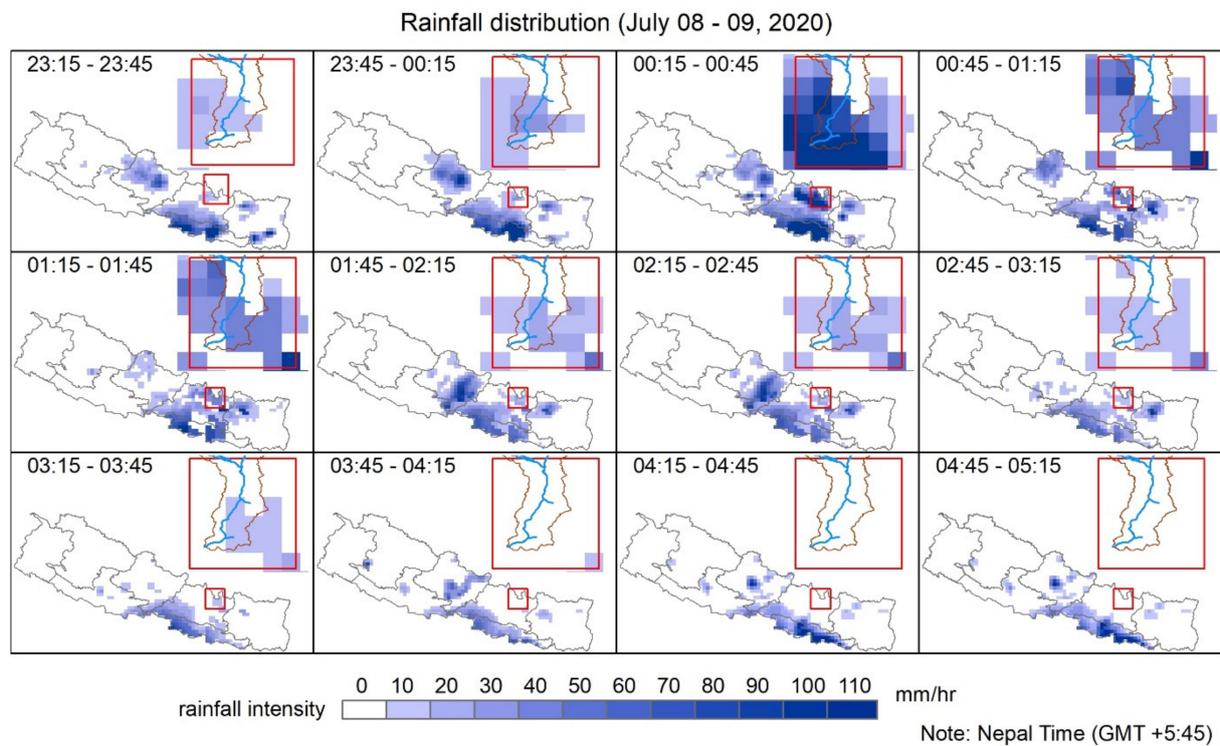
Figure 11. Spatiotemporal distribution of rainfall intensity (in mm/hr) for the period of 8 July 23:15 to 9 July 05:15 across Nepal. The rainfall intensity estimates were taken from the IMERG early product, available at a spatial resolution of ~10 km and a temporal resolution of 0.5 h. Inset at top right of each panel shows the Bhotekoshi–Sunkoshi Watershed. The disastrous mudslide/landslide and resulting debris flow occurred around 1:30 am local time.

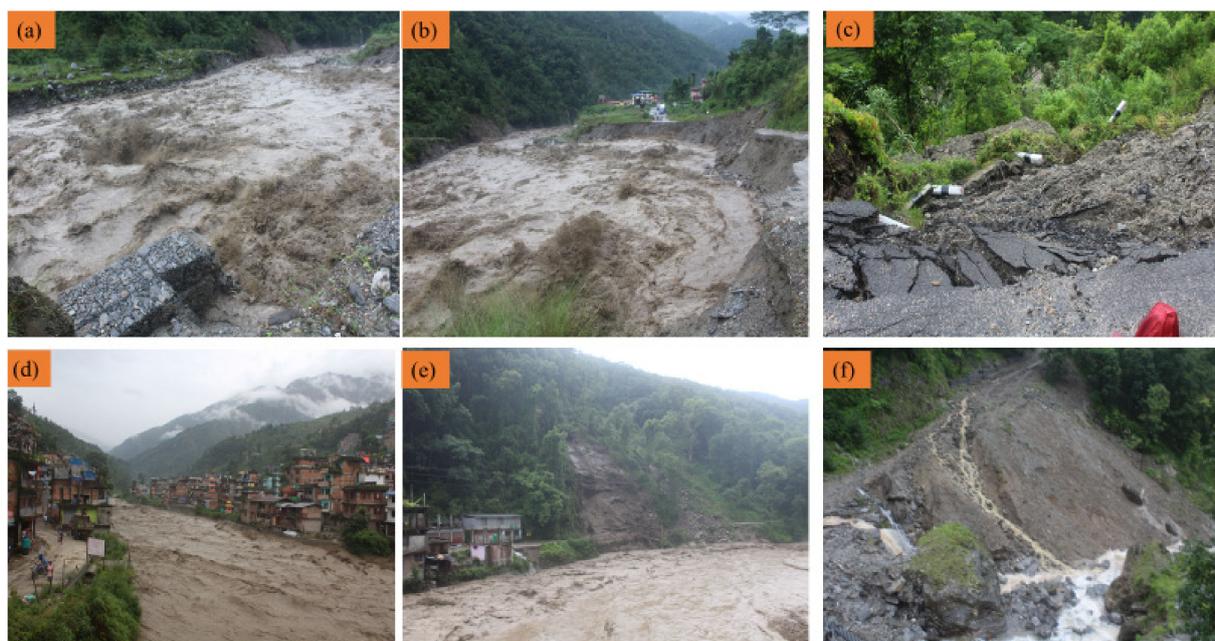
Figure 12. Effects of flooding and debris flow: (a) toe cutting and subsequent damage to protection structure by Sunkoshi River, (b) mass movement and slope failure due to toe bank erosion, (c) highway section damaged due to debris flow, (d) flooding in Bahrabise neighborhood, (e) obstructed road section due to slope failure, (f) slope failure across a gorge.

The debris flow and the flooded Sunkoshi River significantly affected communities and infrastructures, as shown in Figures 12 and 13. For instance, toe cutting was observed along the river stretch that threatened several settlements and damaged retaining structures. Nearly 700 m of the highway was swept away by the debris flows and toe cutting. Two people were confirmed dead and 17 others were reported to be missing. Meanwhile, 16 houses were damaged by the debris flows. Apart from this, a bridge (Purkutte bridge) collapsed due to the flooding that occurred in the Bhotekoshi River. The Middle Bhotekoshi

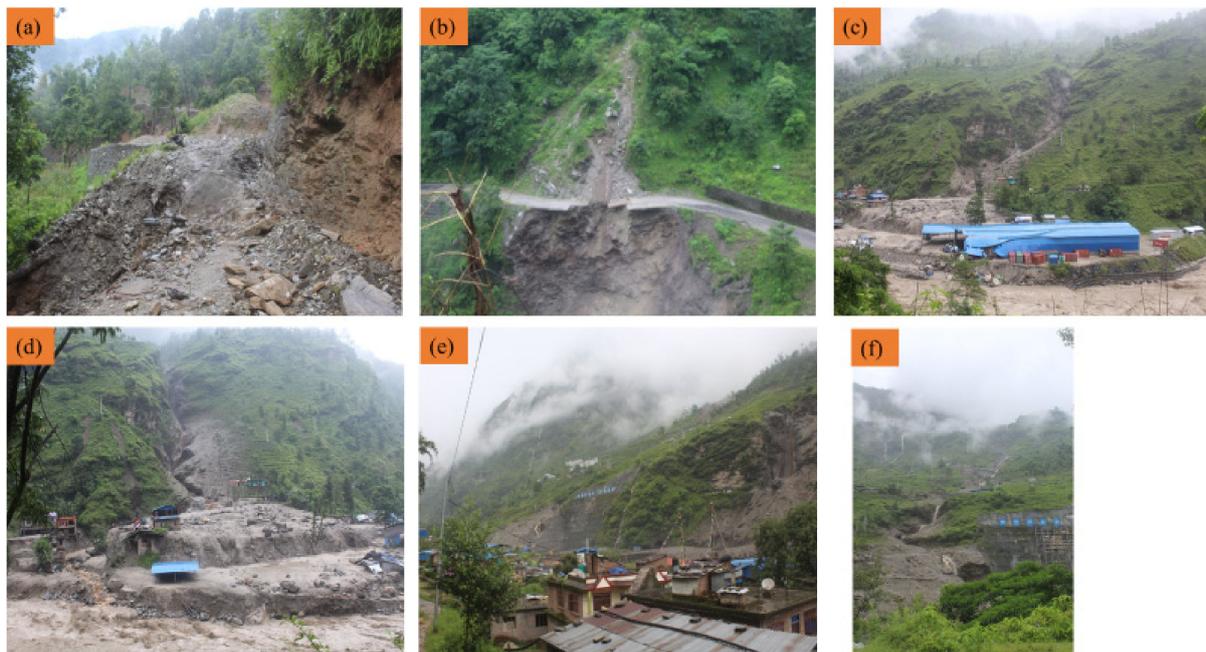
Figure 13. (a) Rural road section wiped out by debris flow, (b) highway section damaged by debris flow, (c) damage to warehouse, (d) completely destroyed Jambu neighborhood by debris flow, (e) damage to Middle Bhotekoshi Hydropower Project, (f) widening of debris flow along the gorge.

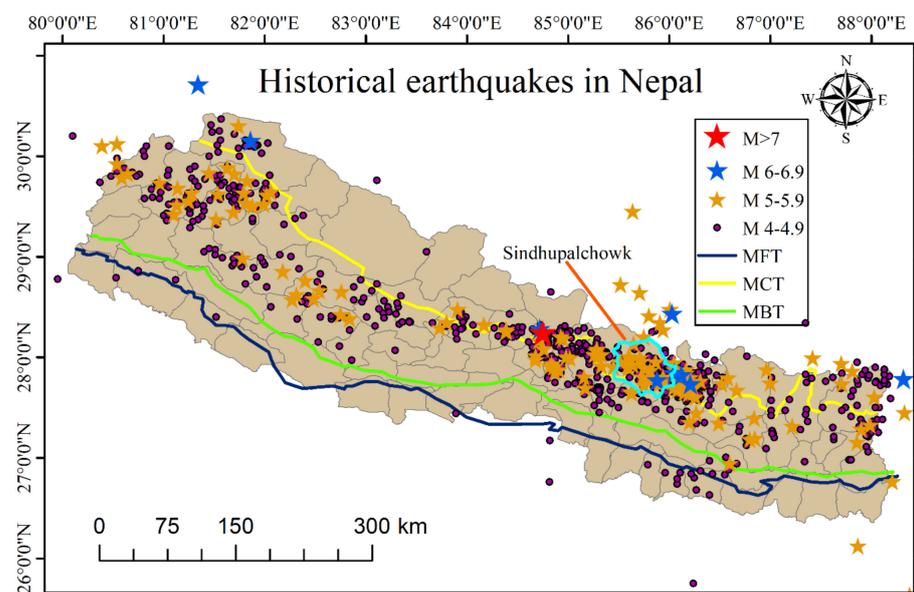
Figure 14. Earthquake events in Nepal between 1998–2020.

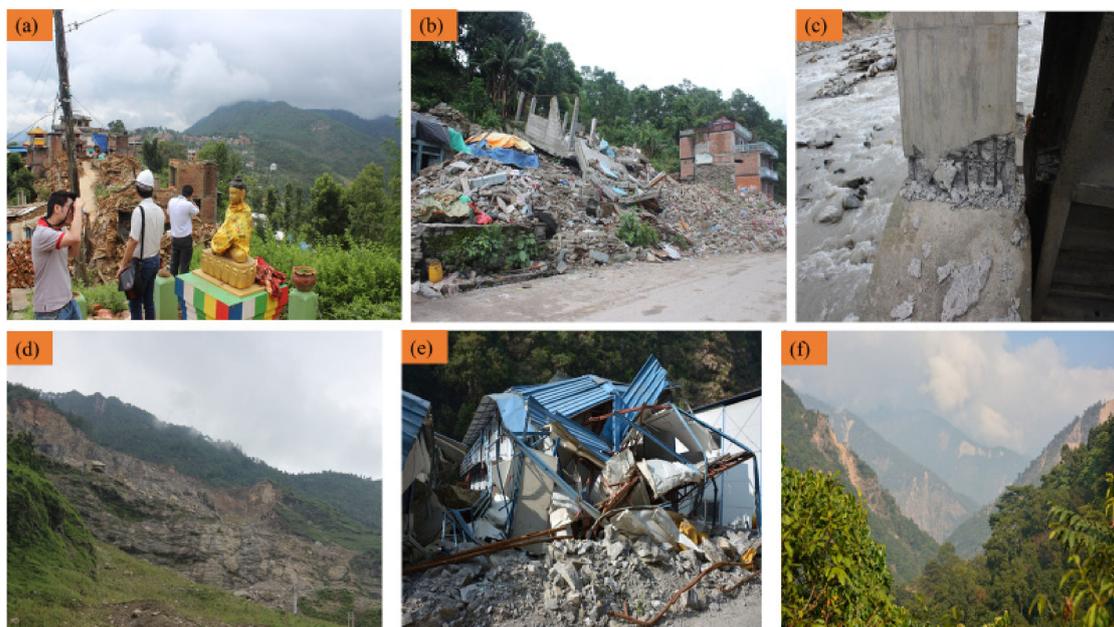
Figure 15. (a) Damaged settlement across a ridgeline in Sindhupalchowk district, (b) destroyed settlement along the Arniko Highway in Sunkoshi–Bhotekoshi watershed, (c) damaged pier of the Sunkoshi hydropower project reservoir site, (d) reactivated Jure landslide due to the earthquake, (e) damage to water supply infrastructure, (f) landslides triggered in the mountains across the Bhotekoshi–Sunkoshi watershed.

Some notable evidence displayed by the 2015 Gorkha earthquake in Sindhupalchowk is presented in Figure 15. Figure 15a shows a dense settlement at the ridge collapsed by the earthquake. Similarly, the entire settlement across the Bhotekoshi–Sunkoshi corridor was destroyed by the earthquake, as shown in Figure 15b. The earthquake also caused extensive damage to the infrastructure. Figure 15c shows the damage to a pier of the bridge at the reservoir location of the Sunkoshi hydropower project. An important piece of cascading evidence was displayed in the Jure landslide area, as shown in Figure 15d. The landslide was again triggered. Due to the reactivation of the landslide, large boulders and debris flow occurred that blocked the Arniko Highway. Similarly, the water supply infrastructure was affected by the earthquake in Sindhupalchowk. Figure 15e shows the damage caused by the earthquake in Melamchi Water Supply Project headwork site. The earthquake triggered many landslides across the Bhotekoshi–Sunkoshi watershed. However, the size of landslide was not uniform, as shown in Figure 15f.

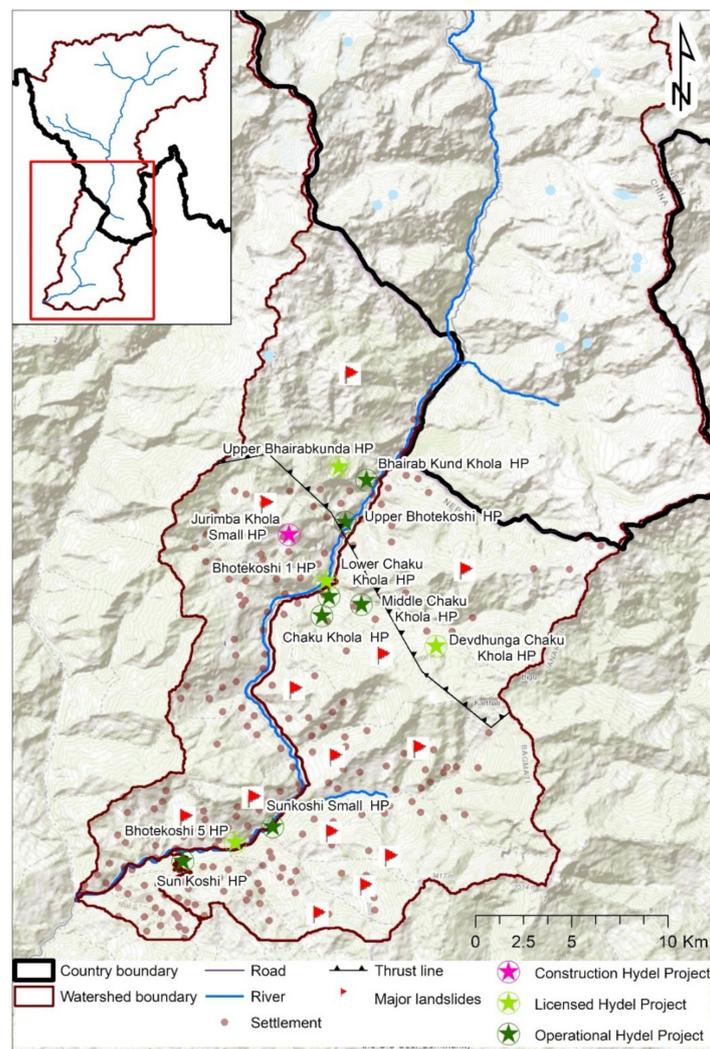
Figure 16. Built-up area of the catchment with potential sources of natural hazards and natural hazard impressions.

Despite susceptibilities to multiple natural hazards, the existence of much critical infrastructure, such as the hydropower stations, in the study area prompts more rigorous multihazard studies. As shown in Figure 16, 10 hydropower projects are either in operation or being constructed in the region where seismic activity is very frequent. The 2020 disaster incidents have proved how landslides induced by torrential rainfall and subsequent incidents affect lives, livelihoods and built environment in the study district. Owing to this sensitive scenario, stakeholders should reframe the current practices either in terms of added safety levels considering multiple natural hazards and their cascading impacts or the relocation of critical infrastructure. For example, in the case of GLOF, most of the bridge infrastructure would be swept away, as conventional bridge design and construction practice does not incorporate the scenarios that would be created by GLOF. In mountainous terrains, bridges would be easily swept away due to torrential rainfall led flash floods, as reported by Gautam and Dong [17]. The case would be more pronounced in the case of the BSW due to the fact that the Arniko Highway is one of the major lifelines that connect Nepal and China.

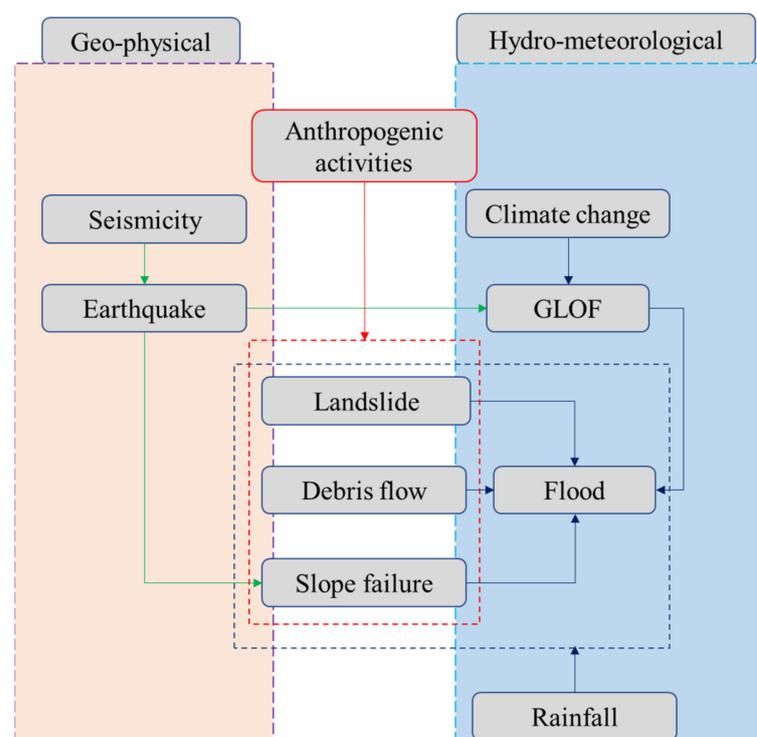
Figure 17. Cause and consequence matrix for multiple independent and cascading hazards for Bhotekoshi–Sunkoshi watershed.
