The Melamchi flood disaster

Cascading hazard and the need for
multihazard risk management

PREPARED BY*

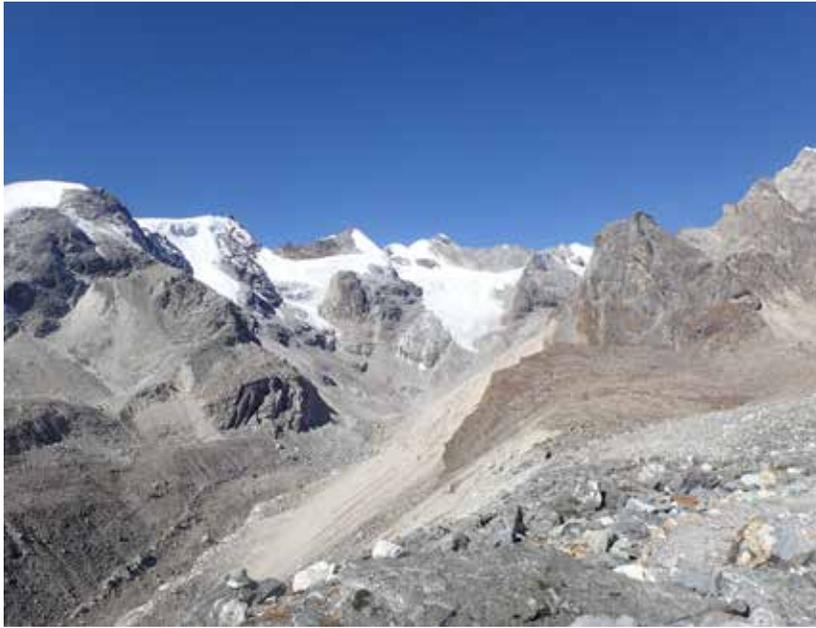
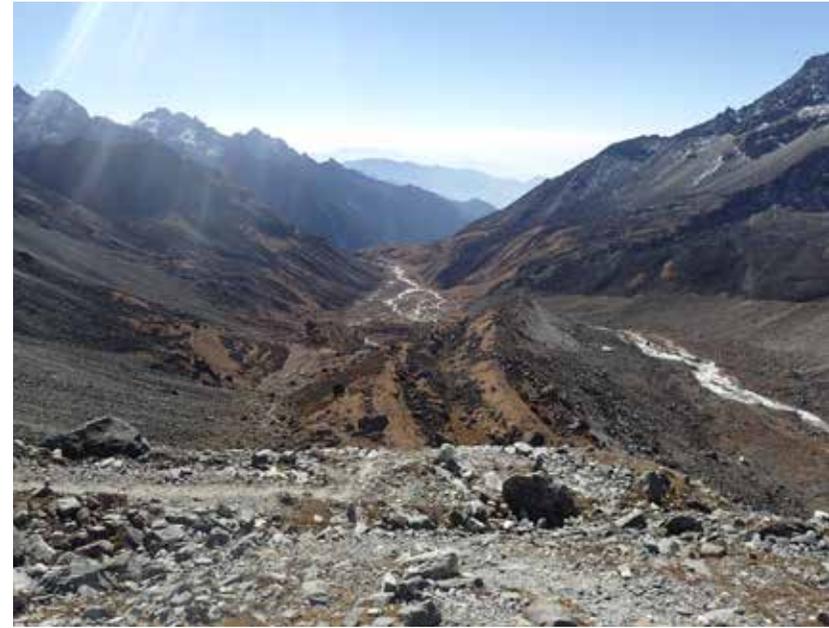
Figure 7: The upstream of Yangri Khola in 2018. On the left, the recently deglaciated para-glacial terrain is visible. It was the source of one of the debris flows in June 2021, predominantly from the source visible as bright debris in the centre of the image. On the right, the old moraines slightly downstream are visible with the plateau formed by the old glacier tongue. This same plateau is present in Pemdang Khola as well where the initial flood accumulated and then drained rapidly.

A similar process likely occurred in the headwaters of Yangri Khola as similar environment exists in that area (Figure 7).

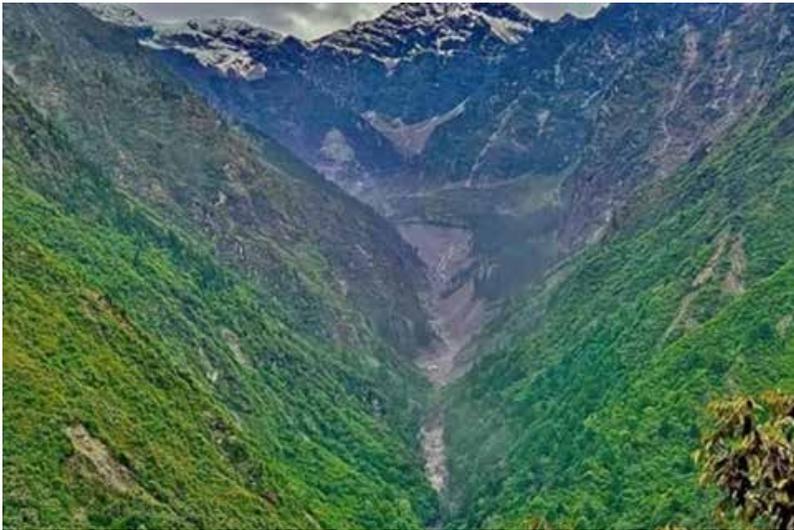
Figure 8: (on the left) Photo-showing the outer slope of the Bremthang landslide dam and the area downstream (Source: social media). On the right is a Google Earth image (dated 15 December 2017) that shows the morphological features of the river valley at the confluence of Melamchi Khola and Pemdang Khola, about 4 km downstream of the lake area. The brown dash line shows the old Bremthang landslide dam; the yellow dash line shows the fan deposits; the blue dotted line shows the talus deposits; and the light grey patches along either side of the valley are active landslides/rock fall and valley erosions.

The old landslide dam at Bremthang is located 5.8 km downstream of the glacial lake and 1.8 km downstream of the confluence of Pemdang Khola and Melamchi Khola. The landslide dam is about 950 m long and 900 m wide. Old satellite images indicate that debris flows have occurred in this stretch in the past too as seen by a large fan deposit and a number of talus deposits beside the Pemdang Khola, which are marked in Figure 8.

The water and debris mixed flow originating from the headwaters of Pemdang Khola and Melamchi Khola then filled the 1 km wide plain behind the Bremthang landslide dam. When the flow reached the crest of the landslide dam, it led to congestion within the existing river outlet.

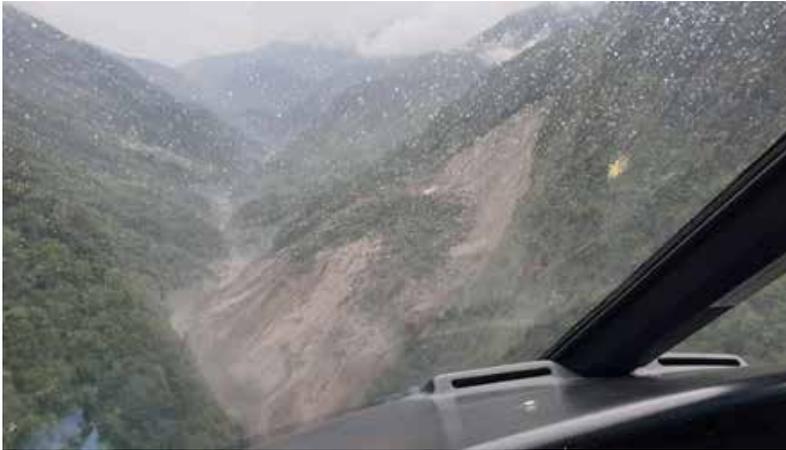
Figure 11: Photograph of the landslide dam taken from a helicopter (Source: social media).

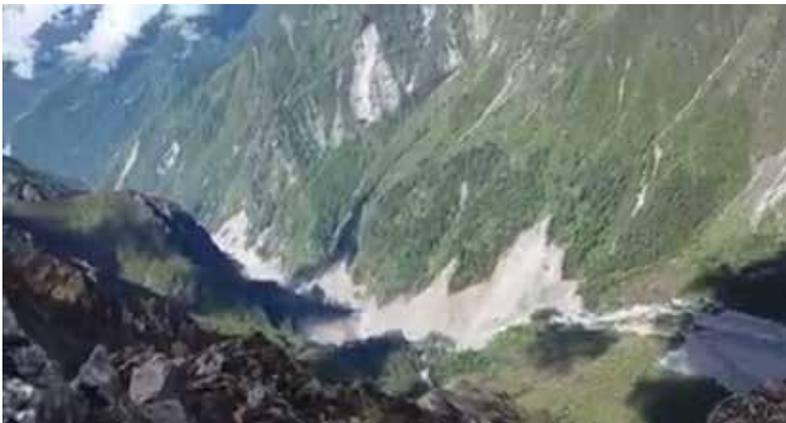
Figure 12: A still image from a video shared by Dorze Ghale on Facebook on 25 June 2021 showing the erosional area viewed downstream from Bremthang.

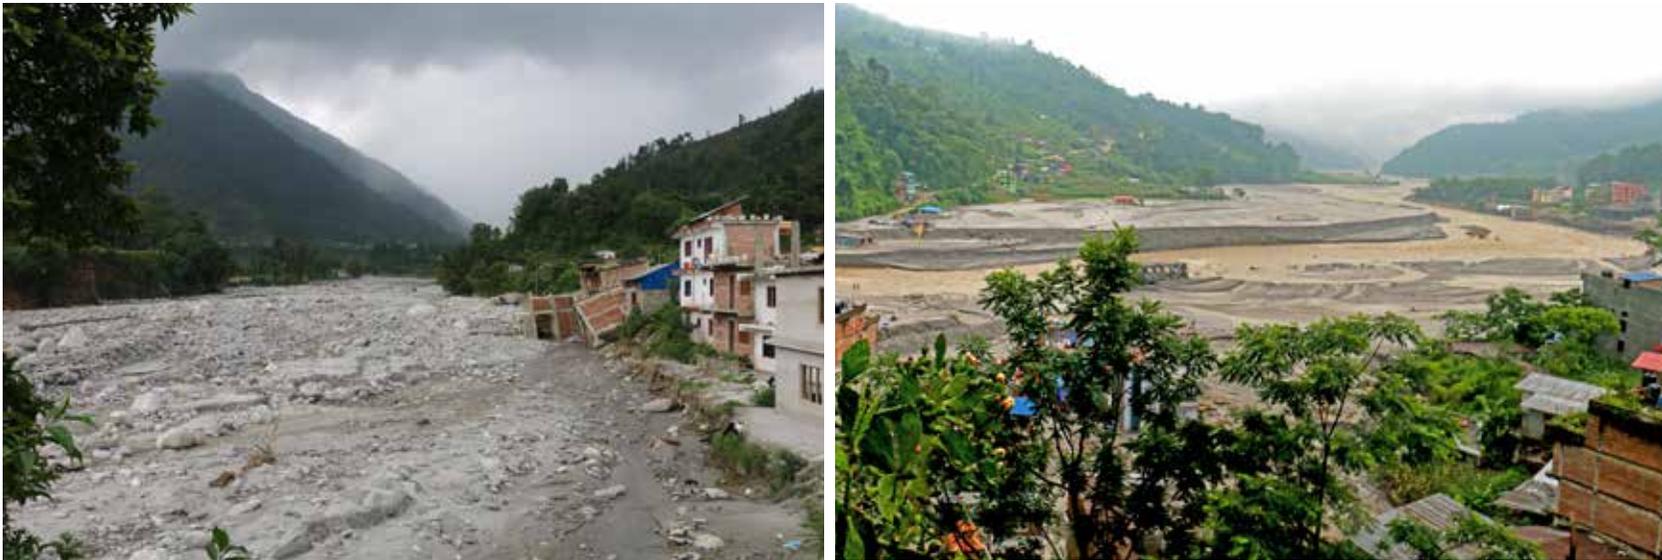
Figure 13: Sediment deposition in the a. upstream part about 1 km upstream from Chanaute Bazaar and b. downstream part (Melamchi Bazaar) of the watershed.

The size of the sediment fills in the river valley is higher upstream of the Melamchi Bazaar. Moreover, the proportion of coarse and larger sized boulder deposition is higher above the Malamchi Bazaar whereas the deposition of finer sediment such as sand and silt including gravel- and pebble-sized sediment is more downstream, which is an area that is more unstable (Figure 13).

The material deposited along the river stretch from near Ribarma village to Haldebesi was estimated by comparing a post-event satellite image from Planetscope with a 5 m resolution ALOS digital elevation model (DEM). The analysis showed that the width of the deposition ranges from 20 m to 385 m with an average width of 163 m covering an area of 6.5 km². The volume of the deposit from Ribarma village to Haldebesi near Dolalghat was estimated at 1.3 x 10⁷ m. This volume of sediment is enough to fill the area of Kathmandu city within the Ring Road, an area of 43 km², up to a height of 0.3 m.

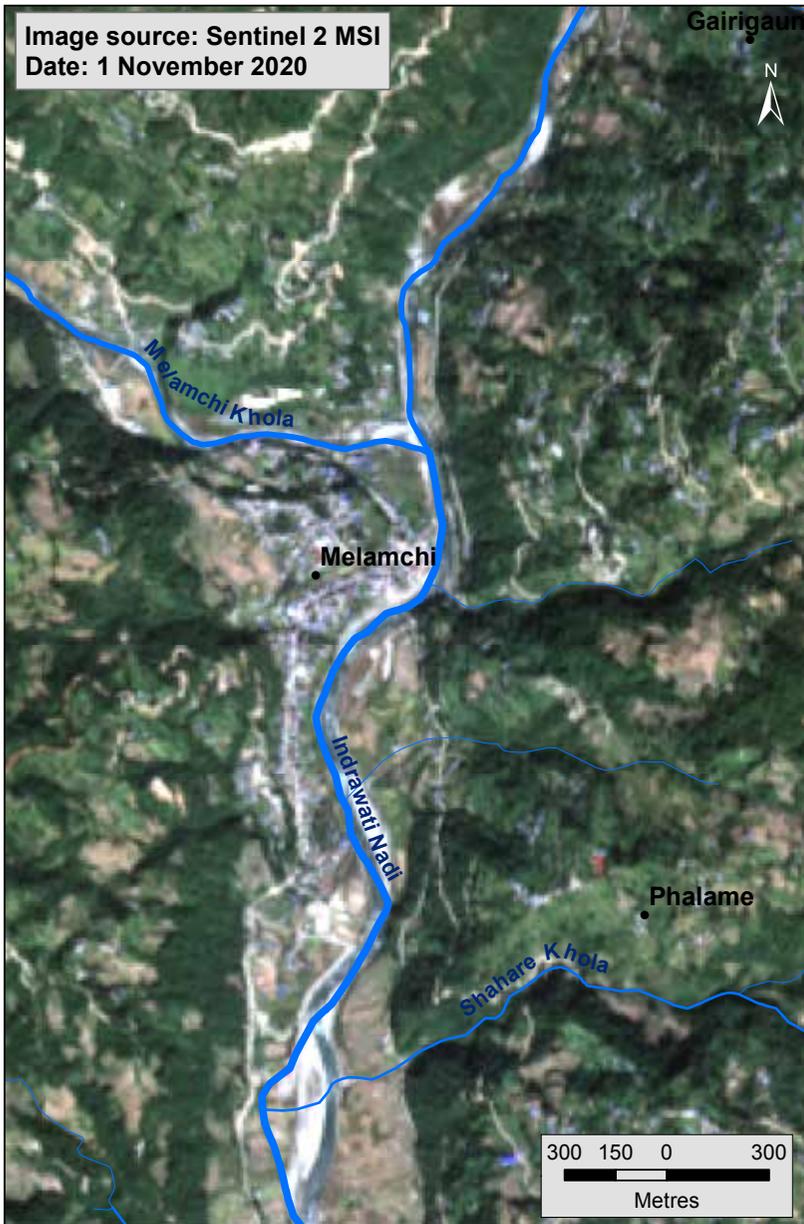
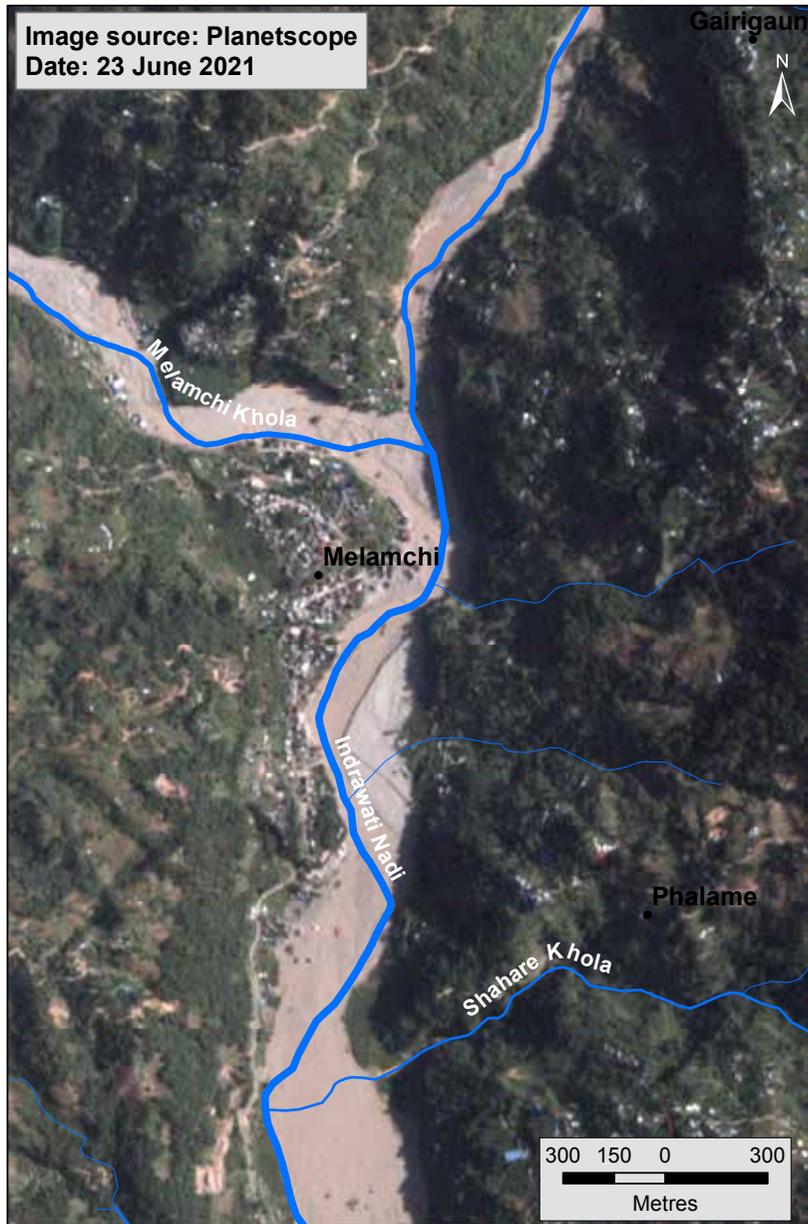
Figure 14: Debris deposition as seen from satellite images taken before (left) and after the event (right).

The floods adversely impacted large swathes of areas, including human settlements, agricultural land, river-based livelihoods and critical infrastructure such as roads, bridges, hydropower plants and electric poles. This unprecedented flood event carried with it large-scale debris from upstream which were later deposited in downstream areas, indeed, as far away as Dolalghat which is approximately 54 km away from Melamchigaon (the site of the new landslide). The images in Figure 14 show debris deposition in the Melamchi Bazaar area.
