Tracking surface and subsurface deformation associated with groundwater dynamics following the 2019 Mirpur earthquake

Muhammad Younis Khan, Ekrem Saralioglu, Syed Ali Turab & Sher Muhammad

ABSTRACT

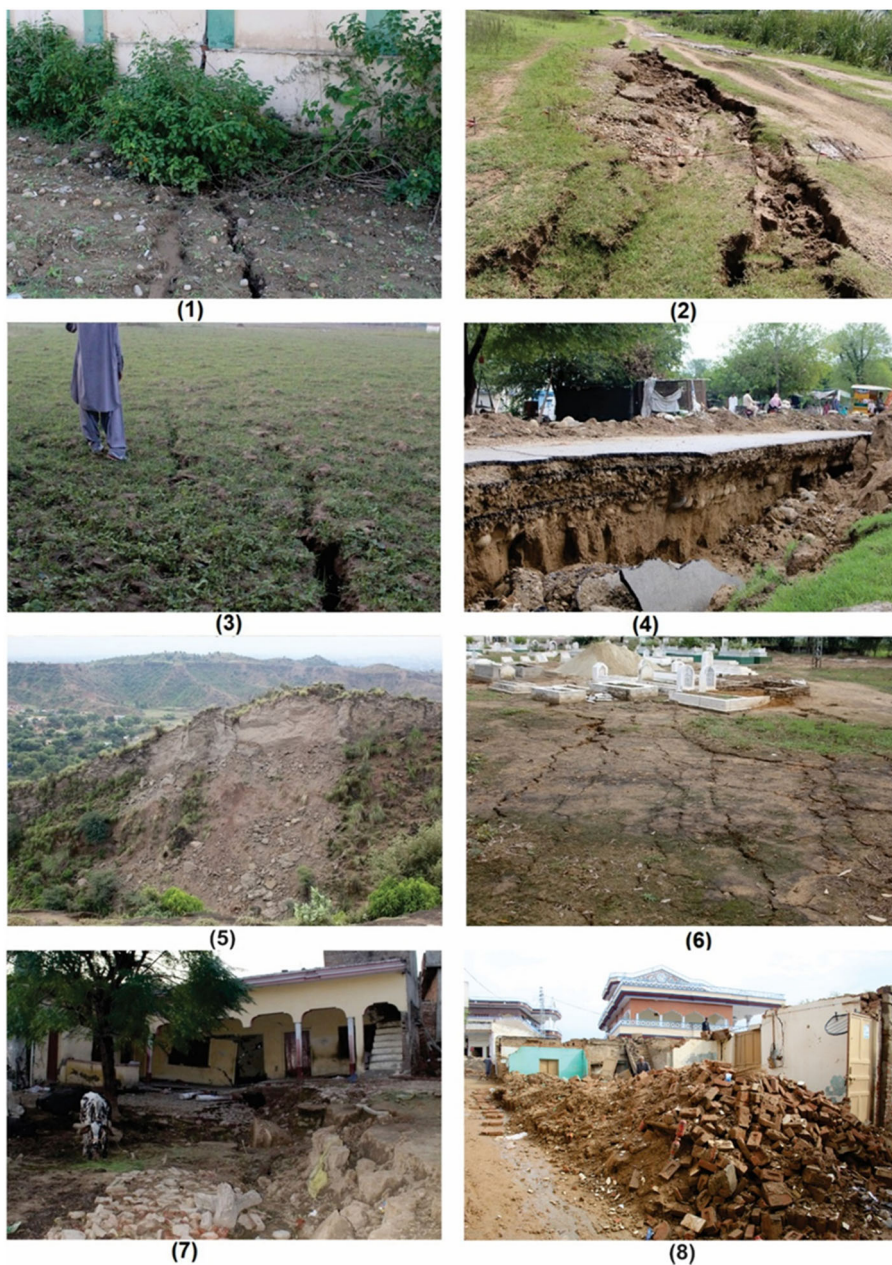
Figure 2. Field photographs showing ground deformation at various locations (1-8, see [Figure 8](#) for their locations). surface fractures in the field (1-3,6); damaged infrastructure (4,8); small-scale landslide (5); and ground subsidence/uplift (7).

Canal (UJC), rice fields, and shallow aquifer system) may have significantly contributed to the extensive liquefaction effects. Moreover, the geology is dominated by the loose alluvial deposits overlying a liquefied sandy soil that also played a key role during the seismic hazard. The liquefaction-induced fractures of more than 100 m in length affected the diverse nature of infrastructure, including mosques, residential buildings, schools, the UJC, and bridges. The ground failures produced severe damage manifestations which were observed on the surface and within the near-surface in the epicentral area, including the most common ones within 50 m from the UJC (Figures 1b–d, location 4 on Figure 2).

Fractures running along the canal banks were 0.5–160 cm wide and 6–187 m long and were characterized by vertical and lateral displacement and subsidence of coherent sediment masses toward the canal (location 4 on Figures 2 and 8; Khan et al. 2021a). These fractures are oriented parallel to the UJC (i.e. $\sim N60^{\circ}W \pm 15^{\circ}$). Predominantly, fractures found at a distance of >50 m from the canal bank (i.e. at sites S1–S8) displayed width and length of 0.5–50 cm and 4–134 m, respectively. However, at site S2, the fracture width, and length reached 180 cm and 280 m, respectively. Most of the fractures displayed lateral extension, with some showing vertical movement of 2 cm to 135 cm (locations 2 & 7 in both Figures 2 and 8). Modest left lateral strike-slip movement (0–15 cm) was also recorded along a few fractures at sites S1, S5, and S7 (Figure 3f of Khan et al. (2021a)). All the fractures are striking towards $N25^{\circ}W$ – $N45^{\circ}E$.

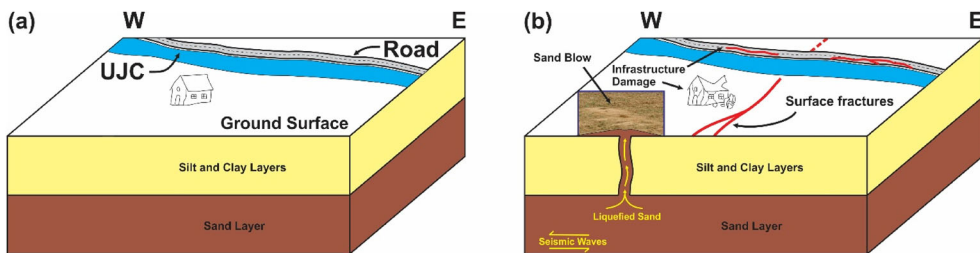
Figure 4. (a, b) Schematic representation of before and after the Mirpur earthquake liquefaction hazard and related coseismic surface and subsurface deformation features.

To study surface and subsurface deformation features resulted from the Mirpur earthquake ([Figure 4](#)), this work presents a novel methodology using space-borne and ground-based radar techniques and field geological survey ([Figure 5](#)).

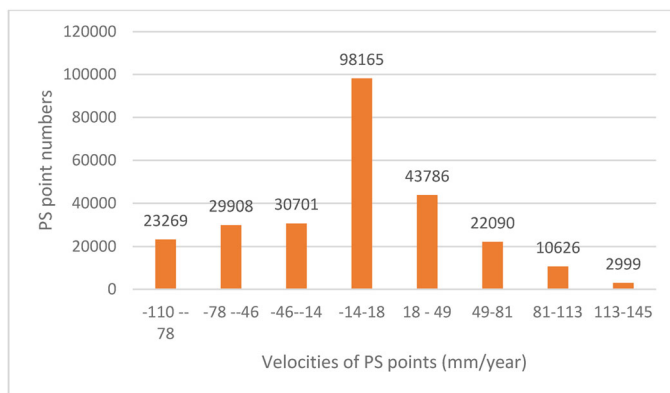
Figure 7. Distribution of PS points.

Figure 6 shows the PS points produced by the StaMPS method in the region within the study area and the annual displacement rates of these points. In total, 261544 (Figure 7) PS points were created. The displacements of the PS points in the LOS direction range from -110mm to $+145\text{mm}$. It is important to examine the PS points produced in Figure 6 for accuracy. In Figure 6, the red dots indicate subsidence, and the blue dots show the uplift. The fact that the red and blue points with high-velocity variation differences are not adjacent to each other and the clustering of the point groups belonging to the close velocity values in certain places shows that the PS points are compatible in terms of accuracy (Figures 6, 8, and 9). The baseline distance between the images should be short of achieving this harmony. In addition,

Other PS points show higher annual velocity changes. There are 53177 (Figure 7) points with -46 to -110 mm/year change rates. These points are shown in Figure 6 with the colors red and orange. The (-) direction change in this region means that

the points move away from the RADAR sensor. The + directional PS point count is 35715 (Figure 7), with high change rates (49 to 145 mm/year)). The + direction change means that the points in this region get closer to the RADAR sensor. In short, PS points with positive signs indicate surface deformation movement upwards and

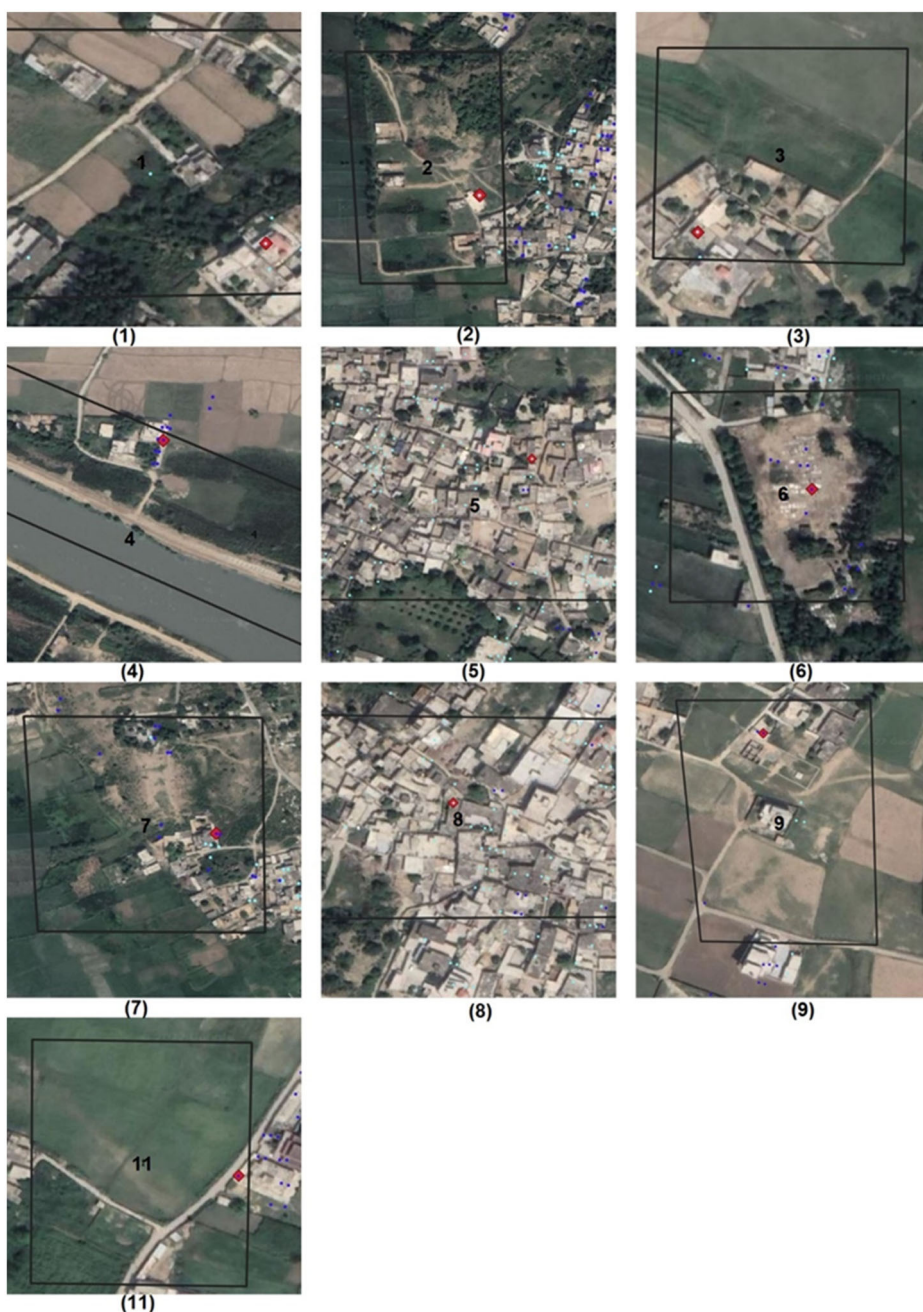
Figure 9. The red dots represent the PS points at locations 1-11 representing high deformation in the study area. Time-series plots of these points are shown in [Figure 10](#) (For locations, see [Figure 8](#)).

Figure 10 shows the time-series graphs of the 10 points shown in Figure 9. The region in the red box in the figures includes the two images obtained before the earthquake (September 17, 2019) and after the earthquake (September 29, 2019) and is closest to the earthquake date. In Figure 10, the effect of the earthquake can be observed in selected places within the study area. For example, in Figure 10a, it is seen that the time series graph, which continues steadily, jumps with a difference of approximately 50 mm between the two pre and post earthquake images. The time-series graphs indicate an uplift in the post-earthquake scenario. In some of these points
