Integrating Copernicus Satellite Products and Ground-Truthing for Documenting and Monitoring the Impact of the 2022 Extreme Floods in Pakistan on Cultural Heritage

Muhammad Younis Khan ^{1,2} , Federico Zaina ³ , Sher Muhammad ⁴ and Deodato Tapete ^{5,*}

Keywords: archaeology; Pakistan; floods; risk assessment; satellite remote sensing; Sentinel-1; Sentinel-2; Global Flood Monitoring; ground-truthing; UNESCO

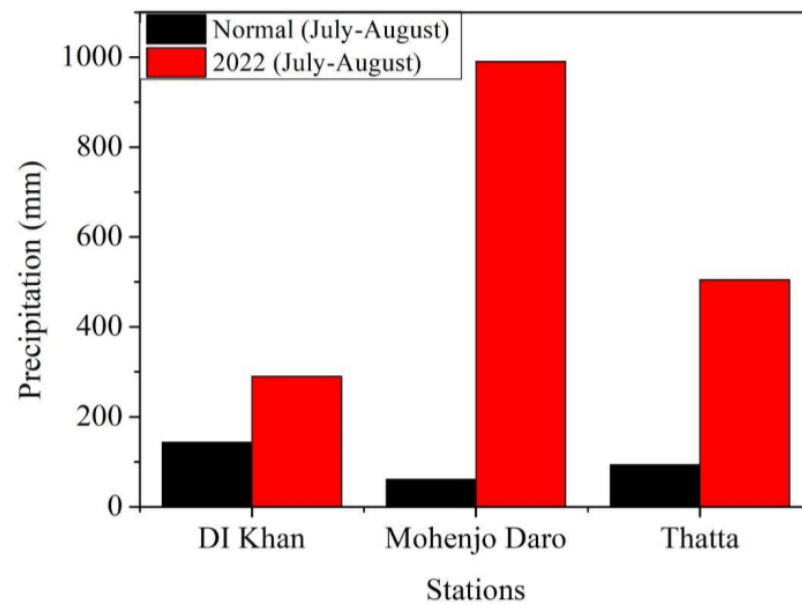
Figure 2. Comparison of rainfall data measured in July and August 2022 vs. the normal values that are typically recorded in the same months at the three closest stations to the heritage sites investigated in this study.

The geographic variable regards the selection of archaeological sites and monuments in those regions that were mostly affected by the 2022 summer floods and, as such, are representative of flood-prone sites. According to PDNA (2022) and the ICIMOD report [18,21] (see Section 1.2), Sindh and Khyber Pakhtunkhwa were the most affected regions. In particular, the rainfall records measured near three of the selected sites (see locations of the meteorological stations in Figure 1 and the rainfall data in Figure 2) was exceptionally high by 20-fold and 16-fold in July and August 2022. In DI Khan meteorological station, the rainfall was double the normal, but the situation was worse due to flash floods from the adjacent hill torrents in the west. The comparison of rainfall data between normal seasons and the 2022 floods is shown in Figure 2.

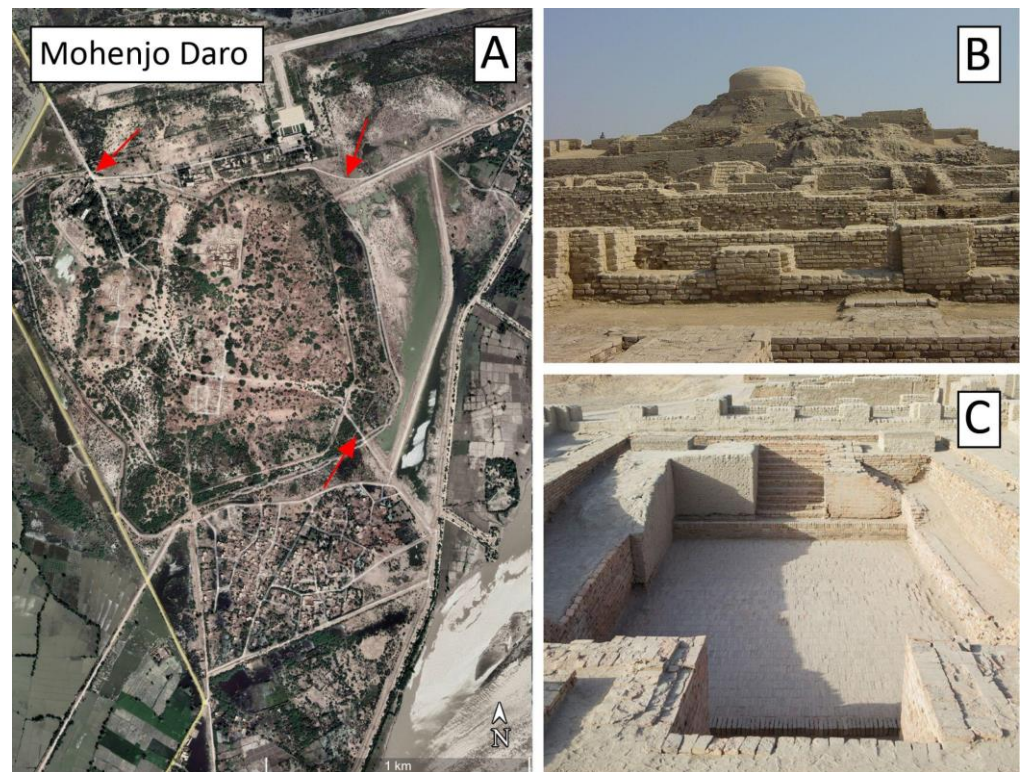
Figure 3. The UNESCO World Heritage site of Mohenjo Daro: (A) satellite image showing the extent of the site. The red arrows indicate the main road (upper left) and the secondary accesses to the site (upper and lower right) (Google Earth, 31 March 2022); (B,C) overview and details of the monuments (retrieved from [34], copyright © CRA-terre).

The archaeological site of Mohenjo Daro is the best-preserved urban settlement in today's Sindh province of Pakistan (Figure 3A–C). Located on the right bank of the Indus River, 510 km north-east from Karachi, the site prospered between the beginning of the 3rd millennium BCE and the first half of the 2nd millennium BCE, representing a major centre of the Indus valley or Harappan civilization [32,33].

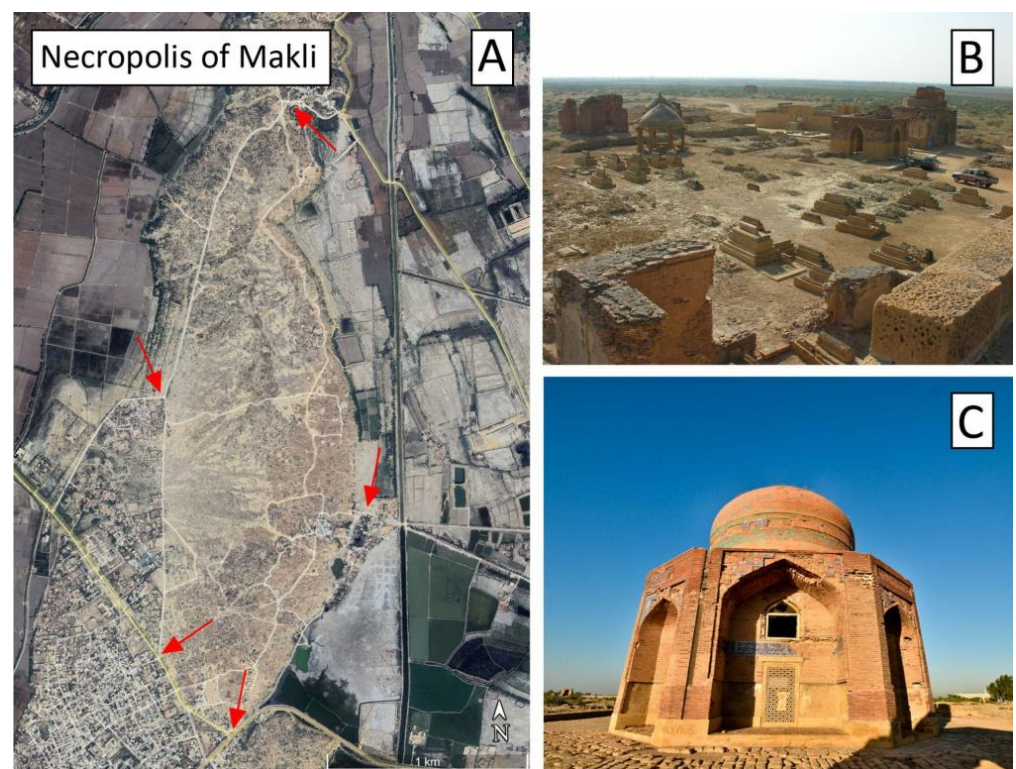
Figure 4. The UNESCO World Heritage Site of Makli Necropolis: (A) Satellite image showing the extent of the site. The red arrows indicate the roads leading to the site (Google Earth, 14 September 2022); (B,C) Overview and details of the monuments (retrieved from [47]).

Makli is among the largest necropolises in the world (Figure 4A–C). Located in the southern province of Sindh, it includes an enormous cemetery with half a million tombs and graves in an area of about 10 km² [45]. This cemetery served the historical Mughal capital of Thatta (located 6 km away from it) which flourished between the 14th and 18th centuries CE. Among others, the necropolis features several large funerary monuments (Figure 4B,C) belonging to kings, Sufi saints and scholars [46].

The main entrance to the site is from the north-east (Figure 4A), although multiple secondary accesses lead to the burials and the monuments from south and west. As for Mohenjo Daro WHS, in case of flooding and heavy rainfall, site accessibility represents a critical element that allows for first aid and constant monitoring by local personnel and the potential end-users of our methodology (see Table 1). Therefore, in our analysis of the impact of the 2022 floods at the site, we have also considered the effect on the road system.

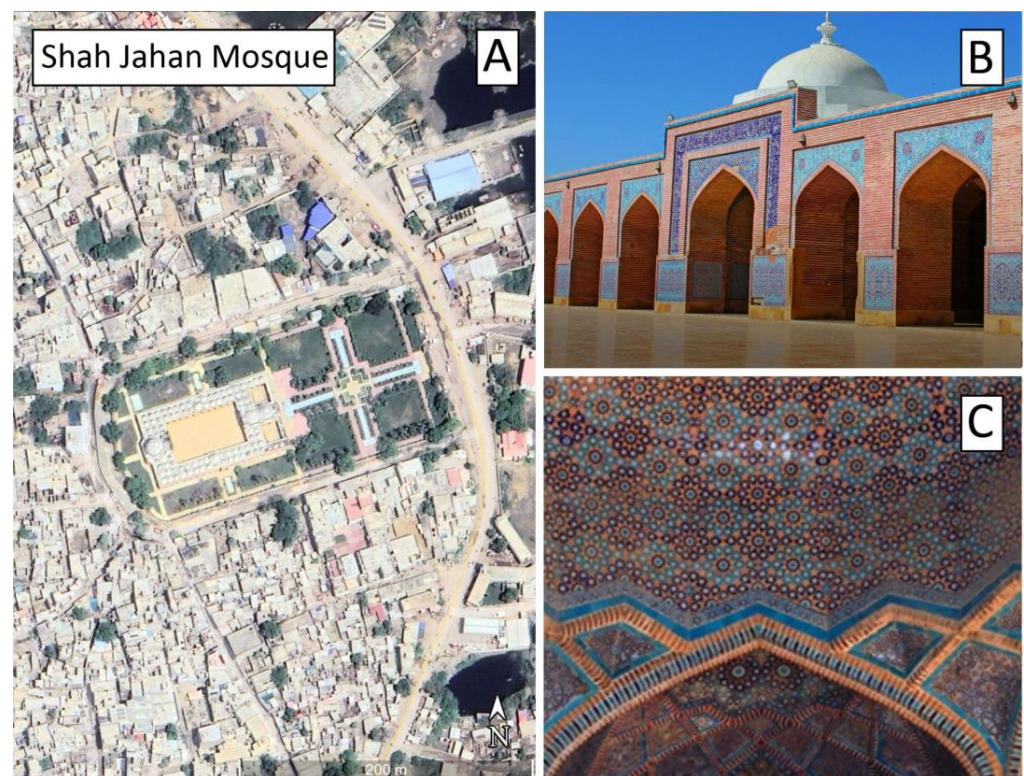
Figure 5. The Shah Jahan mosque in Thatta: (A) satellite image showing the mosque (Google Earth, 14 September 2022); (B,C) overview and details of the monuments (photo by the authors).

The Shah Jahan Mosque built in the mid-17th century CE is the main religious center in the city of Thatta, in the Sindh province (Figure 5A). The brickwork structure is considered one of the most elaborate stylistic examples in Asia [60]. Its fourinwan layout is characterized by 93 domes and two main chambers enriched with blue tiles decoration representing a mixture of Turkic and Persian styles (Figure 5B,C) [61].

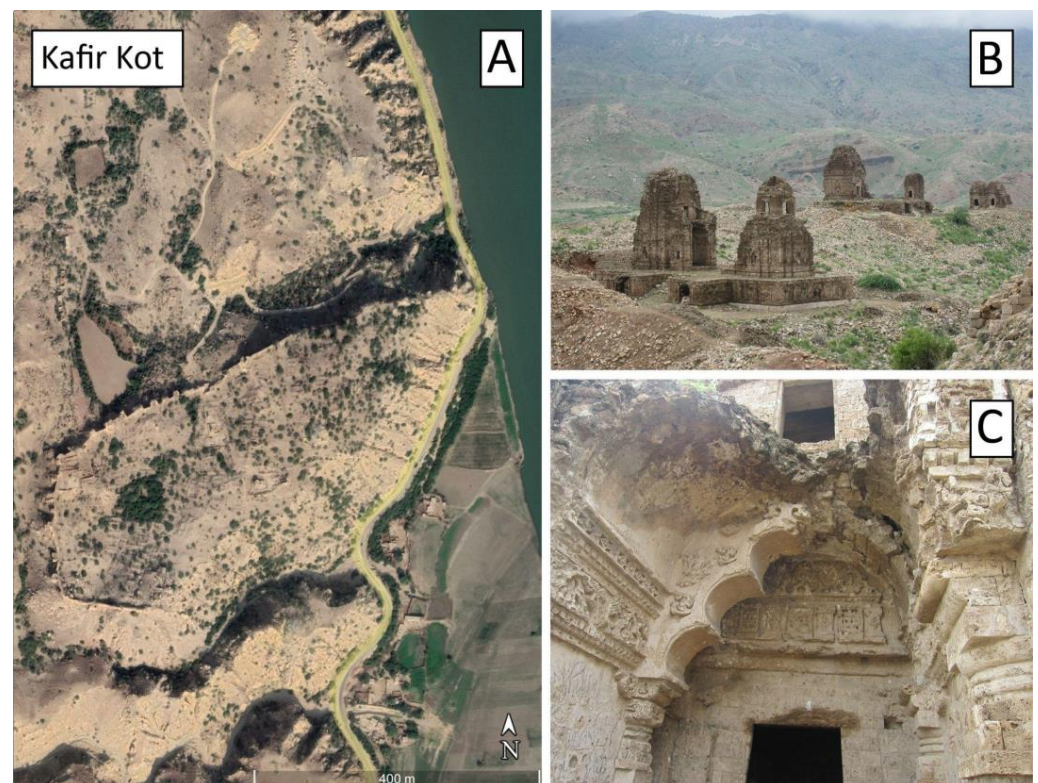
Figure 6. The fortress of Kafir Kot: (A) satellite image showing the walled site and the main accesses and roads (Google Earth, 4 December 2022); (B,C) Overview and details of the monuments (from Wikimedia commons).

The main entrance to the site is located on the northern side (Figure 6A), with the main access road running along the right bank of the Indus River. As for Mohenjo Daro and Makli Necropolis WHSs, the accessibility to the fortress represents a critical element for first aid and constant monitoring by the local personnel and the potential end-users of our methodology (see Table 1) in case of floods. Therefore, in our analysis of the impact on Kafir Kot due to the 2022 floods, we have also considered the effect on the road system. Furthermore, the site is located less than 6 km from an important hydraulic infrastructure, named Chashma barrage, which was built in the 1960s–1970s, is used for irrigation, flood control and power generation [64], and includes a large barrage and a reservoir to regulate the supplies of Tarbela reservoir [65] and collect waters in case of heavy rains and floods.

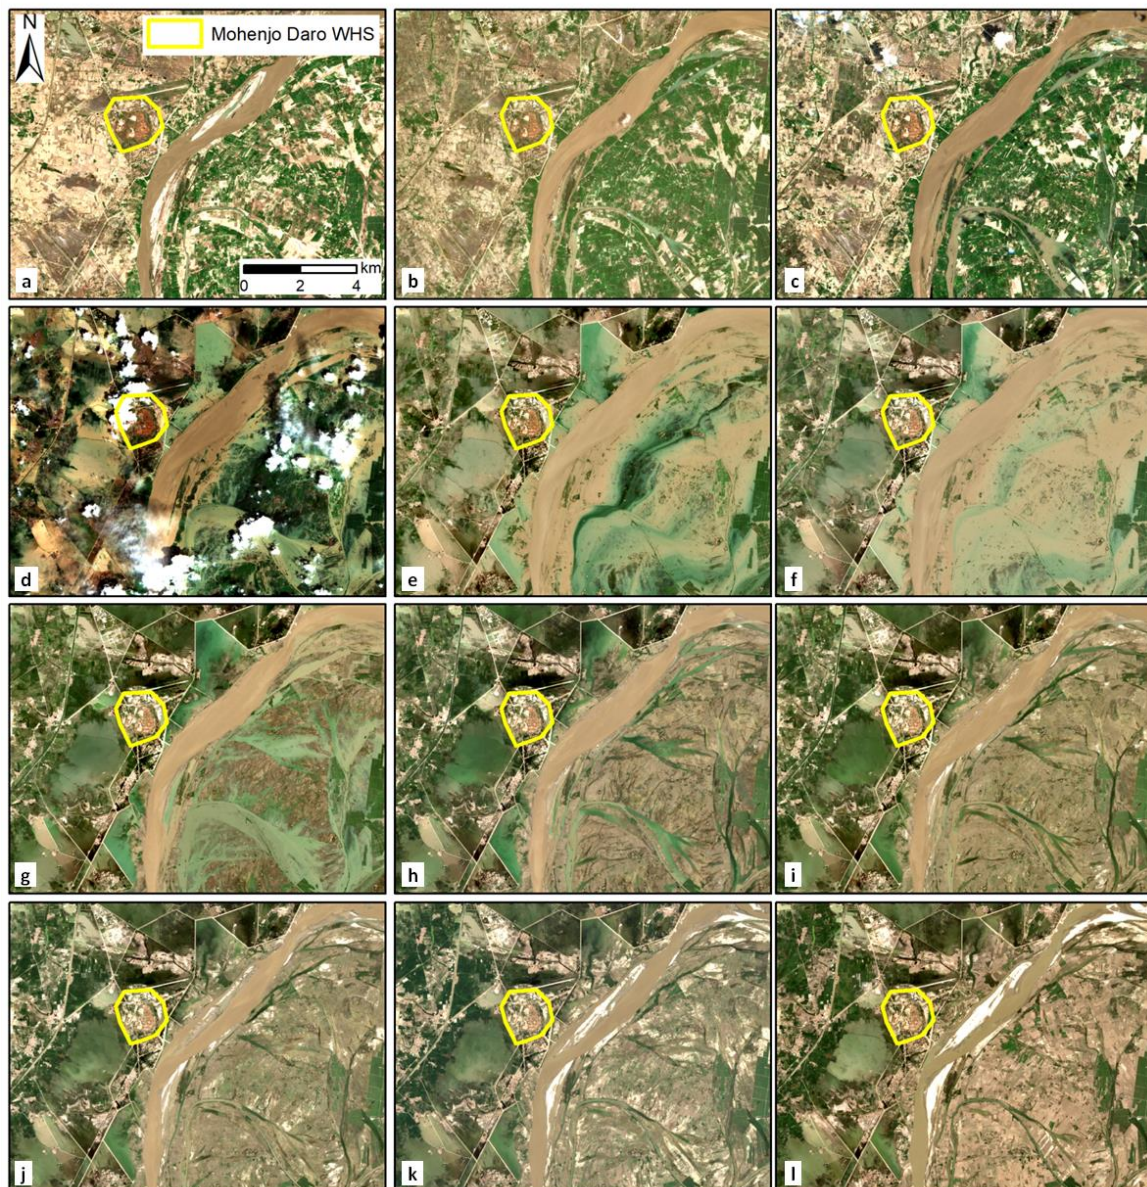
Figure 8. Sentinel-2 time series of the area of Mohenjo Daro WHS (site boundary marked by yellow polygon) showing the spatial and temporal evolution of floods between 12 July and 30 October 2022, and in particular: (a) 12 July; (b) 1 August; (c) 11 August; (d) 26 August; (e) 31 August; (f) 5 September; (g) 10 September; (h) 15 September; (i) 20 September; (j) 25 September; (k) 5 October; (l) 30 October. Contains Copernicus Sentinel-2 data, 2022.

left riverbank since at least 20 September. This layer represents a side effect and a source of significant damage to the landscape. With a constant temporal sampling of five days (Figure 8h–k), Sentinel-2 shows the gradual retreat of waters which mostly evacuated by 30 October (Figure 8l).

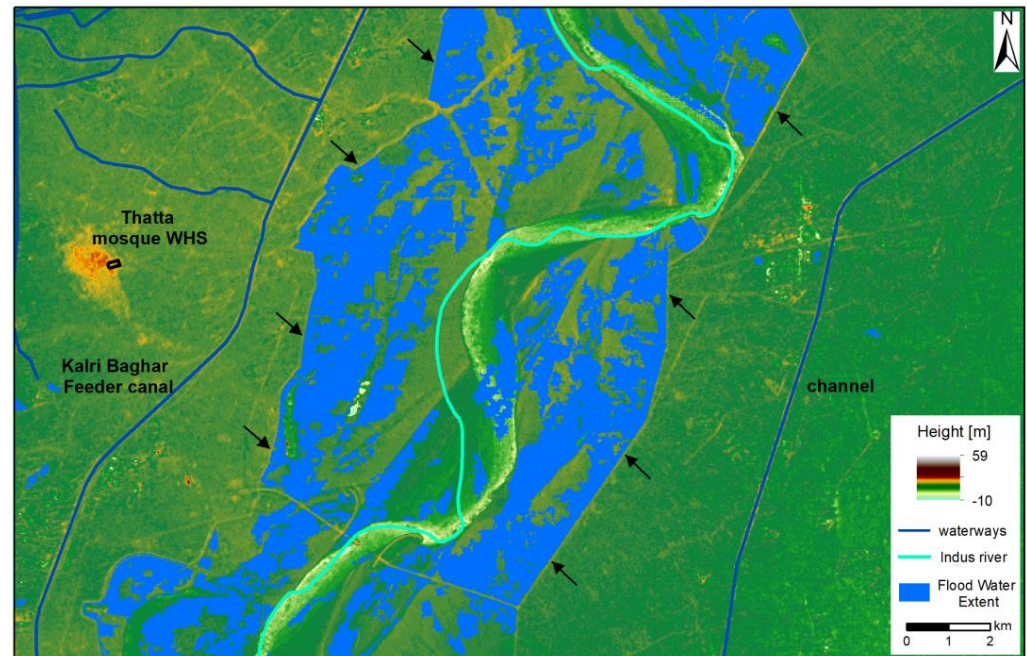
Figure 12. Flood water extent as per the GFM product generated from the Sentinel-1 image collected on 8 September 2022 (cf. Figure 11e), overlapped onto the topography according to ALOS AW3D30 DEM of the floodplain of the Indus River in the area of Thatta mosque WHSs. Black arrows indicate the sharp boundaries of flood waters confined by embankments acting as physical barriers to further inundation. Contains CEMS GFM products, 2022.

for the necropolis and 8 km for the mosque) and their topographic position (approximately 22 and 20 m height, respectively, versus 10 m in the alluvial plain) (Figures 11a and 12).

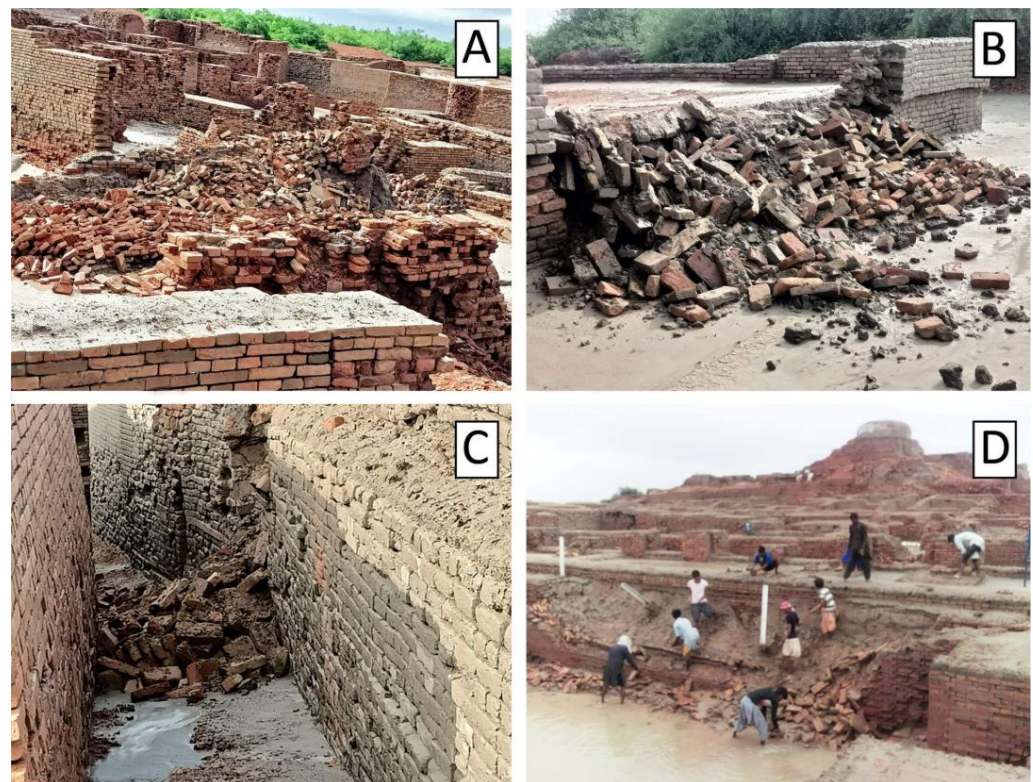
Figure 17. Ground-truthing photographs taken at the UNESCO World Heritage Site of Mohenjo Daro, showing: (A–C) collapsed walls following the heavy rains and floods and (D) restoration and protection of the ancient walls against flooding and water stagnation.

Ground-truthing confirms that the 2022 floods caused considerable damage in Mohenjo Daro across the site (Figure 17A–D). Likewise, standing water along the front walls of the site can be observed in Figure 17D where restoration/repair work was already underway. This information integrates well with the observations made from satellite data. While the site was surrounded by flood waters and permanent water bodies for weeks, inside its perimeter, heavy rains, stagnation of water and increase in soil moisture contributed to wall collapses. The ground-truthing activities conducted by the local staff working at Mohenjo Daro also confirmed the difficulty of accessing the site during the floods, as suggested by the analysis of the Sentinel-1 and Sentinel-2 imagery. Accessibility to the site is indeed a crucial component for early response and site preservation, as damage or obstruction to the roads does not allow access, and therefore for the quantification or prevention of any further damage caused to the monuments within the site.

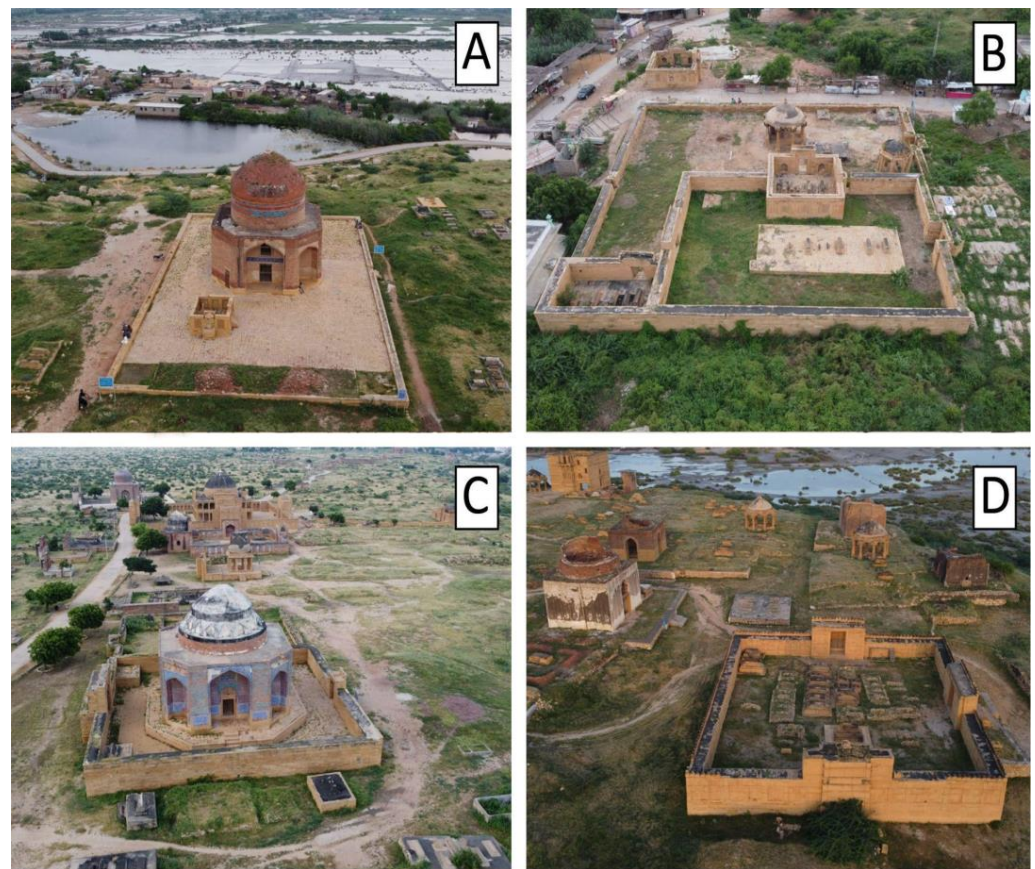
Figure 18. The UNESCO World Heritage Site of Makli Necropolis. (A–D) General view of the site and the flooded areas in the surrounding landscape.

The ground-truthing activities confirmed the remote sensing results, i.e., that the 2022 summer floods have not directly damaged the Makli Necropolis. However, Figure 18 shows clearly that depressions or low-lying areas nearby were completely filled with water due to the heavy rainfall, thus resulting in stagnant water at a close distance to the WHS.

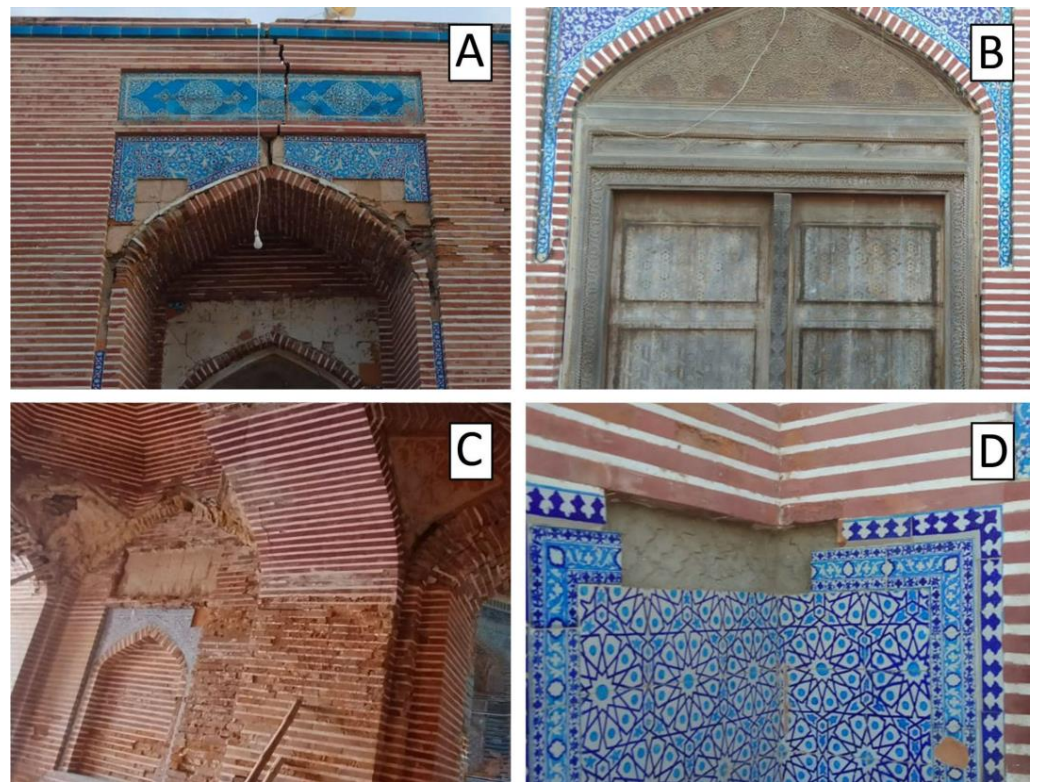
Figure 19. Ground-truthing photographs taken at the UNESCO World Heritage Site of Shah Jahan mosque of Thatta, showing: (A,B) the cracks in the vaults and (C,D) the collapsed bricks and tiles.

The ground-truthing activities at the site suggested that no new damage emerged as a consequence of the 2022 heavy rainfall and floods. However, some considerations about the potential impact of such events in the longer term can be made. Normally, 93 mm rainfall accumulates in the month of July and August in Thatta, whereas in 2022, a total of 505 mm rainfall was recorded during the same months. If this circumstance repeated over time, such a substantial increase may contribute to worsening current structural issues already documented at the site. This is suggested by the field photographs taken in collaboration with the local authorities which showed significant cracks in the vaults (Figure 19A,B) or the collapse of the tiles revetment and the bricks of the building facade (Figure 19C,D).

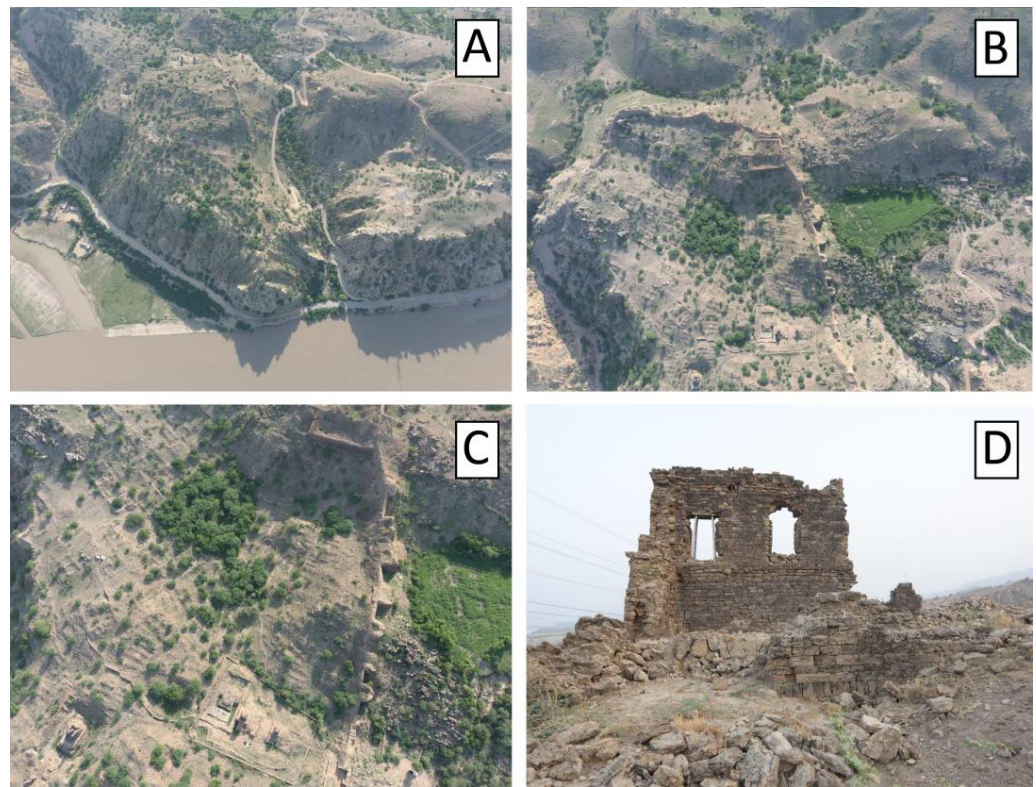
Figure 20. UAV photographs documenting the condition of the fortress of Kafir Kot in the aftermath of the 2022 summer floods. (A–C) General view of the site and the flooded areas in the surrounding landscape; (D) detailed view of one of the buildings at the site.

Moreover, as shown in Figure 20A, a huge volume of flood water accumulated along the eastern side of the site. Fortunately, this has not reached the archaeological remains of Kafir Kot (Figure 20D) and did not affect the access to the site.

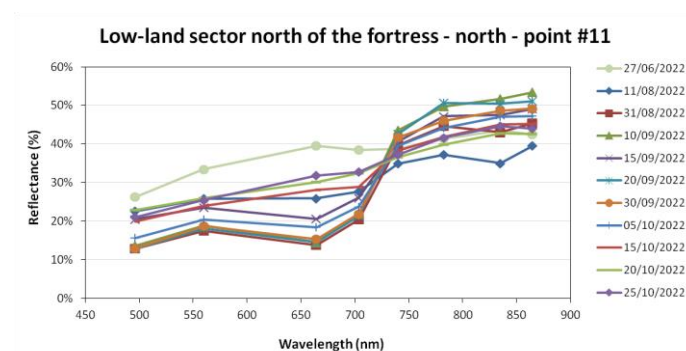
Figure A1. Spectra of the low-land sector north of the fortress, northern portion, point #11, from Sentinel-2 imagery.

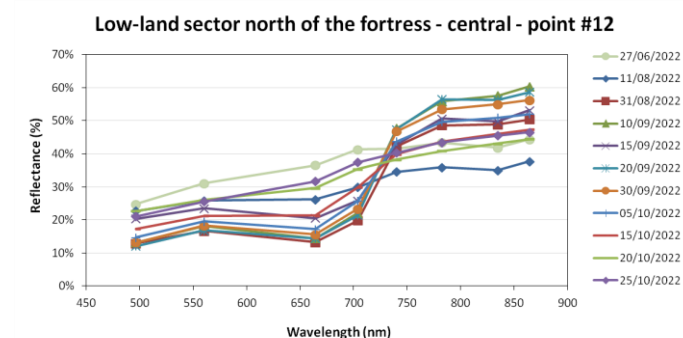
Figure A2. Spectra of the low-land sector north of the fortress, central portion, point #12, from Sentinel-2 imagery.

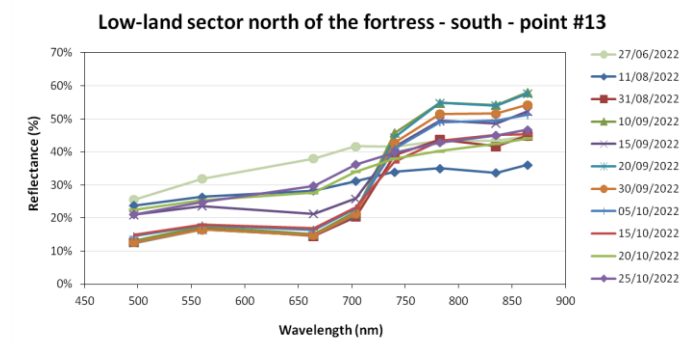
Figure A3. Spectra of the low-land sector north of the fortress, southern portion, point #13, from Sentinel-2 imagery.

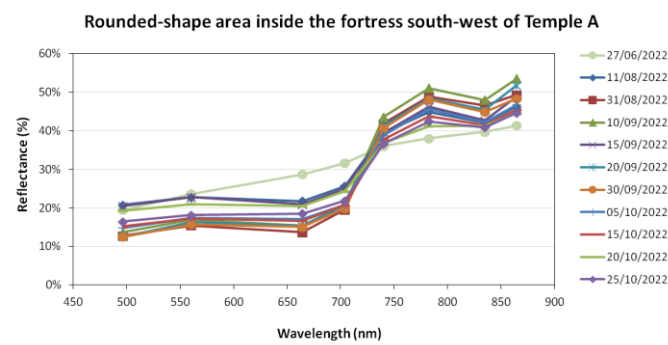
Figure A4. Spectra of the rounded-shape area inside the fortress south-west of Temple A, point #10, from Sentinel-2 imagery.

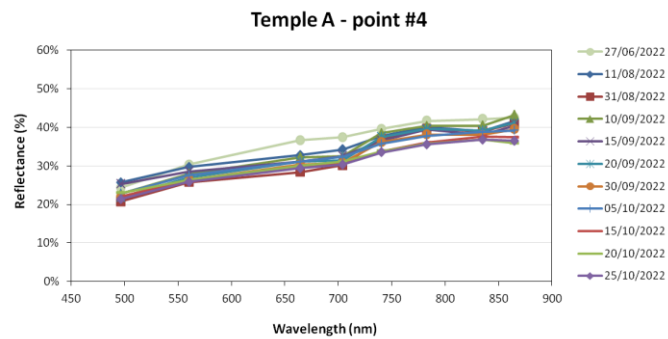
Figure A5. Spectra of Temple A, point #4, from Sentinel-2 imagery.

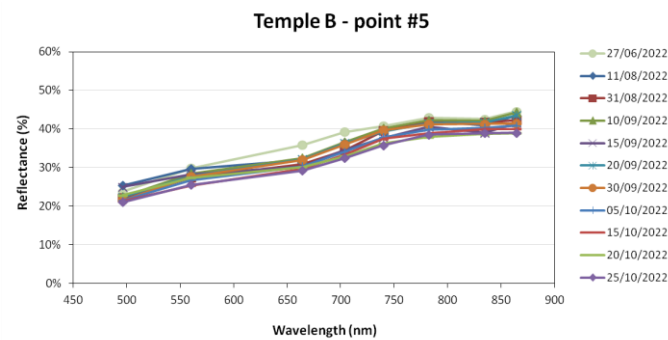
Figure A6. Spectra of Temple B, point #5, from Sentinel-2 imagery.

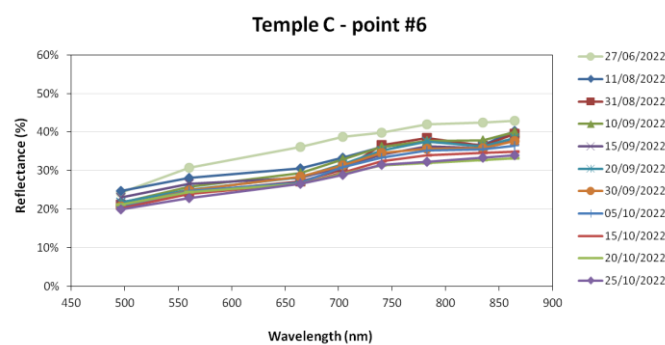
Figure A7. Spectra of Temple C, point #6, from Sentinel-2 imagery.

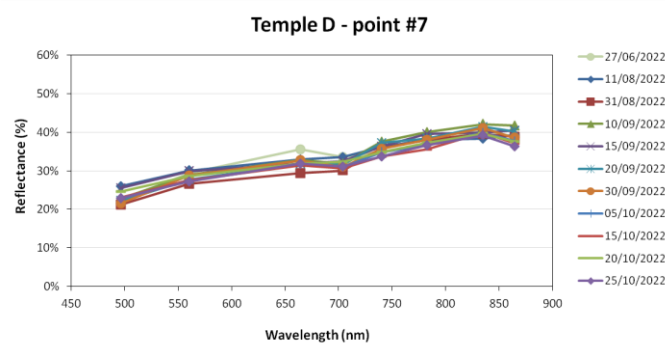
Figure A8. Spectra of Temple D, point #7, from Sentinel-2 imagery.

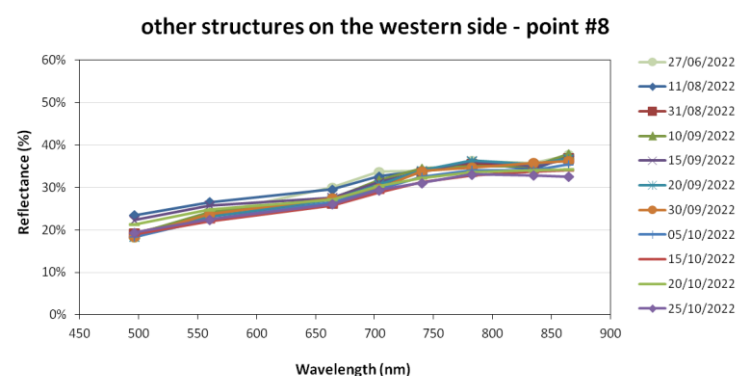
Figure A9. Spectra of other structures on the western side, point #8, from Sentinel-2 imagery.

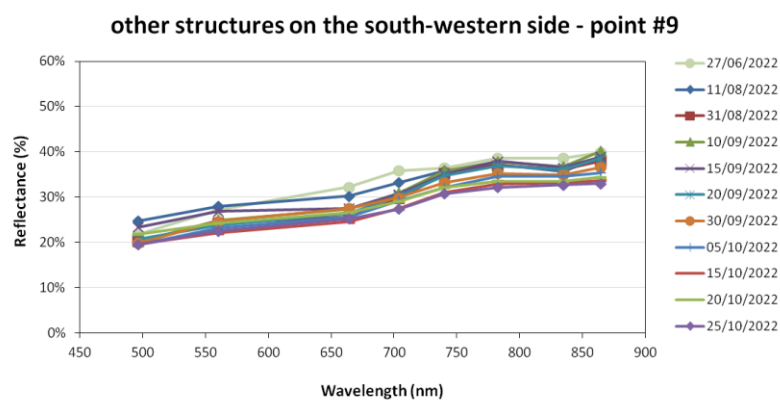
Figure A10. Spectra of other structures on the south-western side, point #9, from Sentinel-2 imagery.
