# Understanding the Gyirong–Rasuwa disaster of 26 August 2026

A preliminary synthesis

ICIMOD (2026). *Understanding the Gyirong–Rasuwa disaster of 26 August 2026: A preliminary synthesis*. International Centre for Integrated Mountain Development (ICIMOD).

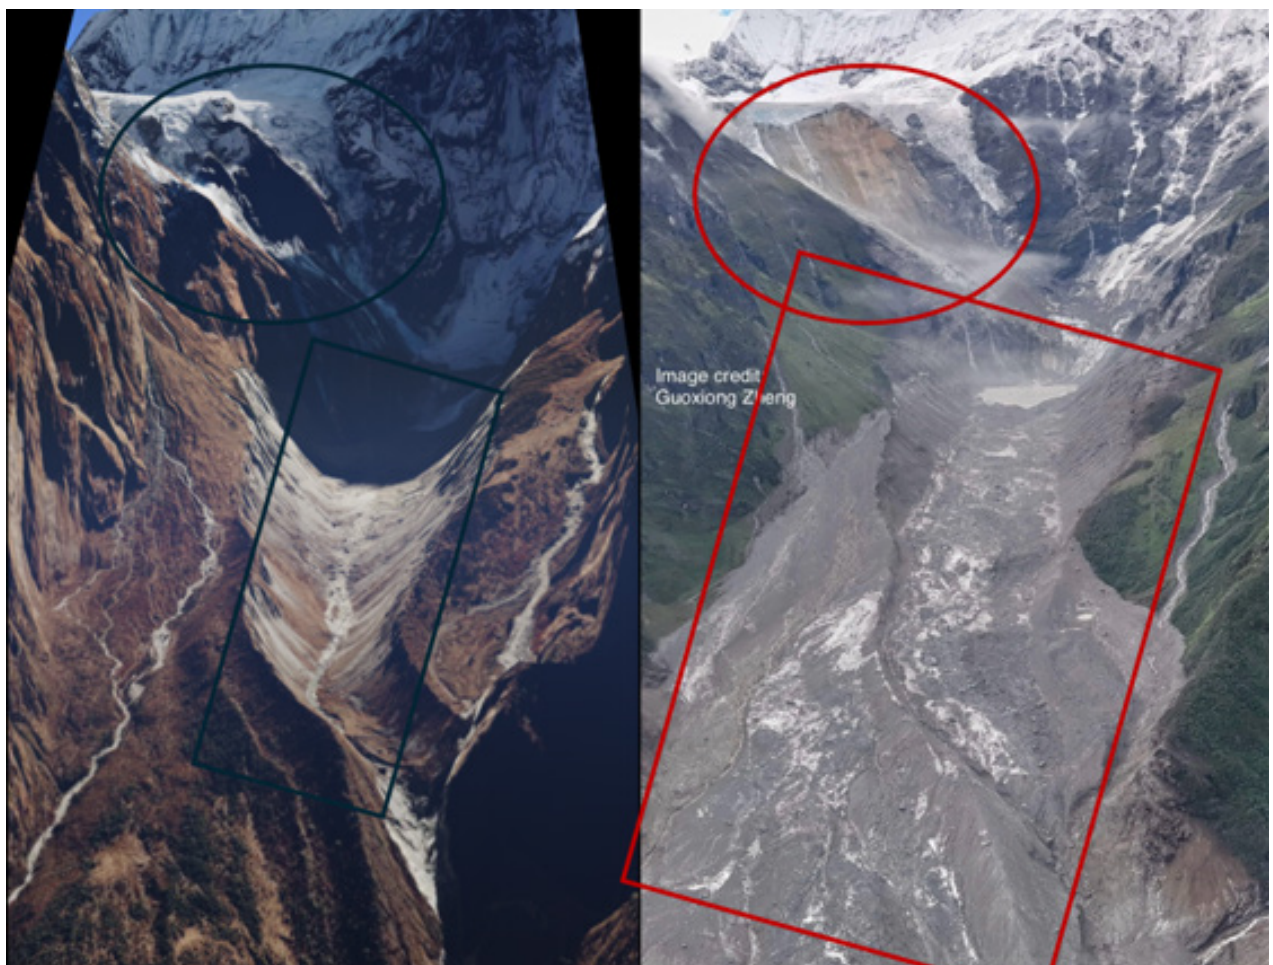
**FIGURE 1**

**AN AERIAL VIEW OF THE SOURCE AREA ON THE NORTHERN FACE OF LANGTANG LIRUNG BEFORE (LEFT) AND AFTER THE ROCK-ICE AVALANCHE (RIGHT)**

Once the seismic data and satellite images were studied more closely, it became clearer that it wasn't the tremor that had caused the collapse of a part of the glacier, but the other way around – that the collapse had caused the tremor. By the night of 26 August, it became clear that a massive rock-ice avalanche had occurred on the northern face of the Langtang Lirung massif, causing the Gyirong-Rasuwa disaster (Figure 1).

As has been discussed, the flood was triggered by a large rock–ice avalanche originating on the northern face of the Langtang Lirung massif. It was a bedrock failure that sheared away part of a hanging glacier (Figure 1). The massive block of ice and rock fell from an elevation of ~5,200 masl down a steep slope of nearly 50 degrees to the bottom of the valley, a near-vertical fall of about ~1,200 m and a total fall of ~2,200 m, and then rose ~450 m on the opposite slope (Figures 2 and 3).

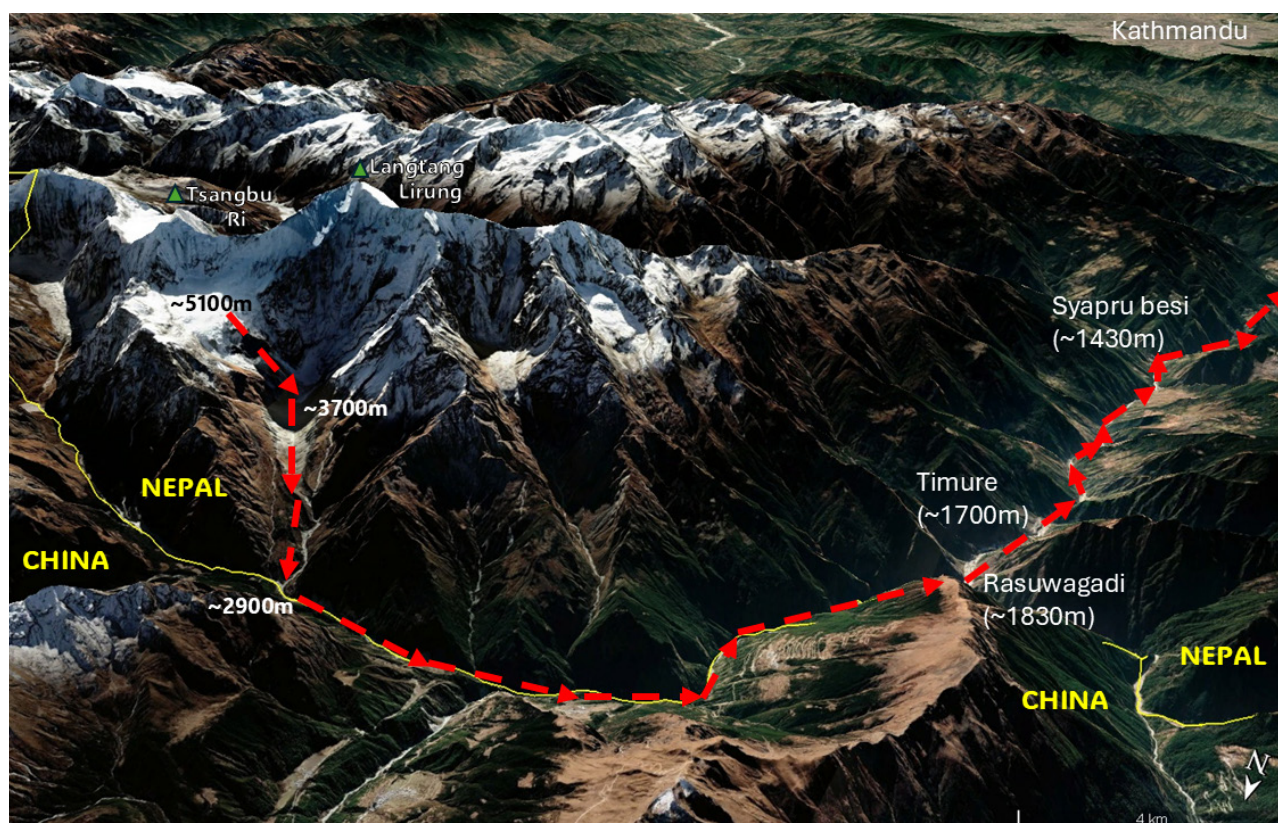
FIGURE 2

A BROAD VIEW OF THE RASUWAGADHI REGION ALONG THE NEPAL–CHINA BORDER, WITH KEY LOCATIONS MARKED, INCLUDING TIMURE, SYABRUBESI, AND RASUWAGADHI

Note: Elevation contours are noted at approximately 5,100, 3,700, and 2,900 masl.

This triggered a catastrophic debris flow that propagated through the Lhende Khola–Bhotekoshi–Trishuli river system, causing extensive damage in both China and Nepal (Figure 2). A secondary

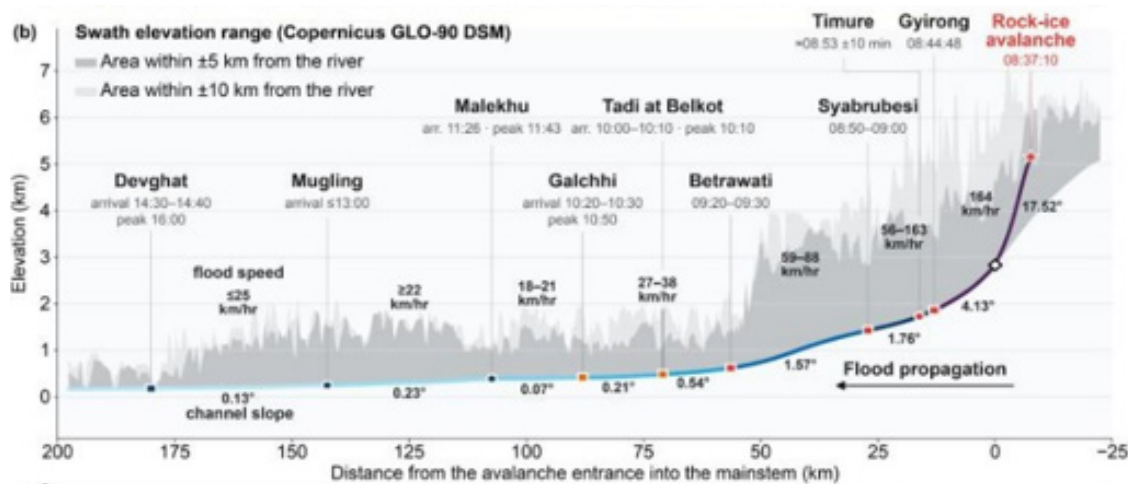
**FIGURE 12** FLOW PROPAGATION AND IMPACTS ON 26 AUGUST 2026

The flood corridor, estimated arrival times, and preliminary impact classification of major settlements

Longitudinal topographic profile along the rock-ice avalanche pathway and downstream channel, together with elevation ranges within  $\pm 5$  and  $\pm 10$  km of the mapped river centre line

Relative water-level changes at DHM stations on 26 August  
Source: Center for Land Surface Hazards (2026)

Comparisons of pre- and post-event satellite imagery offer a way to measure the extent of the flood's inundation. Figure 12 shows the estimated arrival times, topographic profile, and relative water-level changes at DHM stations on 26 August (Center for Land Surface Hazards 2026).

Information from Figure 12 was combined with seismic timing, gauge records, CCTV footage, witness accounts, and satellite and UAV imagery to reconstruct the propagation of the flood wave downstream (Table 1). Because these sources use
