# Insights behind the unexpected flooding in the Budhi Gandaki River, Gorkha, Nepal

**Authors:** Sudan Bikash Maharjan<sup>1\*</sup>, Pradeep Dangol<sup>1</sup>, Tenzing Chogyal Sherpa<sup>1</sup>, Arun B Shrestha<sup>1</sup>, Sharad P. Joshi<sup>1</sup>, Finu Shrestha<sup>1</sup>, Birendra Bajracharya<sup>1</sup>, Amrit Thapa<sup>2</sup>, Rakesh Kayastha<sup>3</sup>, Rijan Kayastha<sup>3</sup>

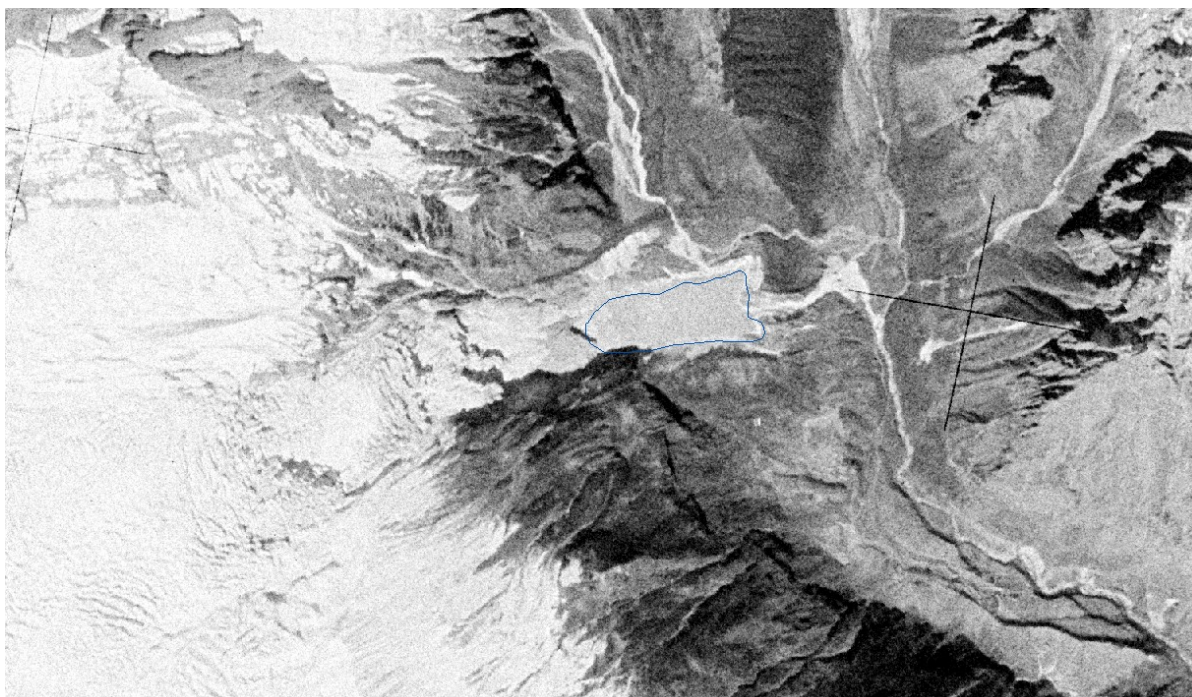
**Figure 12:** Declassified hexagonal telescopic satellite photograph (KH9-7, ground resolution 20–30 feet) dated 16 Nov 1973 shows the opened channel of the Lake and fresh debris at the lower section of the dam. No trace of flood is visible along the river in the downstream. The blue line shows the lake boundary mapped from the Landsat MSS satellite images of 1973. (The image is georeferenced but not orthorectified).

The Landsat image dated 28 October 1976 shows the distinct channel opening, whereas the image from 2 January 1973 (Figure 11) shows the position of the lake but the lake outlet is not distinctly visible. We further tracked the high resolution historical declassified satellite photographs from Corona (8 Nov 1967) and Hexagonal (16 Nov 1973), which confirm the open channel of the lake with erosion and deposition along the moraine dammed area (Figure 12 and Figure 13). However, we cannot find any significant changes in the downstream river flow area, indicating erosion or deposition of flow sediments due to flash floods over time from the late 1960s onward. This suggests that the lake either experienced a breach prior to the late 1960s or the channel was opened during the glacial process of melting, deposition of debris and formation of lakes. Understanding and tracking these processes require obtaining and analysing further historical aerial photographs and other sources of satellite images before and after the lake formed.

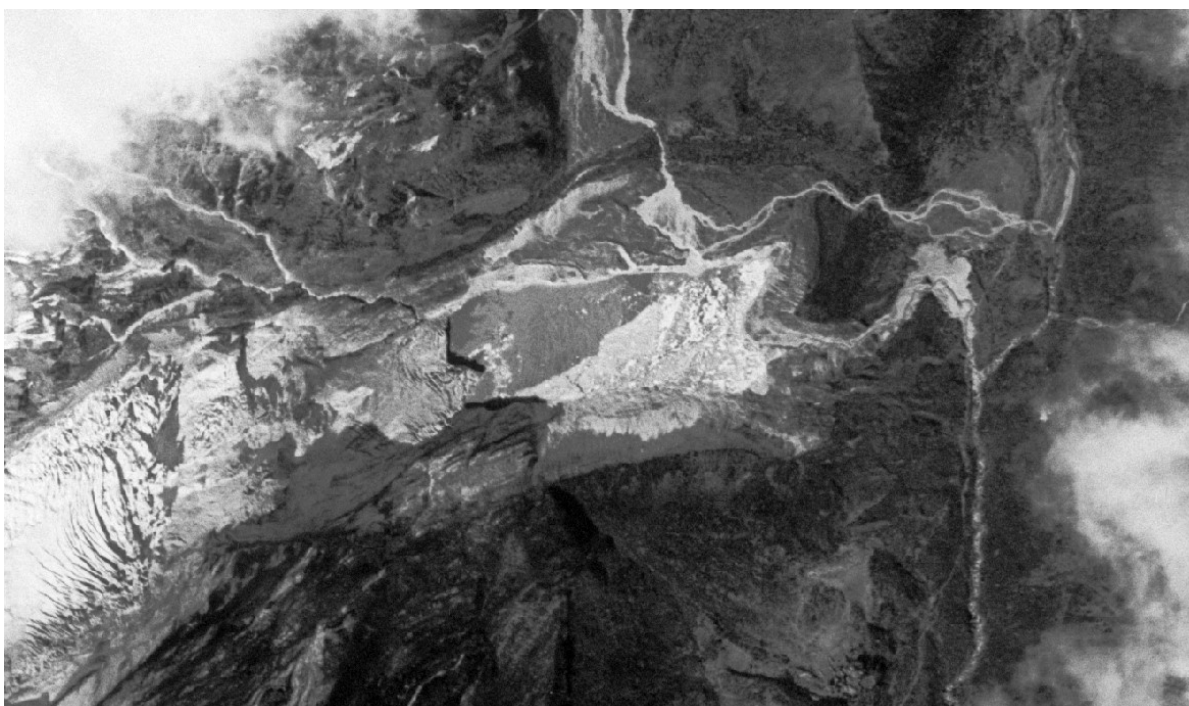
**Figure 13:** Declassified corona telescopic satellite photograph (KH-4A, ground resolution 9 feet) dated 8 Nov 1967 shows the opened channel of the Lake and fresh debris at the lower section of the dam. There is no distinct indication of a flood along the river in the downstream area. (Note: This image is not in scale, nor is it geo-rectified/orthorectified. In this case, the rivers and other features are not properly oriented as in other geo-rectified images above. Due to the rapid nature of this assessment, it has not been possible to geo-rectify/orthorectify these images as this is a lengthy process.)
