# Enhancing permafrost research capacity and community engagement in Humla

02 – 12 June 2025

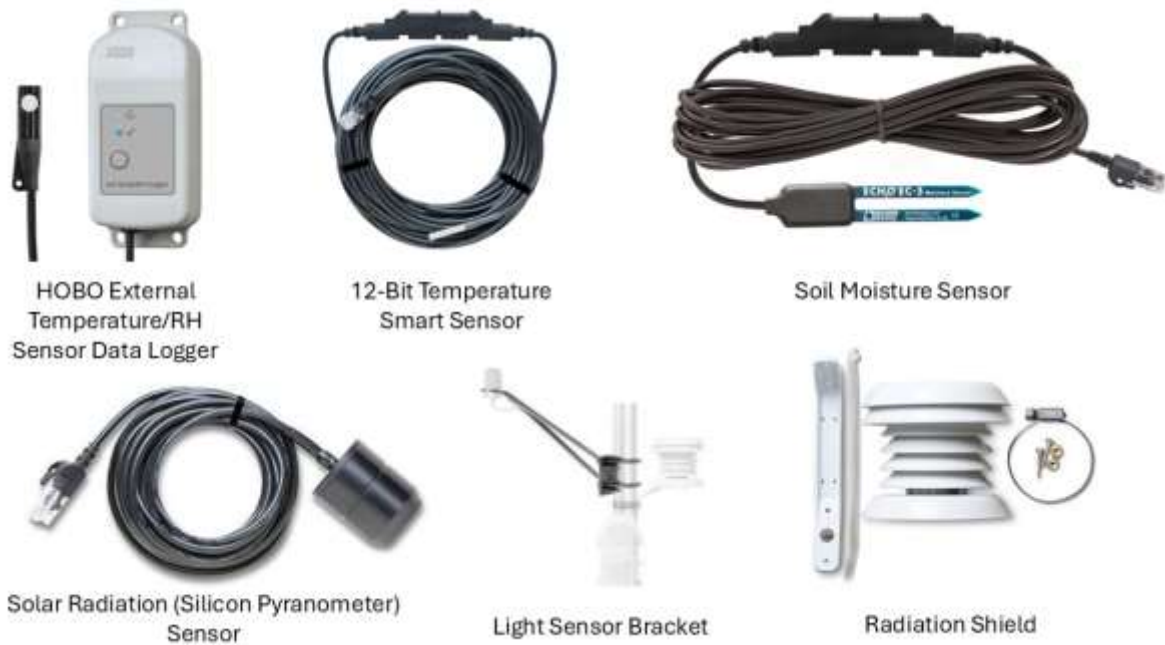
Figure 5. Sensors/instruments installed at the micro weather station

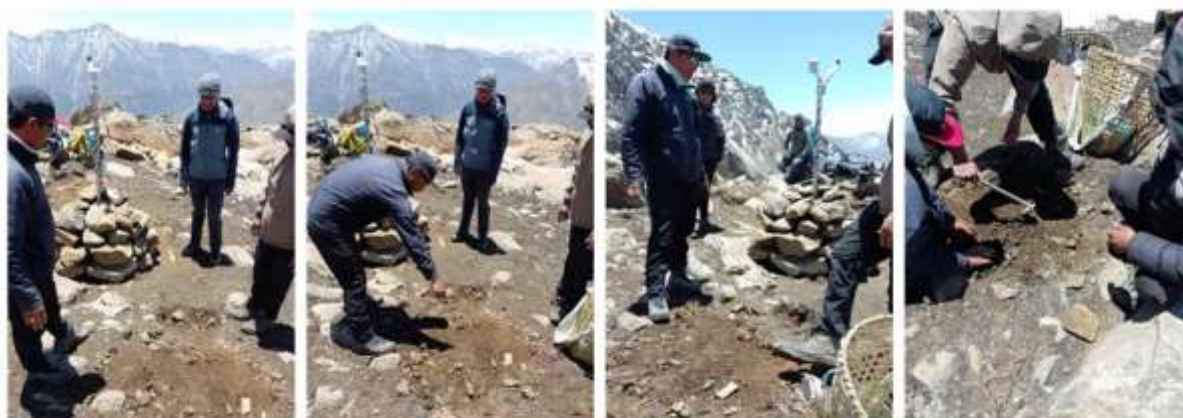
Figure 7. Placement photographs of the two TidbiT sensors deployed near the micro-weather station installed near the source area of the flood.

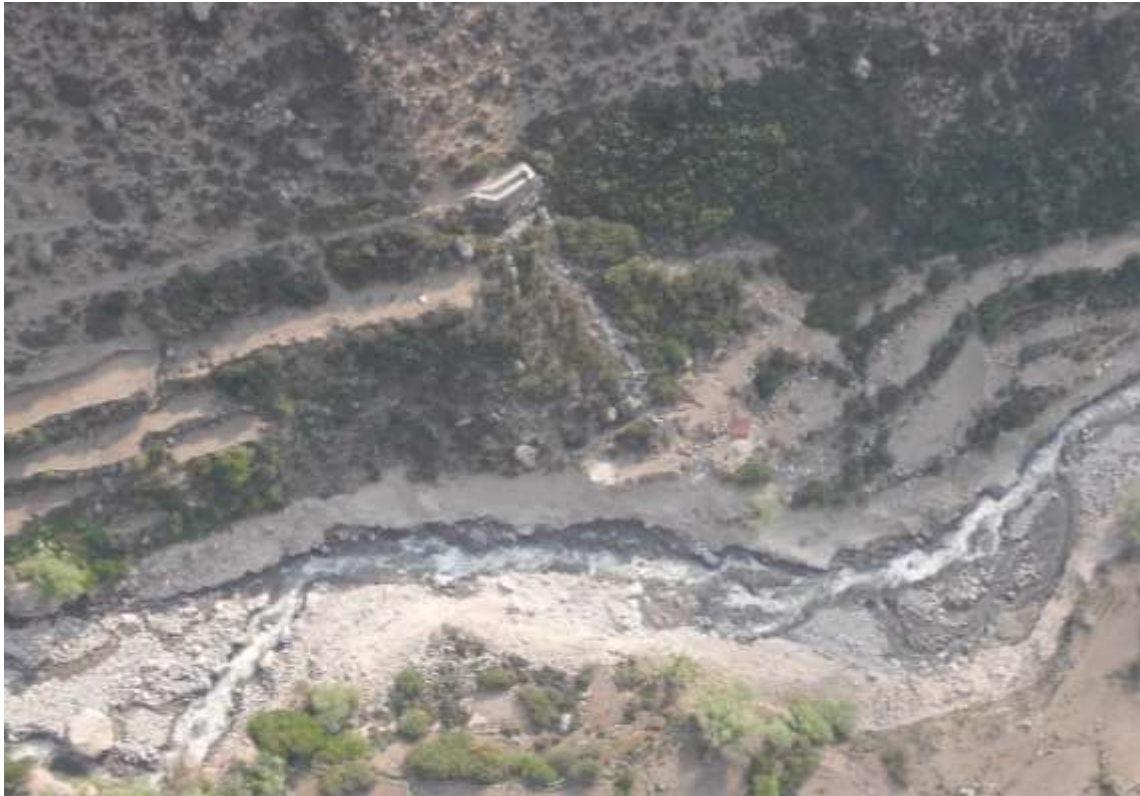
*Figure 9. Photo from the UAV showing the 15KW HP Powerhouse washout area including the collection of penstock pipes impacted by the flood. (Source: Sudan Bikash Maharjan).*
