Bulletin of the Department of Geology, Tribhuvan University, Kathmandu, Nepal, Vol. 10, 2007, pp. 79-88

# Bio-engineering measures for stabilising cut-slopes of Dipayal-Mellekh road, Far Western Nepal

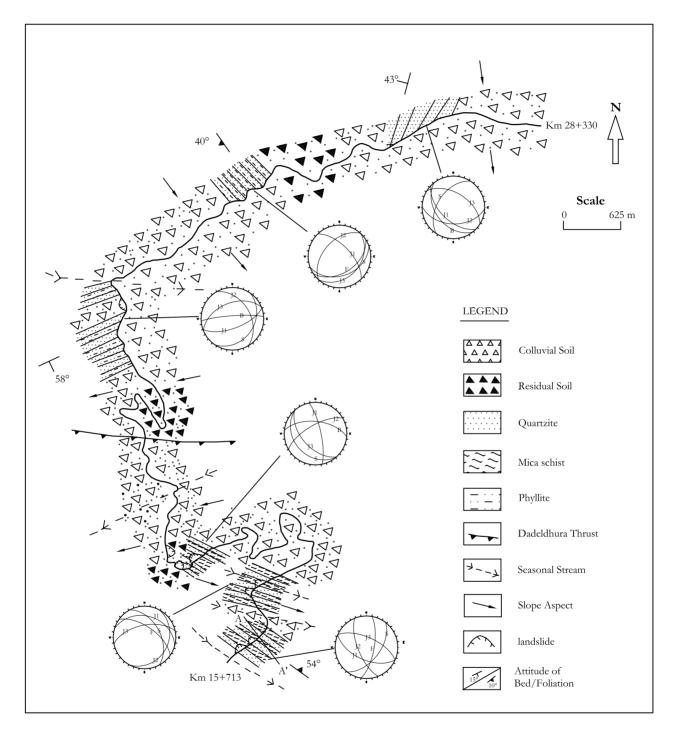
Fig. 3 Engineering geological map of the road alignment

terrain of the Kalikot Formation and are still hazardous suggesting instabilities in future. The active gully and rill erosion on the colluvial and residual soil surfaces also exhibits high vulnerability of mass wasting.
