Geotechnical Study of Unstable Slopes: A Case Study at Sunkoshi Power-house Site, Central Nepal

G.S. Pokharel

Soil, Rock and Concrete Laboratory, Nepal Electricity Authority
Bhagwan Pau, Swayambhu, Kathmandu, Nepal

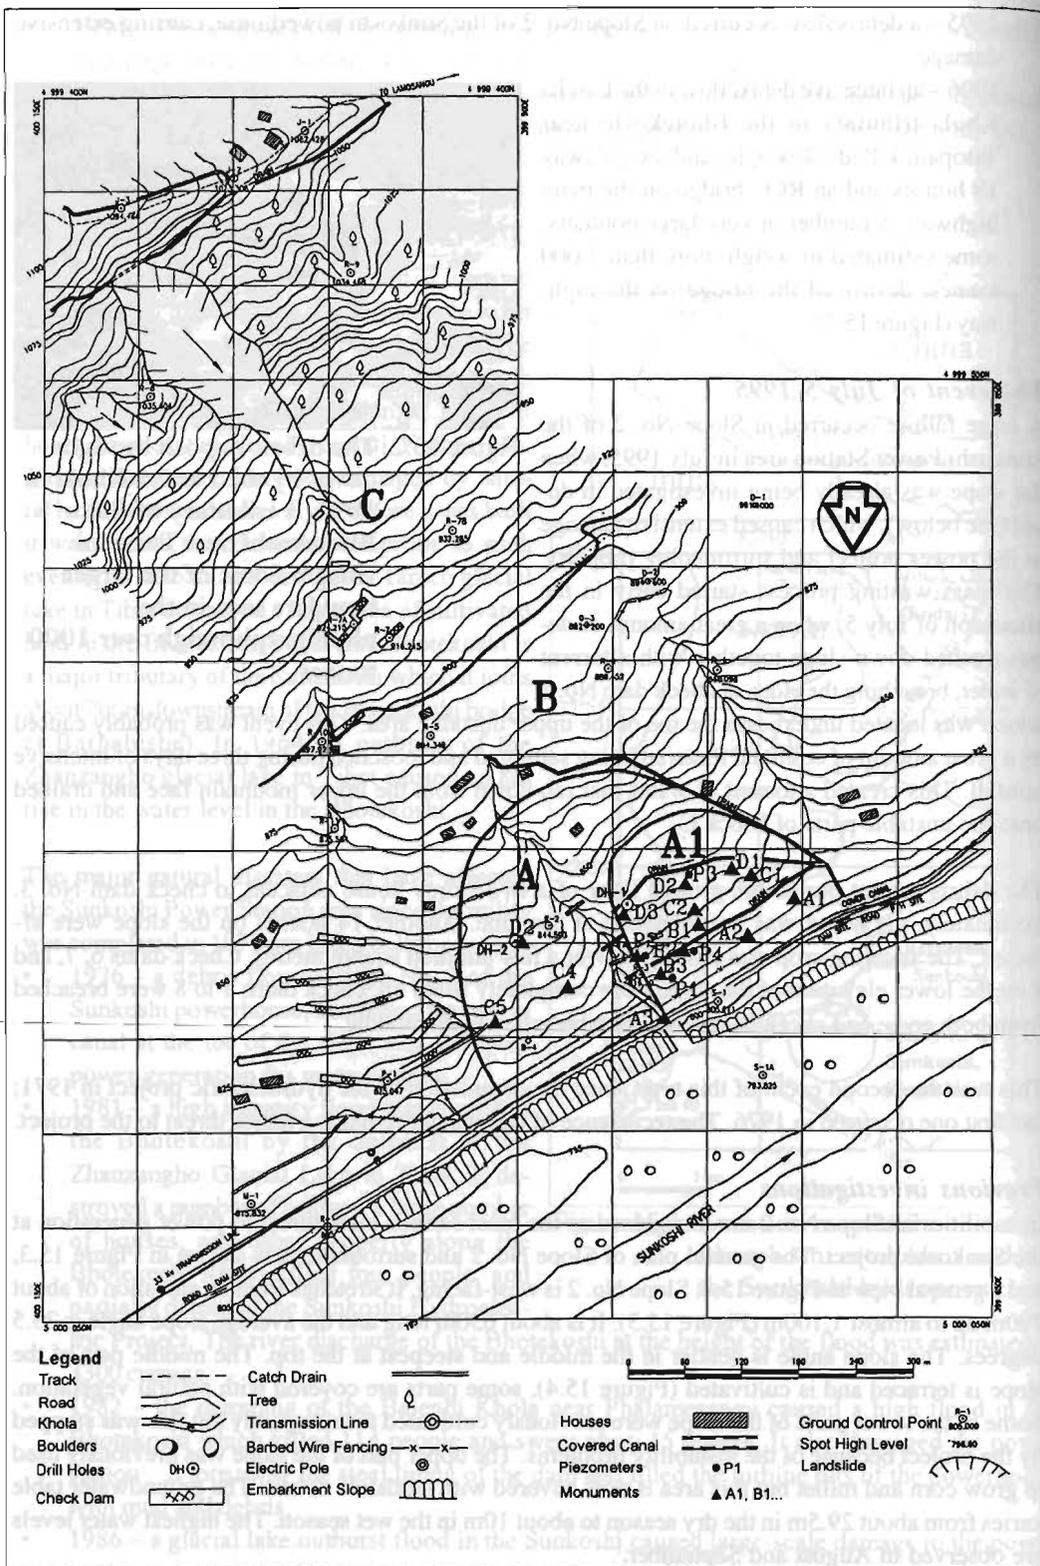
Figure 15.3: General plan of Slope No. 2 and its surroundings

Instabilities in Slope No. 2 are recognised as the most serious local threat to power generation at the Sunkoshi project. The general plan of Slope No. 2 and surroundings is shown in Figure 15.3, and a general view in Figure 15.4. Slope No. 2 is west-facing. It stretches from an elevation of about 790m up to almost 1,100m (Figure 15.3). It is about 630m long and the average slope angle is 25.5 degrees. The slope angle is gentler in the middle and steepest at the top. The middle part of the slope is terraced and is cultivated (Figure 15.4), some parts are covered with natural vegetation. Some of the lower parts of the slope were previously cultivated for rice paddy but this was stopped by the project because of the instability problems. The upper part of the slope was previously used to grow corn and millet but this area is now covered with landslide debris. The groundwater table varies from about 29.5m in the dry season to about 10m in the wet season. The highest water levels are observed in August and September.

In 1977-78 a team of geologists from the Water and Energy Resources Development Project (WERDP) of the Electricity Department of the Ministry of Water Resources, studied the slope. The team recommended that four piezometers be installed in the lower and middle parts of the slope to monitor the groundwater table. The piezometer standpipes were installed in 1979 in the lower and middle parts of Slope No. 2. The drill holes were terminated in the colluvium. The standpipes were numbered from P1 to P4 (Figure 15.3) and were at the elevations shown in Table 15.1.

Fifteen reference monuments marked as A1, A2, B1, C1, D1, and so on, were installed to monitor movement at different parts of the slope (Figure 15.3). Monitoring of these monuments over 14 years

The slope was divided into three blocks A, B, and C (Figure 15.3).

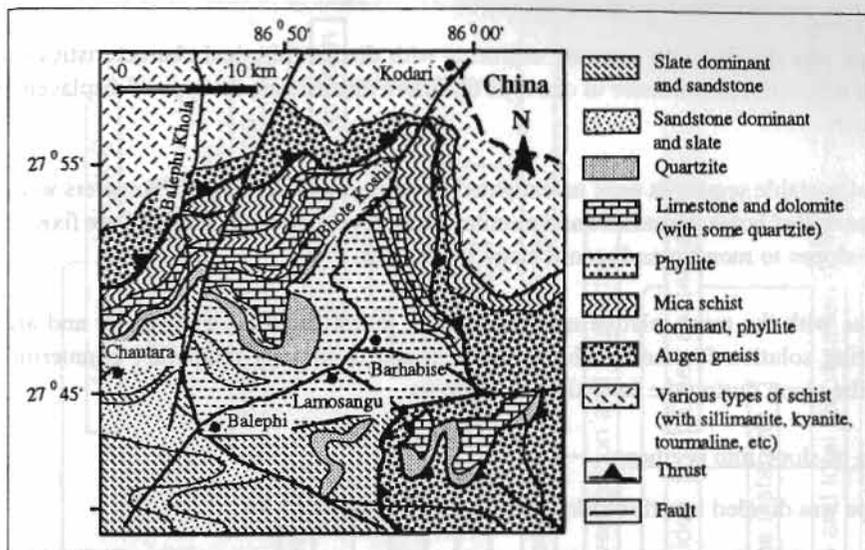
Figure 15.8: Geological map of Sunkoshi area (Maruo et al. 1973)

Figure 15.8 shows the geological map of the area and Figure 15.9 the structural map. The bedrock under Slope No. 2 is composed of rocks of the Midland meta-sediment group or Kuncha Formation consisting of phyllite, quartzose-phyllite, meta sandstone and grey pellic quartzite (Maruo et al. 1993). Structurally, the phyllite rocks constitute the core of the Lamosangu anticlinorium (Department of Mines and Geology 1985).

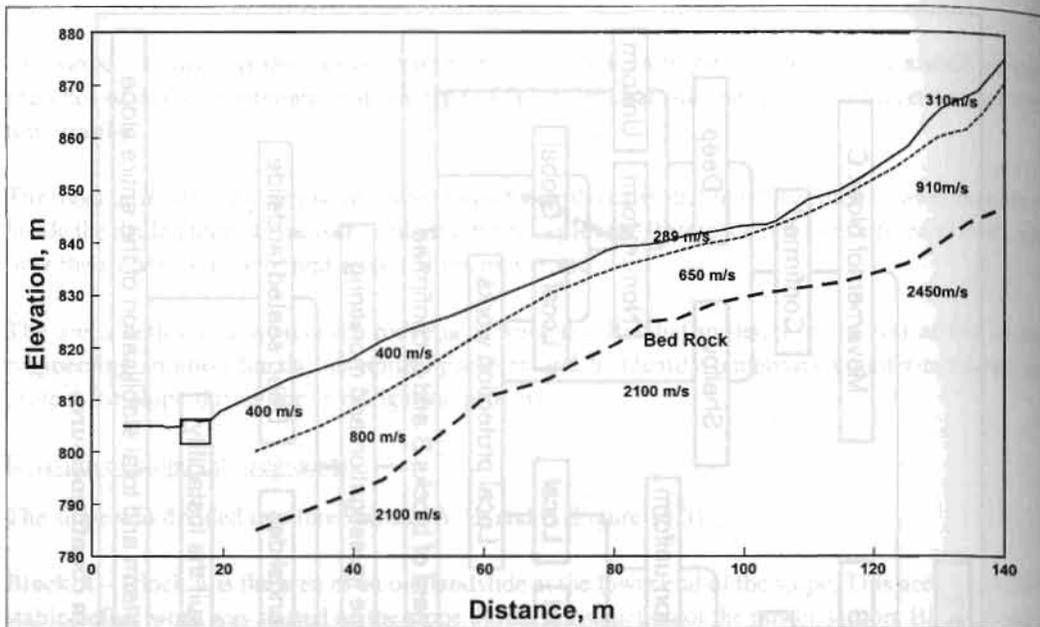
Figure 15.11: Seismic depth profile along Slope No. 2

A seismic profile of the slope was made in 1991 (Figure 15.11). The first stability analysis was carried out using the results of seismic refraction.
