Landslide Control and Stabilisation Measures for Mountain Roads: A Case Study of the Arniko Highway, Central Nepal

T. L. Adhikari

ITECO Nepal (P) Ltd., New Baneswor, Kathmandu Nepal

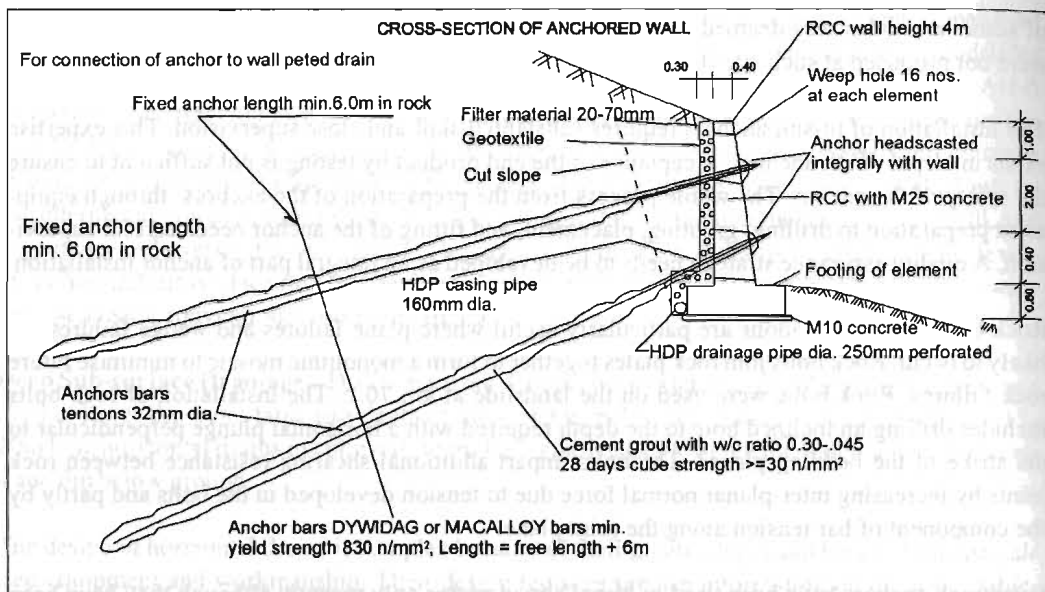
Figure 17.22: Anchorage measures used for stabilisation of Arniko Highway landslide AH-2 (AHP 1997)

Earth/rock anchors were applied at the km 70.2 landslide on the Arniko Highway to tie a composite retaining wall to weathered bed rock at a depth of 9-10m. Typical anchorage measures used for stabilisation of the landslide AH-2 are shown in Figure 17.22.

The most commonly used anchor tendons are continuously threaded MACALLOY or DYWIDAG anchor steel 32 mm ϕ with a minimum yield strength of 830–1030 N/mm². A working load of 250 kN on each anchor has been found suitable for the geotechnical conditions of landslides in the Sunkoshi Valley.
