# Chapter 3

## The Penstock and Allied Structures

### 3.1 The Penstock Pipe

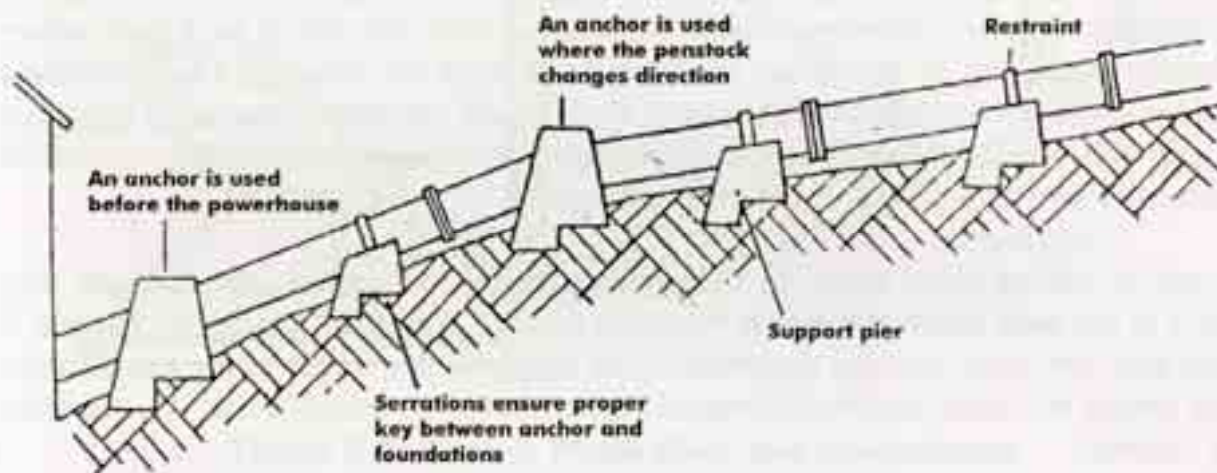
**Figure 3.1: A Typical Penstock Installation with Support Structures**

The penstock carries water from the forebay, which is an open tank, to the nozzle of the turbine at high velocity and under pressure (Figure 3.1). Thus considerable pressure may develop within the penstock towards the lower end. The penstock is usually made of mild steel, equal lengths of pipe with flanges on both sides are bolted together. Unflanged pipe lengths can also be welded at the site if such facilities exist. In low head schemes, the penstock can also be made from HDPE pipe.

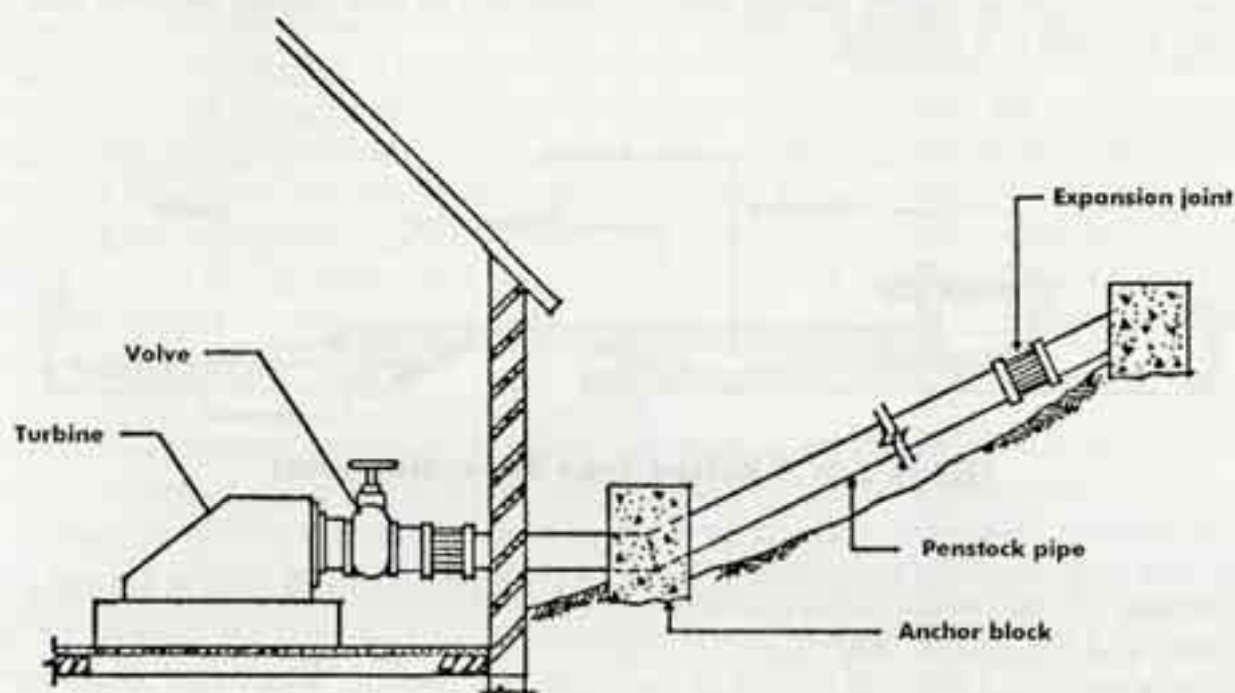
**Figure 3.2: Anchor Block Near the Powerhouse**

Support structures include support piers, which allow some axial movement of the penstock, and anchor blocks, which do not allow any kind of movement in any direction. Support piers are mostly made from cement-stone masonry and plastered with cement mortar, whereas anchor blocks are almost always made from concrete (Figure 3.2). In some cases, the support piers may also be made from dry stone masonry or some other cheaper materials.

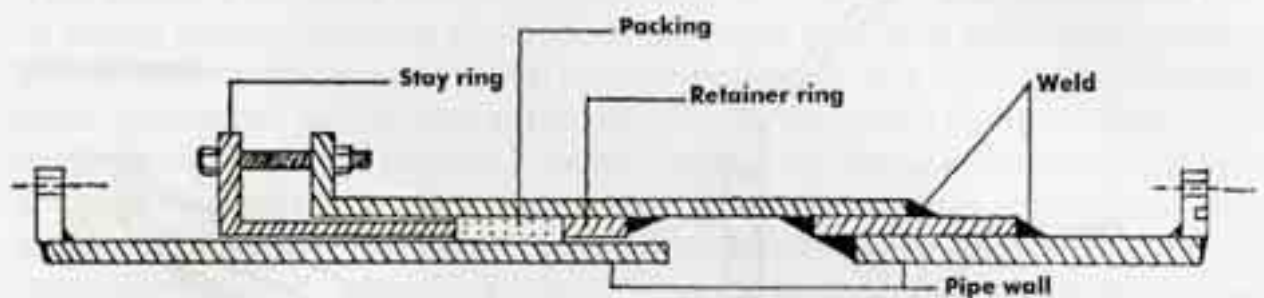
**Figure 3.3: A Bolted Type Expansion Joint**

The main function of expansion joints is to allow axial movement of the penstock pipe caused by changes in the ambient temperature. If this natural expansion were to be prevented it would induce undue stress in the penstock. The most common type of expansion joint consists of two pieces and is bolted (or in some rare cases welded) to the flanges of the lengths of penstock pipe (Figure 3.3). When the pipe expands or contracts, one piece of the expansion joint slides over the other. Leakage is prevented by inserting a suitable sealing packing that is compressed to stop leakage with the help of bolts provided in a stay ring.
