Stability Analysis: Practical Problems in Rock Slopes

A.B. Singh

Institute of Engineering, Tribhuvan University,
Pulchowk Campus, Lalitpur, Nepal

The first part of this paper attempts to assess rock mass qualitatively and as far as possible quantitatively in the light of recent developments in the field of rock mechanics. It also provides the basic theoretical background needed for the analysis of the most common types of rock slope failure. The second part discusses examples of the stability analysis of rock slopes at the dam sites of the Upper Arun and Kali Gandaki A hydroelectric projects in Nepal. The analyses are based on information provided by field geologists. The geological and geotechnical conditions in the Upper Arun were not complex so the stability analysis of the rock slopes at this site was more definitive. The geological and geotechnical conditions for the Kali Gandaki A Project were more difficult to interpret, for example the contact between dolomite and phyllites inside the slope could not be ascertained unequivocally even after the conclusion of the design phase. It is likely that problems will be encountered during construction at Kali Gandaki A.

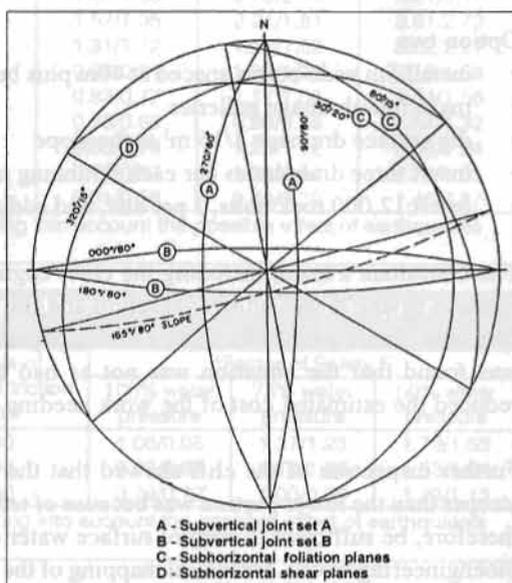
Figure 9.9: Stereographic plot of various discontinuities at the proposed Upper Arun dam site area

The sub-horizontal C-set joints are either the bedding plane or foliation plane joints. Spacing between foliation planes in intact rock varies from 10 cm to a few metres; however, spacing between planes of weakness due to foliation or schistosity is estimated to be 10-20m. At this site, the foliation planes show greater scatter in terms of their dip direction and dip angle. The dipping is, in all cases, into the cliff. Figure 9.9 shows a stereographic plot of the various discontinuities.
