# Landslide Hazard Management and Control in Pakistan A Review

M.H. Malik and S. Farooq Copyright © 1996

International Centre for Integrated Mountain Development

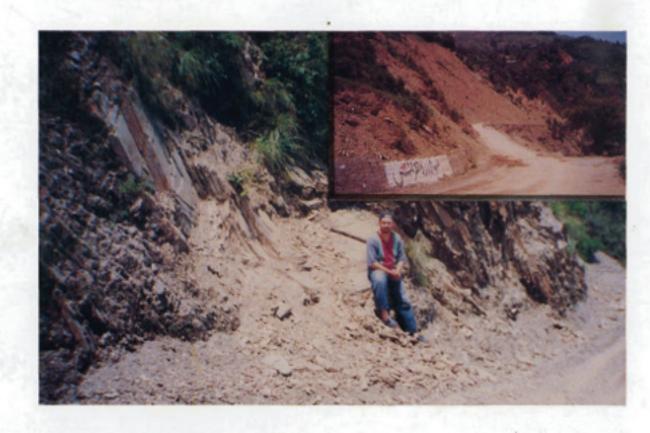
Cover Photograph: Plane failure in schists at Lower Gali, Muzaffarabad

Inset: Movement of scree slope blocking the road between

Muzaffarabad and Garhi Habib Ullah.
