Risk-conscious Reconstruction in Pakistan-administered Kashmir

A Case Study of the Chakhama Valley

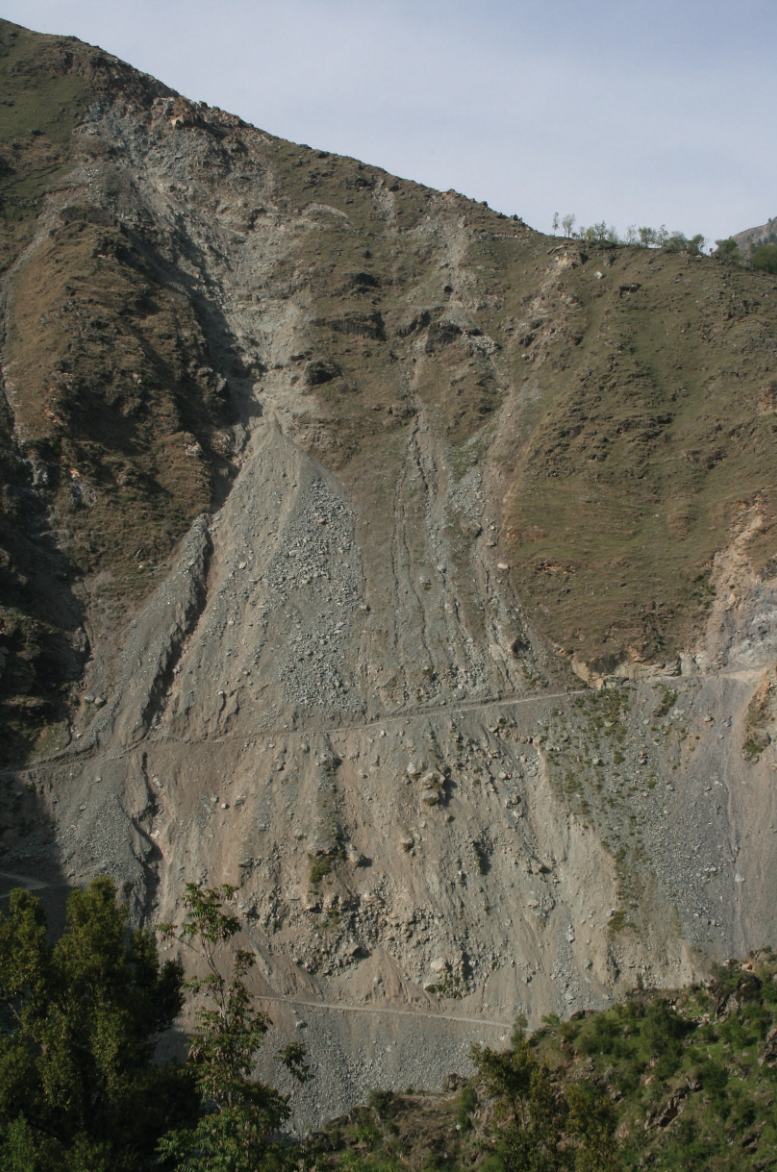
FIGURE 3 Landslide affecting the road to the upper Chakhama Valley. (Photo by AKDN, 4 April 2007)

The footzone of the Himalayas in Pakistan-administered Kashmir possesses a medium to high degree of landslide hazard, according to the World Bank's hot spot study (World Bank 2006). In Chakhama, rock formations in the vicinity of the fault lines are highly deformed, fractured, and sheared. The intense shaking of the recent earthquake caused new openings of pre-existing fractures and cracks. Infiltration and percolation of rainwater and snowmelt within the system of fractures increased substantially after the earthquake (GeoConsult 2007). Due to more frequent saturation of the soil and rock formations, their strength has declined significantly, resulting in numerous slope movements such as bank collapse, landslides, rockfalls, and large-scale debris flows (Figure 3).

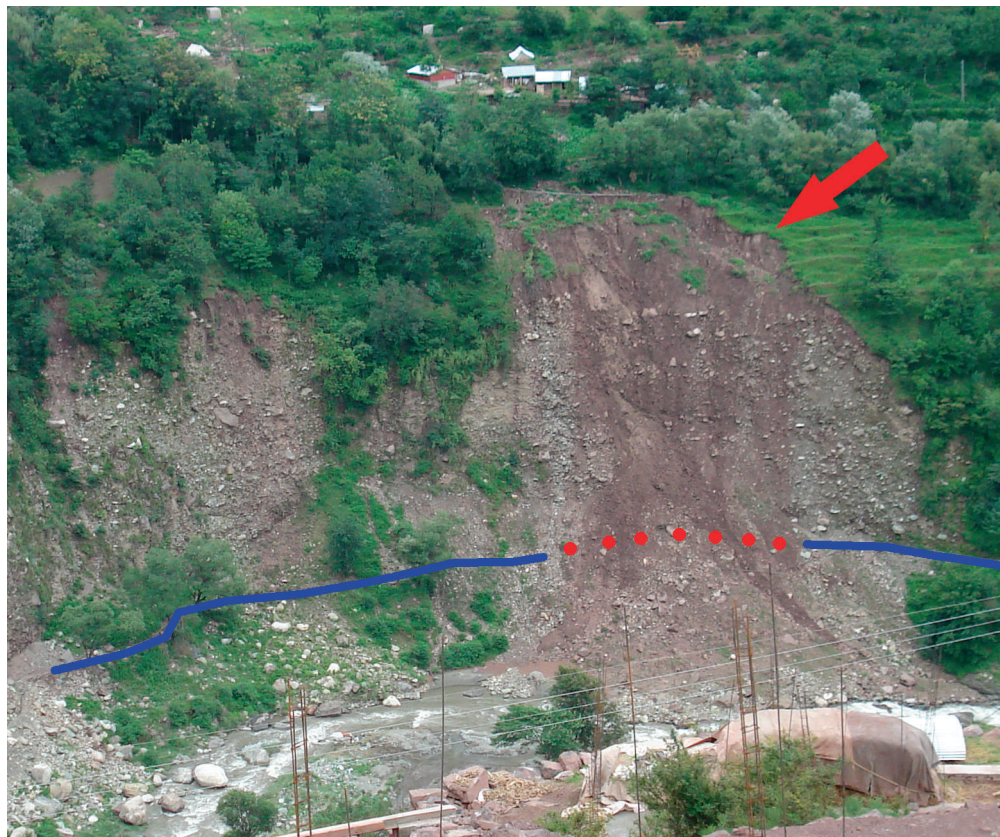
FIGURE 6 Kathai irrigation canal (blue line); most critical section for rehabilitation (red dots) with highly unstable slope above (arrow). (Photo by Markus Zimmermann, 3 July 2007)

The slopes along the canal are of an alluvial nature, comprising gravel, cobbles, and boulders with sand and silt. The slopes are generally stable in dry conditions but begin to move when saturated, particularly in the upper portions. Landslides, slope failures, and falling debris after heavy rains in early 2007 caused significant damage to the canal (Figure 6).

At critical points where landslides were a particular threat (Figure 6), the canal was protected with concrete slabs so that debris could flow over the covered/slabbed section of the canal. Retaining walls were constructed where required. In the most critical section, the freshly accumulated debris in the canal was carefully stabilized for rehabilitation.
