# Rehabilitation of Degraded Lands

P. B. Shah, H. Adhikari, G. Nakarmi and B. Shrestha

Mountain Resource Management Project, International Centre for Integrated Mountain Development,  
ICIMOD, Kathmandu, Nepal

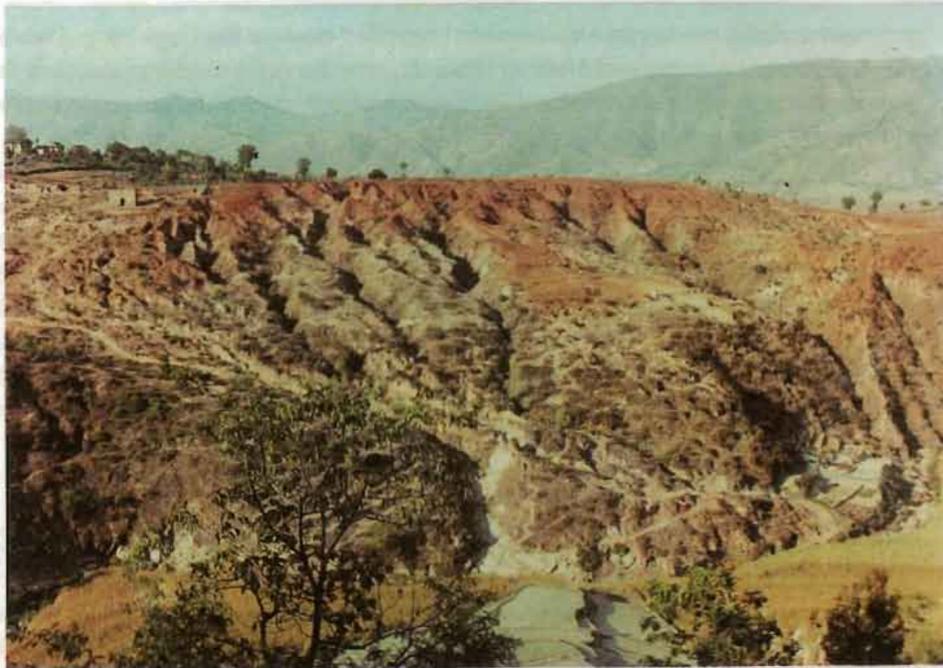
The site chosen is located below Luitelgaun and covers an area of about 2.5 ha of very badly degraded land dominated by red soils. Over the past 20 years all trees were removed from the site and extensive and continuous collection of fodder and litter has resulted in massive rill and gully erosion. During every monsoon season massive headcutting and accelerated erosion occurs at the site and the off site impact on the stream and irrigation systems downstream are serious. A number of experiments were conducted in an attempt to improve soil fertility conditions, stabilize the gullies and introduce an agro-forestry system. An overview of the site at the time the experiments were initiated is provided in Figure 1.

Figure 1. Overview of demonstration site for agro-forestry experiments.

There are no quick solutions to rehabilitate a site which is as degraded as that shown in Figure 1. A long term approach is needed because moving and redistributing the remaining soil material will not stabilize the soils and the nutrient status of all material at the sites is very depleted. The key issues are: (1) ameliorate soil nutrient conditions in the absence of large amounts of manure and fertilizer inputs, (2) stabilize the soils and eliminate or significantly reduce surface run-off, (3) provide a local supply of plant material that can be used for stabilizing the soils and improving the soil conditions and (4) improve the water availability at the site with appropriate irrigation systems that benefit the plants but minimize run-off.

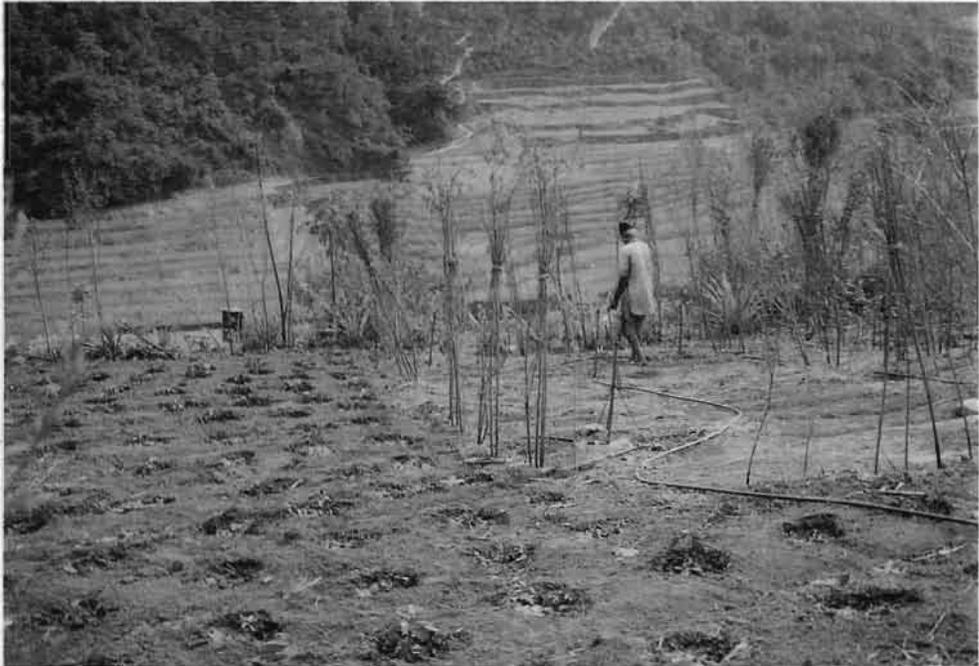
The water is stored in oil drums and galvanized containers, and a very low cost trickle irrigation system was initiated below a number of storage containers. A network of many small 3-10 mm size hoses was connected to the tank, and a inexpensive flow controller was added to the end of the tube. The optimum rate is a 2 L/hour controller. The outlet is placed next to each plant, and water is applied by gravity for about 1-2 hours per day, depending on crops and time of the year. An example of the system is provided in Figure 2. The results obtained to date are encouraging because the method is water-conserving, and the problem with sediment inputs into the irrigation water was solved by including sediment filters in the irrigation system.

Figure 2. Example of a trickle irrigation system.

Since the soils are desiccated during the dry season and surface plant cover is minimal, it was felt necessary to introduce some irrigation capacity. As shown by Carver and Nakarmi (1995), surface cover at the end of the dry season is critical for erosion control, particularly when the first monsoon rains occur. This requires water, and the only way to bring water to the site is by pumping water from the stream to the various planting sites. To solve the elevation problem, a solar pump was installed and storage reservoirs were constructed to provide a constant water supply during the dry season.
